EVALUATION OF TIMBER WEAK-POST GUARDRAIL SYSTEMS

Maurice E. Bronstad, Southwest Research Institute; and Robert B. Burket, Ohio Department of Highways

Six full-scale vehicle crash tests were conducted on guardrail systems to evaluate the effectiveness of substituting timber posts for the standard 315.7 steel posts specified in a current guardrail standard. Results of the tests indicate that timber is a suitable post material for the "weak-post" concept. Although there was some difficulty in determining the proper rail attachment to the post, solutions to the problem are suggested in this report. Basically, the timber post design calls for a 12-gage flexural beam mounted on 6- by 7-in. or $5\frac{1}{2}$ -in. diameter pine posts spaced at 12.5-ft centers. A $\frac{1}{4}$ -in. diameter steel bolt and a pipe insert provide proper attachment of rail to post. The sixth test of the series provided an evaluation of the effectiveness of a continuous installation composed of the new timber weak-post system and the department's strong-post system. The test results indicated that the transition design between the two systems was satisfactory, but design changes could improve performance.

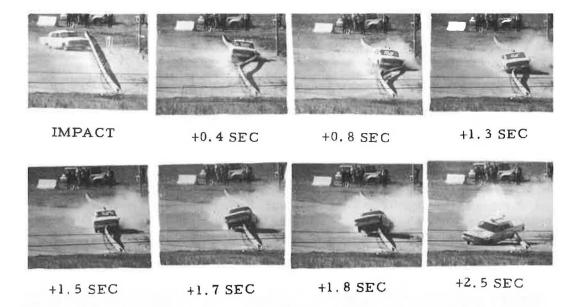
Figure 1. Sequence of events, test ODH-2.

Based on the results of the first test, 4- by 6-in. posts were installed for the test and an additional 50 ft was added to the length of the test installation. The test vehicle impacted the installation with a speed of 62 mph and an angle of 25.3 deg (Appendix, Figs. 10 and 11). Although loss of rail height after impact permitted the vehicle to straddle the rail (Fig. 1), the vehicle was contained by the system and redirected. The vehicle was launched, but remained upright and was braked to a stop with moderate vehicle damage. Peak vertical and lateral dummy accelerations were +3 and -3 g respectively. Peak vehicle accelerations were -2.8 g and -2.4 g in the lateral and longitudinal directions respectively. As in test ODH-1, the $\frac{5}{16}$ -in. diameter post bolts did not shear. Rail separation from the post was accomplished by forcing the rear washer through the post material.

Although the vehicle accelerations and maximum dynamic deflection of the system were considered satisfactory for test ODH-2, two undesirable phenomena were observed that indicated a change in design to be justified:

- 1. The rail dropped excessively permitting the vehicle to straddle the rail; and
- 2. The vehicle remained in contact with the system for an extensive distance, resulting in excessive system damage.

Lack of sufficient post strength and failure of the post bolts to shear on impact were considered primary causes of these undesirable results.

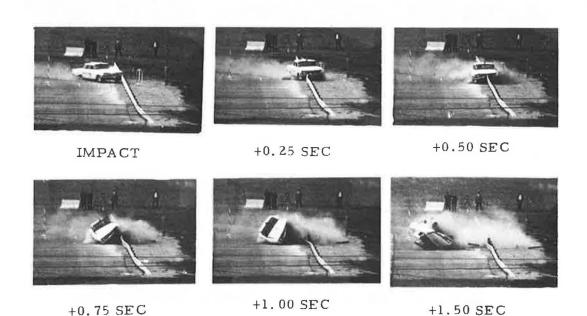
Figure 2. Sequence of events, test ODH-3.

Test ODH-3 impact conditions were 62.5 mph at a 28.7-deg angle (Appendix, Figs. 12 and 13). The vehicle was initially redirected, but pocketing occurred about 30 ft from impact, and the vehicle rolled over and remained inverted (Fig. 2). Vehicle ac-

celeration levels before rollover reached maximum values of -4 g laterally and -7.5 g longitudinally. Dummy accelerations reached maximum values of -11 g longitudinally, -8 g laterally, and -11 g vertically before rollover. Seat-belt and shoulder-harness loads reached maximum values of approximately 2,000 lb before rollover.

As indicated by the magnitude of the forces and accelerations measured prior to rollover, the 7-in. diameter posts were too formidable for the weak-post concept. Although the rollover was a clear indicator of system failure, other measured events before the rollover provided equally clear indications of the need for a weaker post. A positive result of this test was the success in achieving bolt shear in the impact area.

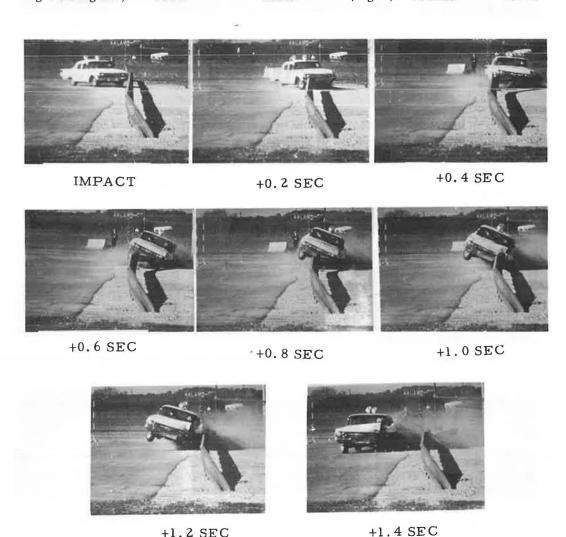
Figure 3. Sequence of events, test ODH-4.

A 6-in. diameter post was selected for test ODH-4; all other details (including pipe inserts) were the same as for test ODH-3. The vehicle impacted the rail with a speed of 63.1 mph and an angle of 28.3 deg (Appendix, Figs. 14 and 15). The vehicle was contained and redirected by the system, but loss of rail height again occurred due to lack of bolt shear. As the rail dropped, the vehicle rolled about 15 deg but remained upright throughout; the vehicle did not straddle the rail (Fig. 3). Vehicle accelerations

reached maximum values of -3.8 g laterally and -3.1 g longitudinally. Maximum values of -5.0 g longitudinally, -10 g laterally, and -7 g vertically were recorded from the dummy response. Maximum seat-belt and shoulder-harness loads were 1,000 and 650 lb respectively. Failure to achieve rail separation from the posts in impact area through bolt shear was considered to be the principal cause of the rail drop.

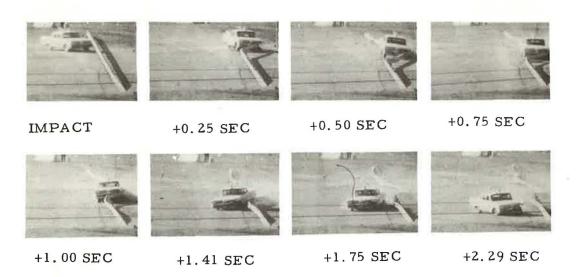
Figure 4. Sequence of events, test ODH-5.

A $\frac{1}{4}$ -in. diameter bolt was substituted for the previously used $\frac{5}{16}$ -in. diameter bolt. A close-fit pipe insert was selected for compatibility with the new bolt size. Because the 6-in. diameter posts from test ODH-4 were considered to be somewhat overstrength, a 6- by 6-in. post with $\frac{1}{2}$ -in. notches on upstream and downstream edges 2 in. above grade was selected. The vehicle impacted with a speed of 70.8 mph and an angle of 26.7 deg (Appendix, Figs. 16 and 17). Redirection of the vehicle was good, and the rail remained at an effective height throughout the test (Fig. 4). The elusive bolt shear phenomenon was attained; however, it was not confined to impact area, as all but one of the bolts sheared. Maximum vehicle accelerations were -4.6 g laterally and -3 g longitudinally. A maximum of 8.8 g laterally was recorded from the dummy; seatbelt and shoulder-harness loads reached maximum values of 1,000 and 800 lb respect respectively.

Although the test vehicle attained a speed well in excess of the desired test value, the system performed well under severe conditions. The notching of the posts had no effect on the performance, as all posts broke approximately 12 in. below ground level.

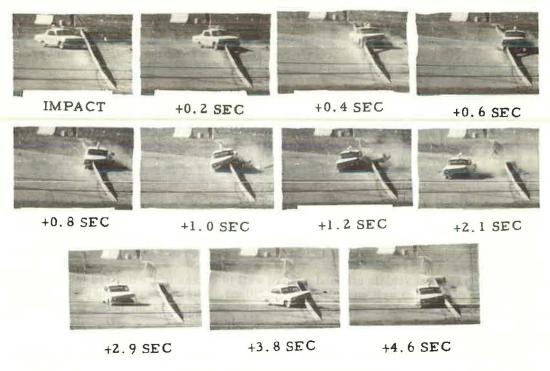
Figure 5. Sequence of events, test ODH-7.

pocket near this exit point was evident, but the vehicle ranged only about 14 ft off the rail line before the brakes were applied and a subsequent second impact with the rail system occurred (Fig. 5). Maximum vehicle accelerations from film data were -3.2 g laterally and -4.3 g longitudinally. Dummy accelerations reached maximum value of -3.0 g longitudinally, -7.5 g laterally, and -6.5 g vertically. A maximum of 1,200 lb was recorded from the right seat-belt load cell. The $\frac{1}{4}$ -in. diameter bolt shear was again extensive and the effect of the notch was negated by post failure occurring below the notch line.

Of the five general performance tests conducted during this test series, three installations performed successfully. After analyzing the events of test ODH-2, it could be surmised that, if the pipe insert or the $\frac{1}{4}$ -in. diameter bolt or both had been used, the rail would have remained at effective height and thus prevented the vehicle from straddling the rail. The loss of rail height that occurred during test ODH-4 could possibly have been prevented through the use of $\frac{1}{4}$ -in. diameter bolts or perhaps a closer fitting insert for the $\frac{5}{16}$ -in. diameter bolt. The performance of the test ODH-5 installation was good, although the extensive bolt shear and subsequent loss of rail support after impact could prove to be a maintenance problem. The other two test installations (tests ODH-1 and ODH-3) must be considered as unsatisfactory because of overall performance. The transition test (test ODH-7) is considered to be a technical success, although the tendency to pocket at the exit point should indicate that improvements are necessary.

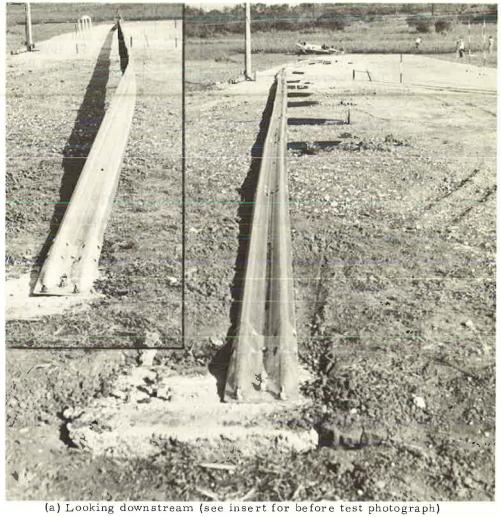
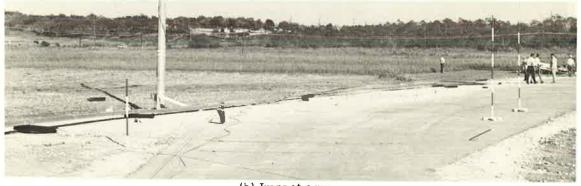
Figure 8. Photographs of test ODH-1.

All posts in the installation were broken near ground level (Appendix, Figs. 8 and 9). Failure of the upstream posts clearly indicated the lack of sufficient post strength. Because of the extended contact with the system, the vehicle engaged the downstream terminal treatment, which indicated there was insufficient installation length for a general performance test.

(b) Impact area

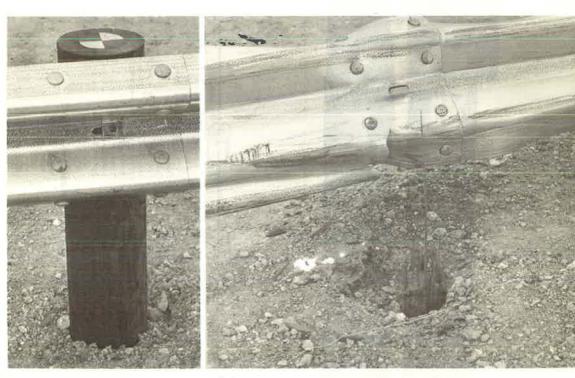
(b) Post detail

(c) Typical post failure (note tear in rail section)
