DYNAMIC TESTS OF AN ENERGY-ABSORBING BARRIER EMPLOYING STEEL DRUMS

Eric F. Nordlin, James H. Woodstrom, and Robert N. Doty,
California Division of Highways

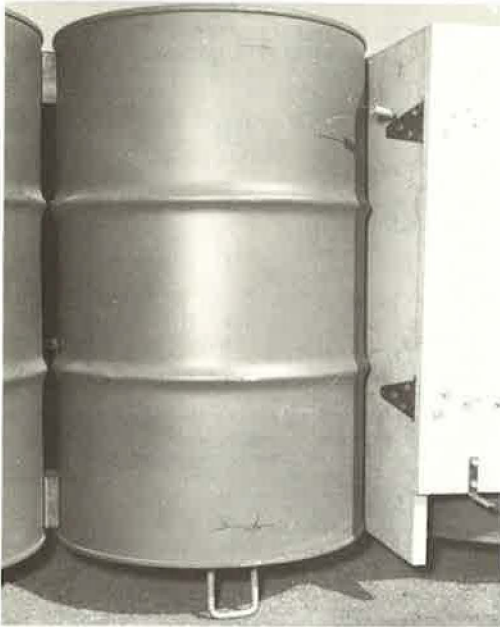
Figure 2.

component of the impact forces. The trailing edge of each fender panel overlapped the leading edge of the next rearward panel in a fish-scale manner such that barrier crush would not be restricted during a head-on impact. Light springs were used to maintain the fender panels in the closed position (Fig. 2).

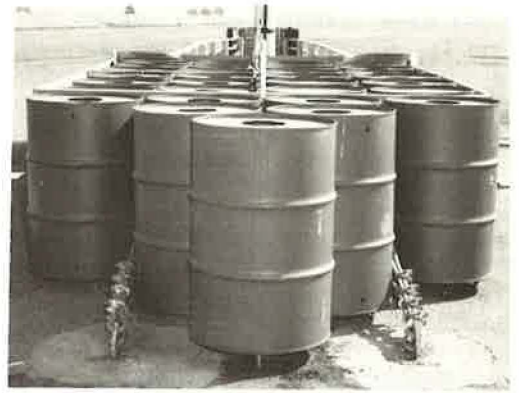
Figure 3.

Lateral and vertical restraint was provided by four $\frac{3}{4}$ -in. wire ropes attached to fabricated steel T-sections embedded in cast-in-place concrete anchors. The wire rope was threaded between the drums so that the drums would be free to slide backward during impact and then attached to the bridge approach guardrail using swaged fittings. A slight pre-impact tensile force was applied to the cables, which were aligned in a straight line to minimize the slack, and subsequent lateral movement that develops during an oblique-angle impact. The concrete anchors were located so that the front drums would receive as much lateral support as possible from cables placed low enough to minimize the possibility of snagging the impacting vehicle (Fig. 3).

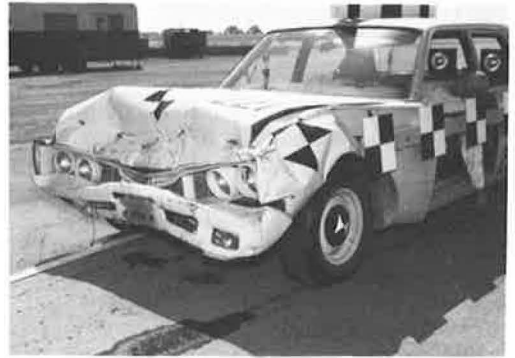
Figure 5.

Vehicular damage consisted of some bumper deformation, a cracked windshield, a jammed door on the right-front side, damage to both front quarter panels, 3.4 in. of steering column collapse (energy-absorbing steering column), and some dashboard deformation (Figs. 5

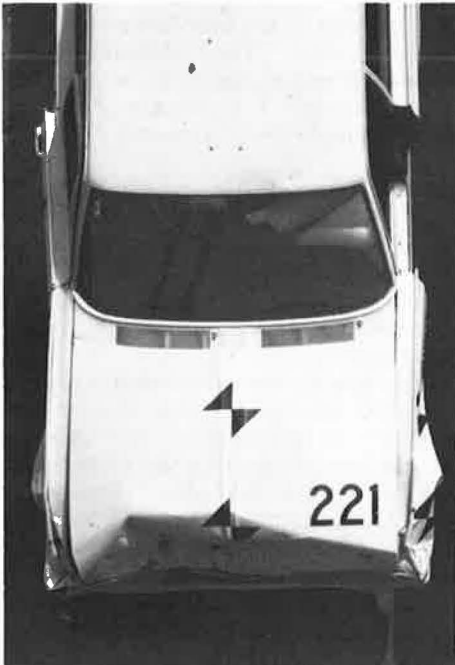
Figure 6.

and 6). Maximum vehicular crush was 16.5 in.

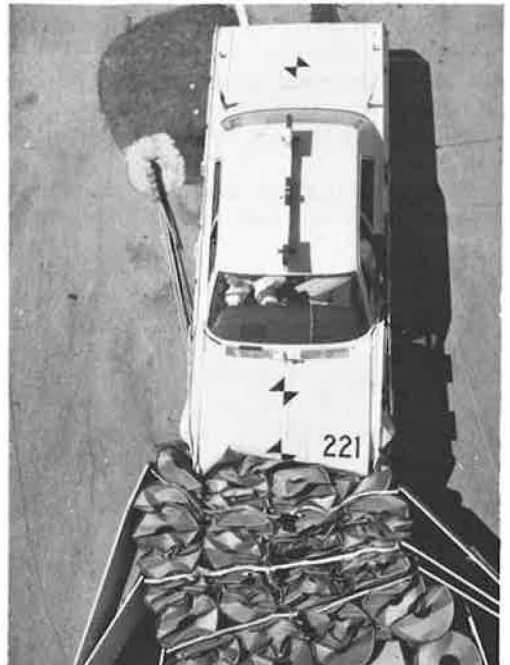
Figure 7.

All the drums in the barrier were deformed (Figs. 7 and 8). The cables were slack but undamaged. The plywood fender panels were badly cracked and splintered but remained attached to the barrier as it was deformed around the nose of the bridge approach guardrail. The drums crushed one row at a time, in successive order, as had been assumed in the design procedure. Figure 20 in the Appendix shows additional test data.

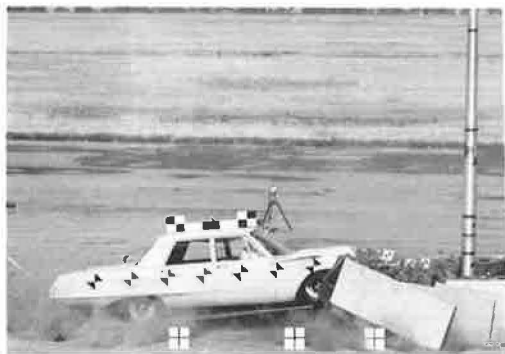
There was a noticeable vertical force imparted to the vehicle as shown by the vehicular rise in Figure 4. The rise was caused at least in part by the right-front wheel riding up on the cable. There was virtually no vehicular rebound.

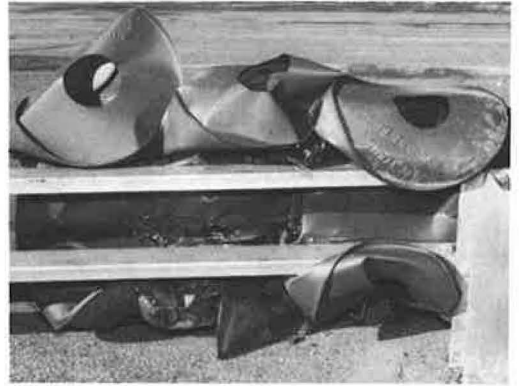
Figure 9.

The force of the impact caused a clamping action to take place between the rear drums and the bridge approach guardrail, thus preventing drum ejection (Fig. 9). Additional barrier damage consisted of crushing of the outside drums in the back half of the barrier on the impacted side. All the fender panels beyond the point of impact were torn off the barrier. There were some failures of hinge pins; the ends of the last few diaphragms were broken off on the impact side. There was an unacceptable amount of debris deposited in what would be the adjacent traveled way. Some of the fender-panel fragments were thrown approximately 155 ft from the point of impact (Figs. 10 and 11).

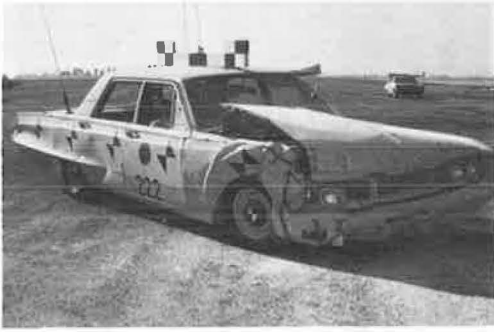
Figure 12.

Vehicle damage included severe crushing of the right-front quarter panel, jamming of the right-front door, scars on the right doors and right-rear panel, and displacement of the radiator to the point of touching one fan blade (Fig. 12). Figure 21 in the Appendix shows additional test data.

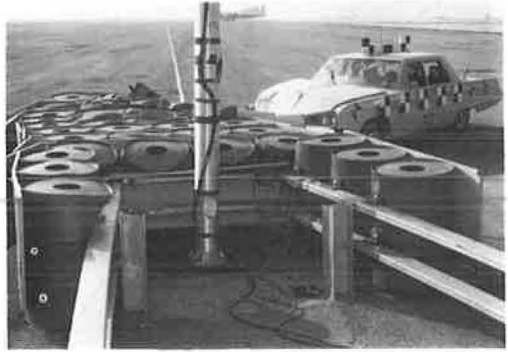
Figure 13.

Test 223 consisted of a 4,740-lb 1968 Dodge sedan impacting the same barrier design used for the previous test. The vehicle impacted the left corner of the barrier nose at a speed of 53.6 mph and an angle of 9 deg. At impact, the center of the front of the vehicle was offset 3.5 ft from the barrier axis. Significant elastic lateral deflection of the barrier took place as the vehicle penetrated 13.2 ft, rotated clockwise, and then rebounded 2.5 ft. The maximum 50-msec average passenger-compartment deceleration, based on accelerometer data, was 10.9 g longitudinally. The average passenger-compartment longitudinal deceleration was 7.2 g. Deceleration of this magnitude would, in most cases, result in moderate to severe injury for an unrestrained occupant, minor to moderate injury for an occupant restrained by a seat belt, and little or no injury for an occupant using both a seat belt and a diagonal shoulder harness. The position of the vehicle after the collision was such that it would have been a hazard to adjacent traffic (Fig. 13).

The fendering system tested did not satisfactorily redirect a vehicle impacting midway along the side of the barrier at an 11-deg angle with the barrier axis. Also, the

debris that resulted from this collision would definitely have been hazardous to adjacent traffic. Consequently, the fendering system included on the test barriers should not be used for an operational installation.
