BREAKAWAY OVERHEAD SIGN BRIDGES, CRASH TESTING

D. L. Ivey, R. M. Olson, C. E. Buth, and T. J. Hirsch,
Texas Transportation Institute, Texas A&M University; and
D. L. Hawkins, Texas Highway Department

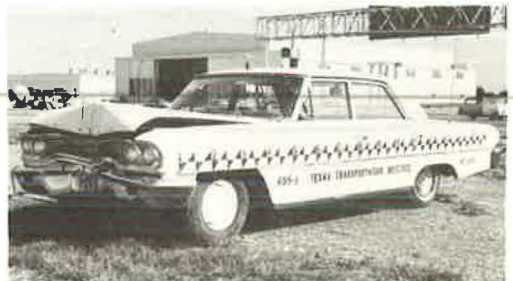
The reaction of the support was predicted by mathematical simulation. The support rotated through 83 deg (observed), allowing the vehicle to pass underneath. Damage to the vehicle was slight as shown in Figure 3. Sequential photographs of the interaction of the overhead sign bridge (OSB) with the test vehicle during the test are shown in Figure 4.

Figure 3. Vehicle after Test A.

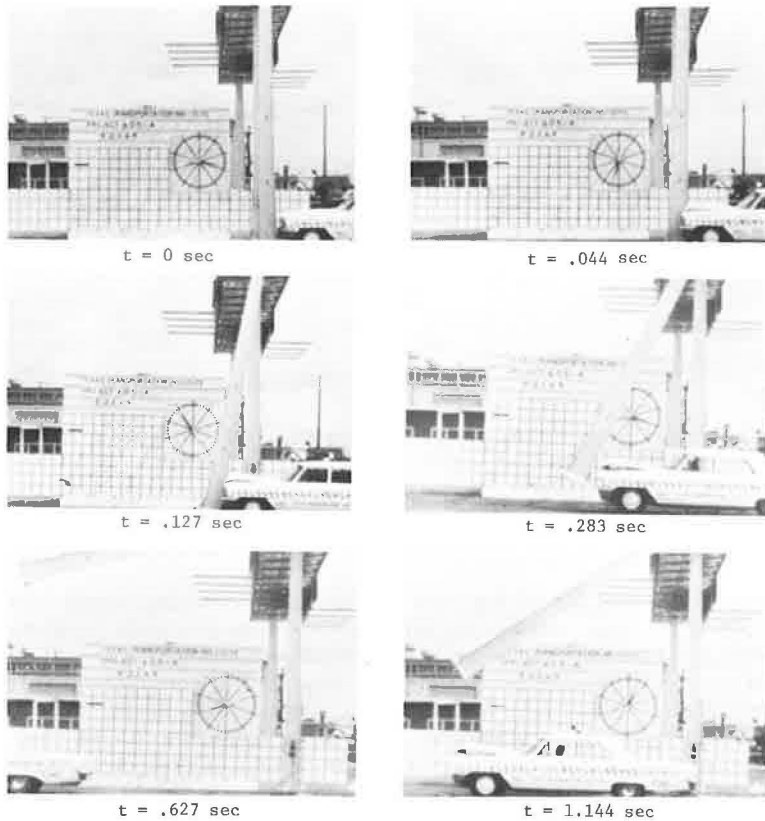
Figure 4. Sequential photographs of Test A.

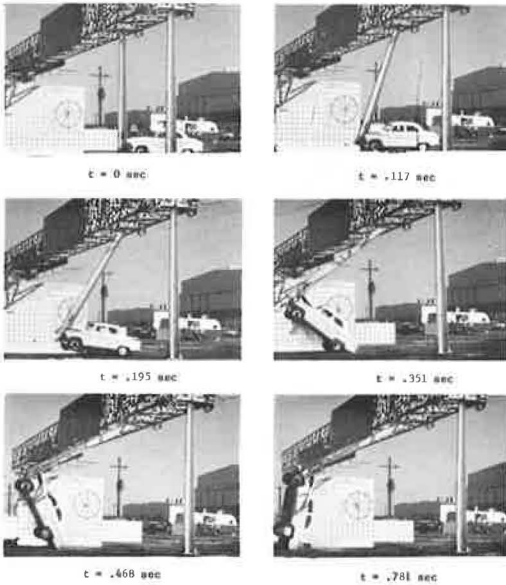
An unexpected incident occurred during Test B: the front of the vehicle was deformed significantly in the collision, remained in contact with the support, and the vehicle was lifted at the front end by the support finally wedging itself between the ground and support in a nearly vertical position. The post penetrated 21 in. toward the engine and the front frame cross member was bent, forcing the two longitudinal frame members to come together, thus clamping the support in a pincer-like action. This pincer-like action prevented the support from springing away from the vehicle after the connections at the base and top of the support broke away. As the support rotated, while maintaining contact with the automobile, the upper baseplate elevated, and the slotted projections of this baseplate acted as a hook which caught the front end of the vehicle and raised it to the maximum elevation shown at $t = 0.781$ second in Figure 9.

Figure 9. Sequential photographs of Test B.

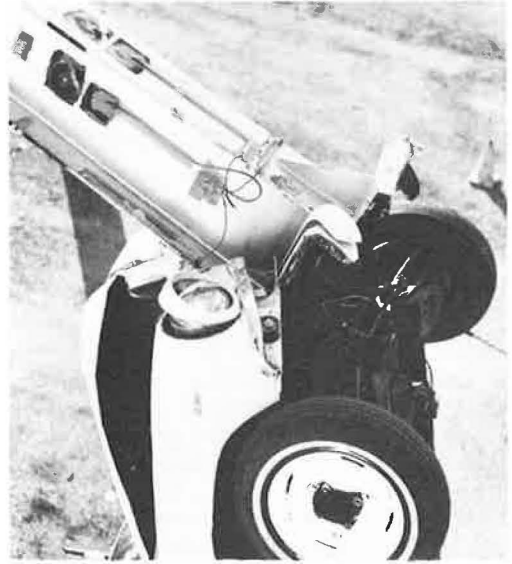
Close-up views of the front end of the car are shown in Figures 10 and 11. Examination of data from accelerometers indicated that the average deceleration was 9.6 g over 0.068 second. The peak deceleration was 22.4 g occurring at ap-

Figure 10. Vehicle wedged between support and ground (Test B).

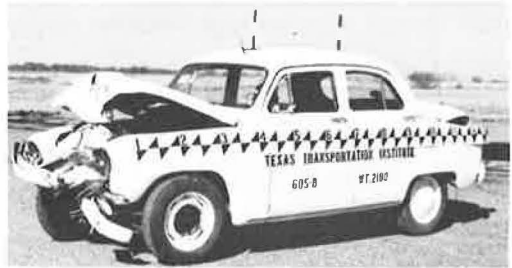
Figure 11. Vehicle after Test B.

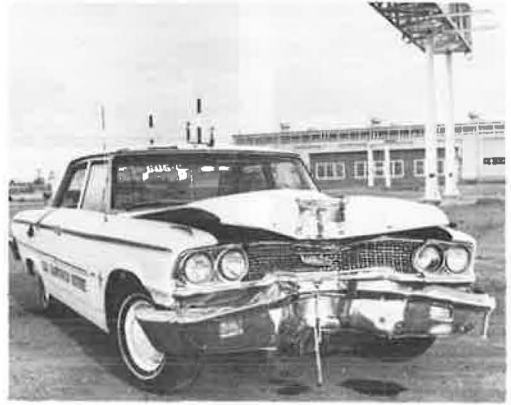
The average vehicle deceleration was determined to be 6.7 g over 0.064 second, and a peak deceleration of 19.1 g, occurring at $t = 0.050$ second, was observed on the accelerometer trace. The vehicle's speed was reduced 8.9 mph by the collision. Damage to the vehicle is shown in Figure 12.

Figure 12. Vehicle after Test C.

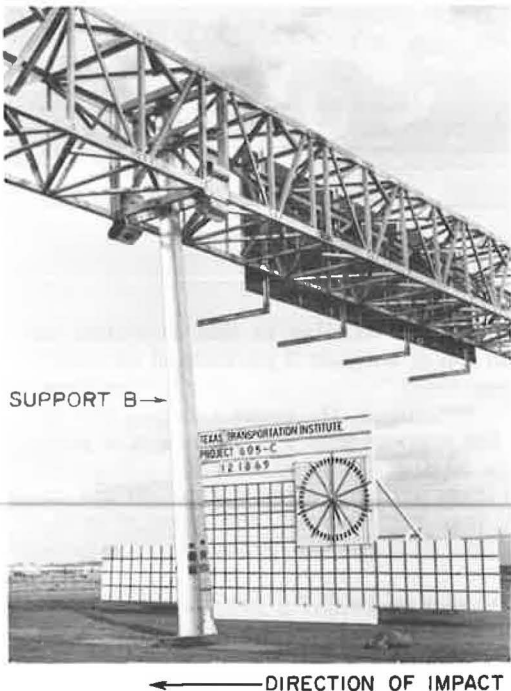
It was observed that the truss deflects downward at inner support B following impact, and as a result the support comes to rest at the lower base plate sooner than when an outer support is struck. The conditions following this test are shown in Figure 13. Similar behavior was observed in later tests, and it was found that, when the outer support is struck, the support post continues to swing as a pendulum for several seconds after impact.

Figure 13. Impact area after Test C.

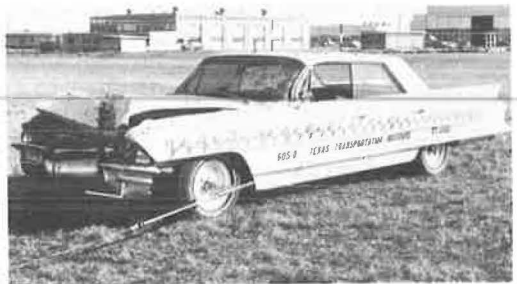
Figure 14. Vehicle after Test D.

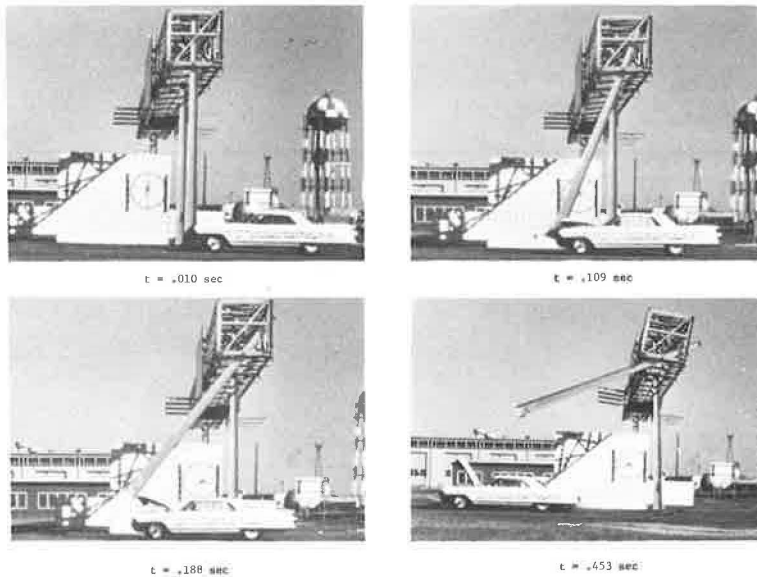
Computer simulation predictions (1) indicated that a head-on collision involving a heavy automobile would produce tolerable damage to the colliding vehicle and the prototype structure. To verify this prediction a 4,880-lb automobile, traveling 54 mph, struck the outer support A. The sign bridge functioned as predicted; vehicle damage was slight as shown in Figure 14, and no structural damage to the truss or support leg was observed. The truss rotation from the time the vehicle contacted the support until the upper connection bolts fractured at support A was less than 1 deg. The maximum rotation of the truss was 9.4 deg as support A rotated upward through 68 deg. During this rotation, the upper connection bolts at support B also fractured. The rotation of the truss at this time is shown in Figure 15 at $t = 0.453$ second.

Figure 15. Sequential photographs of Test D.

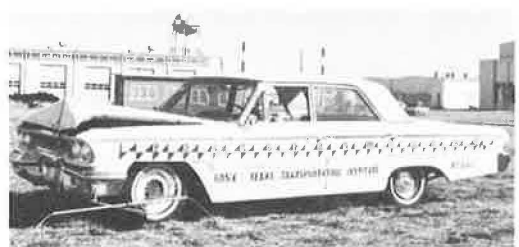
The vehicle in this test was directed into inner support B at a speed of 28.6 mph. The 3,920-lb Ford activated the breakaway connections satisfactorily and the support cleared the vehicle adequately. The load distributors were deformed very slightly and the truss rotated only 1 deg. The results of this low-speed, 15-deg angle test were similar to those observed in head-on Test A conducted at nearly the same impact speed. Damage to the test car, shown in Figure 16, was produced by a decelerative unit force of 3.7 g; and the peak decelerations were observed on electronic records to be 8.8 g (longitudinal) and 3.4 g (transverse).

Figure 16. Vehicle after Test E.

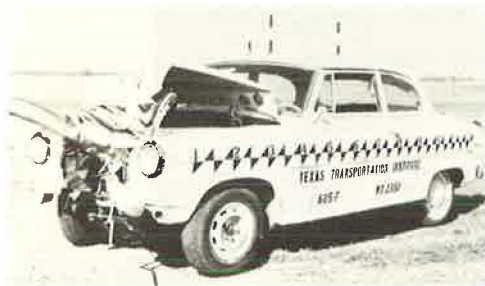
Figure 17. Vehicle after Test F.

away from the vehicle, allowing it to clear the car. The average longitudinal deceleration was 12.2 g; the maximum observed longitudinal deceleration was 30.8 g, occurring at 0.041 second after impact, and the maximum transverse deceleration of 9 g occurred at about the same time. These deceleration levels, bordering on the unacceptable from a passenger tolerance point of view, illustrate the problem inherent in interactions with small vehicles (that is, interactions having a low ratio of vehicle-mass to support-mass). Vehicle damage is shown in Figure 17.

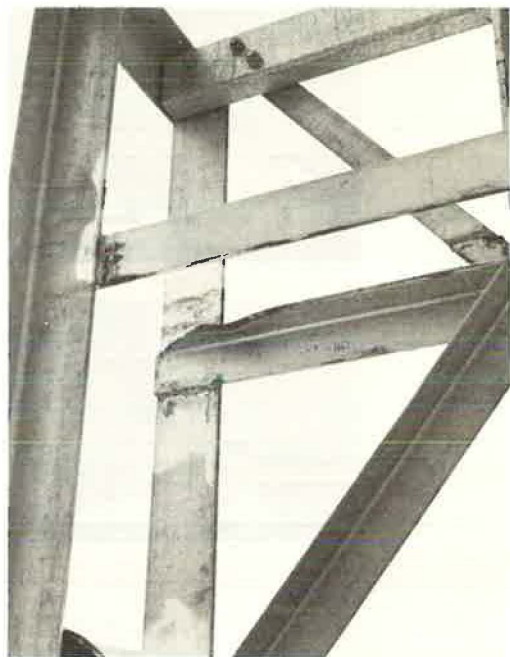
A new development in this test was the contact between the support and guide angles. Guide angles were installed in the truss, as shown in Figure 18, to prevent the support from striking vertical truss members during an angle hit. In this test, when the portion of the support above the hinge point contacted the guide angle, a chunk of steel, shown in Figure 19, was peeled from the toe of the angle, but there was no damage to the support. The damage to the guide angle had no effect on the structural integrity of the truss. However, some energy was absorbed by this action. The support deformed the load distributors on the lower truss chords significantly and twisted the truss through an angle of 4 deg. The upper connection bolts at support B were fractured. The support-post behavior in an angle impact with an outer support is shown in Figure 20, and the pendulum action of the support is clearly demonstrated as the post rotates about its pin connection first in the direction of the colliding vehicle, then past the lower base connection ($t = 2.000$ sec). As noted earlier, this swinging action continues for several seconds following impact with an outside support.

Figure 18. Damage to truss guide angle (Test F).

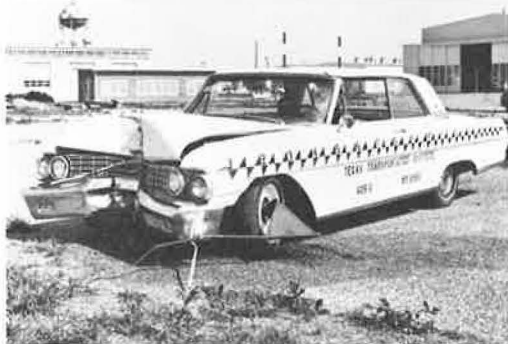
A Ford weighing 3,950 lb collided with support A at 50.1 mph and an impact angle of 15 deg. The vehicle was slowed 10.2 mph as a result of the collision. The average decelerative unit force on the vehicle was 5.8 g, and the peak decelerations were observed to be 15.3 g (longitudinal) and 3.5 g (transverse). These peaks occurred at approximately 0.040 second after impact. Damage to the crash vehicle is shown in Figure 21.

Figure 21. Vehicle after Test G.

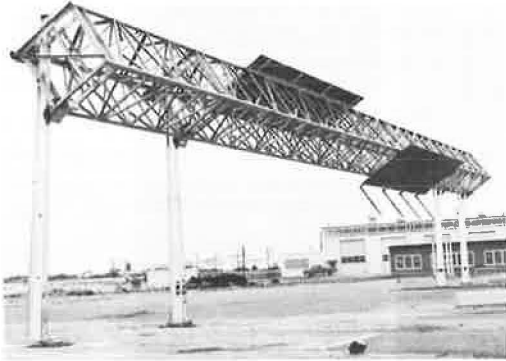
Column A was struck head-on by a 5,150-lb Cadillac traveling at 75.3 mph. The upward rotating support ripped the hood from the car, continued upward, deformed the load distributors, and caused the truss to rotate about the pin connections. The upper connection bolts at columns B, C, and D fractured, and the truss continued to rotate until it came to rest in the position shown in Figure 22.

Figure 22. Condition of structure after Test H.

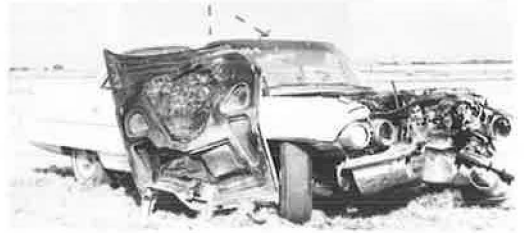
Figure 23. Crash vehicle after Test H.

The vehicle damage is shown in Figure 23. The average deceleration was 6.9 g and a peak of 17.6 g was observed on the accelerometer trace. The car was slowed 11.5 mph by the collision. The post penetration

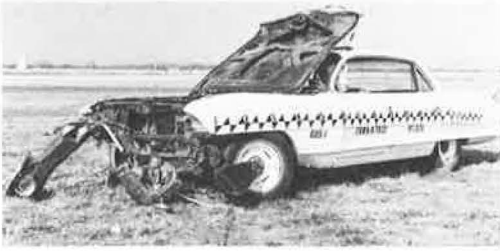
Figure 25. Damaged vehicle after Test I.

This final crash test was conducted on January 28, 1971. A 5,170-lb Cadillac struck column B at 72.0 mph and was slowed 11.2 mph by the impact. The sequence of events in the collision incident are shown in Figure 24, and damage to the car is shown in Figure 25. The average and peak decelerations are given in Table 1. The maximum post penetration was 2.6 ft.

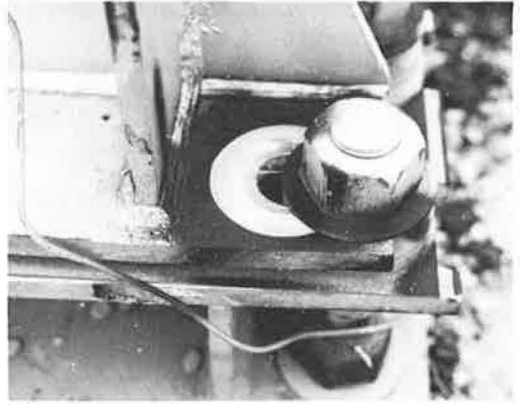
Following the test, it was observed that the upper plate of the breakaway base at column C (Fig. 26) had slipped approximately 2 in. in the direction of vehicle impact. However, the truss and structure remained erect.

Figure 26. Breakaway base movement at column C (Test I).
