# PERFORMANCE OF PLASTIC FILTER CLOTHS AS A REPLACEMENT FOR GRANULAR FILTER MATERIALS

Charles C. Calhoun, Jr., Joseph R. Compton, and William E. Strohm, Jr.,  
U. S. Army Engineer Waterways Experiment Station, Vicksburg, Mississippi

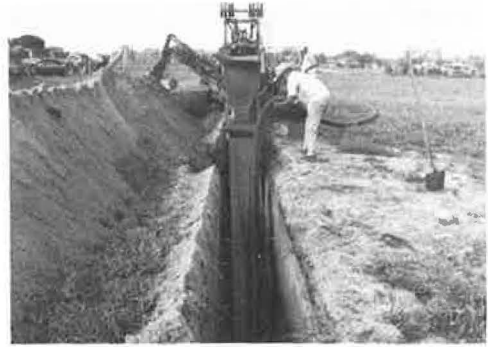
Figure 1. Installation of collector pipe and cloth A in subdrain system.

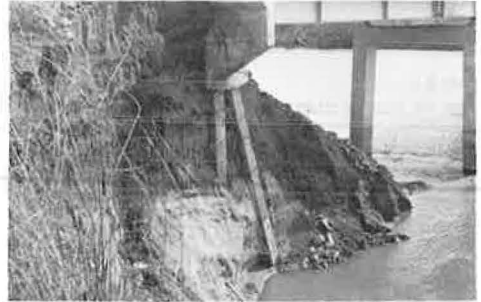
Figure 2. Conditions at bridge prior to repair work in 1962 by the Memphis District.

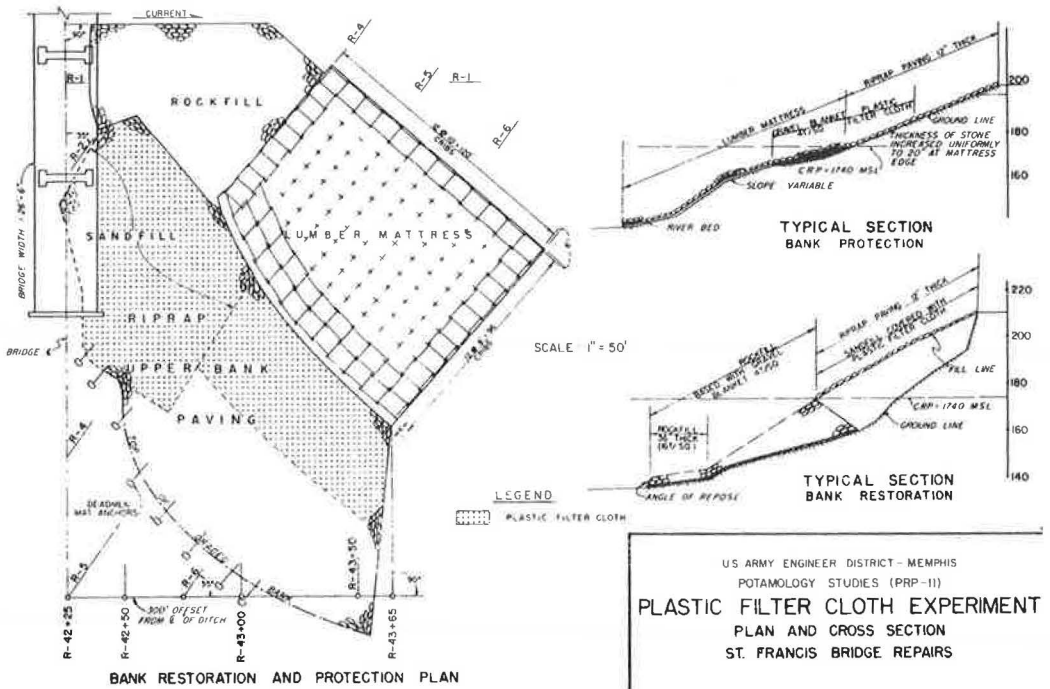
Figure 3. Bridge repair plan.

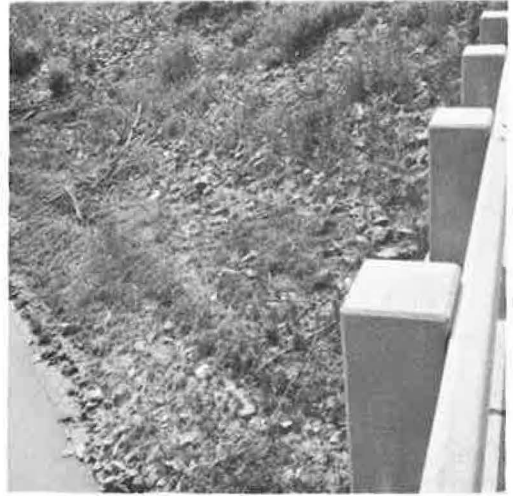
same weight material from 4 ft did not damage cloth B. The sites were inspected after each high water, and no change occurred in the repaired area. Figure 4 shows the condition of one of the repaired areas during an author's visit in 1969. The area was in excellent condition, as were the other repaired areas. The severity of the attack continuing in unprotected adjacent areas was evident from large scour holes noted in the banks immediately downstream of each repaired area.

During an author's visit, riprap was removed from sections of cloths A and B. Although the repaired area as a whole was in good condition, the condition of cloth A was poor. Tears, probably from riprap placement, and holes attributed to abrasion were noted in the cloth. Cloth B was in excellent condition. Samples of both cloths were obtained from the areas and tested at WES. Strength tests indicated there was no apparent deterioration of the fibers since the cloths were installed.

Figure 4. Condition of repaired area in 1969.

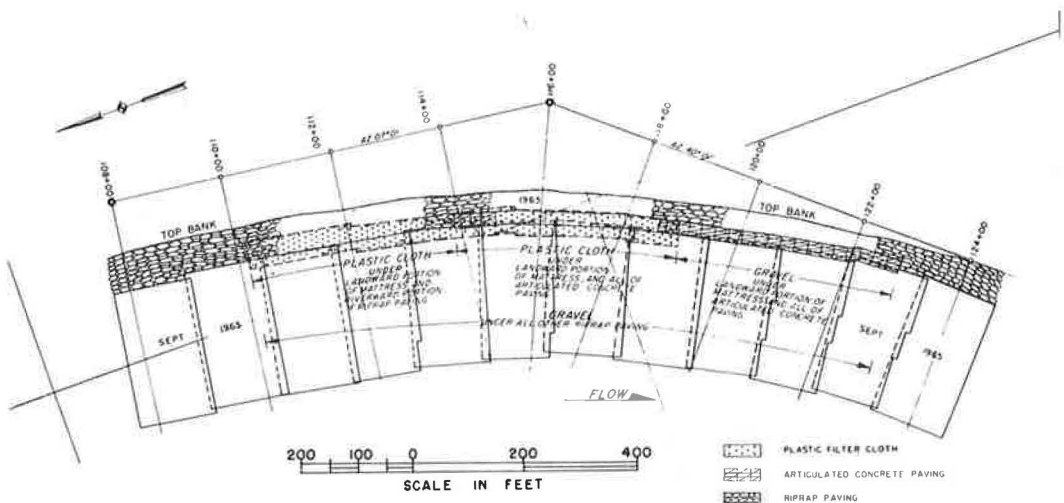
Figure 5 shows a layout of the test site at Island 63 in the Mississippi River near Greenville, Mississippi, where in 1965 filter cloth was placed under riprap and concrete mats in some areas and a 4-in. gravel blanket was used in other areas. The subgrade material was a fine sand. Figure 6 shows cloth B being placed. After the bank had been graded to a 1-on-3 slope, it was covered with two 18-ft wide sections (three 6-ft widths sewed together in the factory) and one 12-ft wide section (two 6-ft widths sewed together in the factory). The field seams perpendicular to the river edge were overlapped 8 in. and secured with 15-in. long pins at 3-ft intervals. The horizontal seams were sewed with nylon twine after it was found that the securing pins did not properly hold in the sand. The lower edge of the cloth was placed 4 ft underwater.

Figure 5. Island 63 test site.

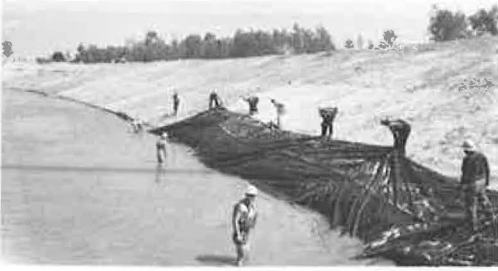
Figure 6. Placement of cloth B at Island 63.

This was accomplished by sewing  $\frac{3}{4}$ -in. reinforcement bars in a continuous line along the riverward edge of the cloth and by sewing additional bars (Fig. 6) perpendicular to the water's edge at 20-ft intervals. The cloth was then manually moved into the water. The weight of the rods was not sufficient to keep the cloth from billowing, and it had to be tamped into place. The revetment materials were placed directly on the cloth. The concrete mattresses extended past the filter cloth and granular bedding into the river.

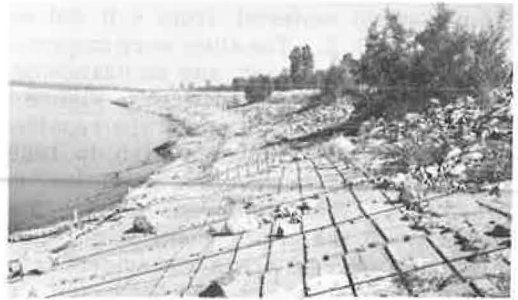
Figure 7. Island 63 revetted area underlaid with filter cloth (range 118+50).

Surveys and inspections were made by the Memphis District after each high-water season. During the first high-water period, scouring occurred in the lower part of the slope where no filter cloth had been placed. Inspections following each of the succeeding 2 high-water periods revealed that scour in the filter cloth area had apparently been stopped by the cloth. In the adjacent area where a gravel filter was used, the scour had progressed up the bank and into the riprap, requiring extensive repairs to the riprap sections. Figure 7 shows the condition of the concrete mattress revetment overlying the filter cloth, and Figure 8 shows the area where gravel filter material was used. It is obvious from a comparison of the 2 photographs that the filter cloth performed in a superior manner to the gravel filter. In the filter cloth area the only noticeable subsidence was at faulty field seams (center of Fig. 7).

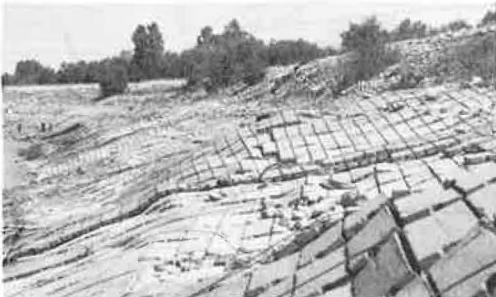
Figure 8. Island 63 revetted area underlaid with gravel bedding (range 123+00).

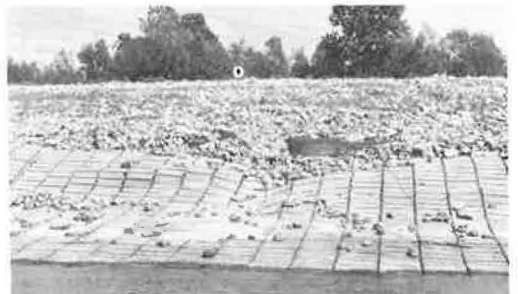
Figure 9 shows a condition that existed in the riprap at its intersection with the mat (subsidence in the center of the photo resulted from a faulty field seam). The cloth had been bulging (first noticed in 1968) at the intersection and displacing the riprap. The bulges, 2 to 3 ft high all along the reach, may have resulted from excess pore water pressures being developed in the fine sand and causing the sand to "flow" beneath the cloth. Apparently, the continuous surcharge provided by the mats and their resistance to displacement stopped the migration of sand. If the mats had not been present, the bulging would probably have been more general.

Figure 9. Island 63 bulged areas.

A sample of cloth adjacent to one of the bulges was removed during an author's visit to the site in 1969. Examination of the underside of the cloth revealed a cake of fines that may have prevented ready drainage from the cloth during falling stages of the river. The inability of the water to drain freely from the cloth could have produced the excess pore pressures that led to the movement of the underlying sand. As data given in Table 1 show, the cloth used (cloth B) had only 5.2 percent open area. A cloth with a greater open area could possibly have prevented such bulging.

The filter cloth appeared to be in good condition with the exception of a few isolated tears near the bulged areas. These tears were probably caused by debris from the river during high-water stages. The cloth in the bulged areas was stretched very tightly, but no fiber ruptures or rips at the factory-sewed seams were noted. Strength tests on samples of the cloth indicated no significant deterioration of the cloth.

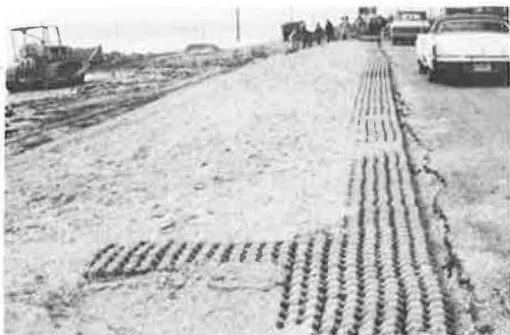
The Louisiana Department of Highways, with some assistance from the New Orleans District, made full-scale field tests using cloth B and cloth Z beneath slope protection for a highway fill along the Gulf Coast (6). Figure 10 shows the test section at Holly Beach, Louisiana. The revetted area, 200 ft long, was constructed in January 1968 by using cellular concrete revetment blocks developed in Holland. Each block weighed approximately 14 lb and was about 8 by 8 by 4 in. The in-place revetment had about 30 percent open area obtained by 2-in. diameter holes in the blocks spaced on centers slightly less than 2 in. in both directions. Filter cloths were placed directly on a graded 1-on-3 slope, and the blocks were placed on the cloths. The soil along this stretch of beach is primarily fine sand with some silt and shell fragments. The elevation of the roadway was 7 to 8 ft above mean low water (called mean low gulf). Cloth B was used in constructing the westward 100 ft, and cloth Z was used for the other 100 ft.

Figure 10. Louisiana Department of Highways test section (sand used as dry mortar).

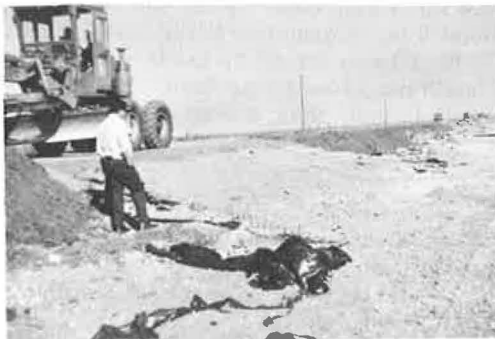
In February 1969 a storm hit the area, and wave heights were well above the roadway elevation. The cloth B area failed, while the area in which cloth Z was used remained in place (Fig. 11). Cloth B was apparently lifted or floated out of position (dislodging the overlying block revetment) because water was not able to pass through fast enough to prevent hydrostatic pressures from developing beneath the cloth. Water apparently was able to pass readily through the more open weave of cloth Z. In February 1970 a similar storm hit the area, and the only damage was at the unprotected ends of the revetted area where cloth Z was used.

Figure 11. Condition of Louisiana Department of Highways test section after storm (in-place revetment underlaid with cloth Z).
