# CONTROLLING HEAD-LAMP AIM

D. M. Finch, College of Engineering, University of California, Berkeley

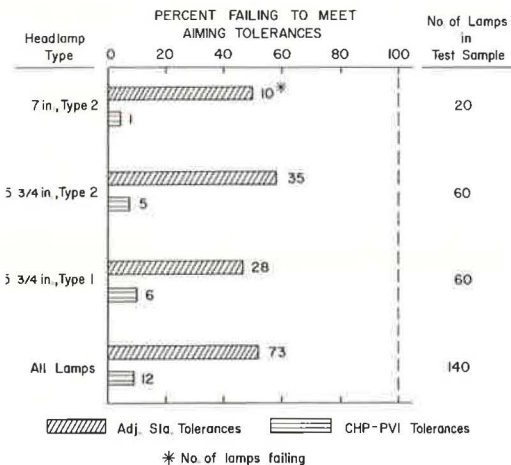
After the head lamps of our 20-vehicle test sample were checked for their "as-is" aim condition, they were carefully adjusted for correct aim in accordance with SAE specifications (J599a). All of the sealed-beam units were then replaced with new ones purchased at various retail outlets and, without disturbing the previously made aim settings, the aim was checked once again. (The same lamp-replacement procedure was also followed after the 90-day field service period to increase the size of our sample.) In this way, we obtained an indication of the extent to which lamp replacement alone can affect the aim in a vehicle population; the results are shown in Figure 2.

Figure 2. Aim of head lamps on test vehicles immediately after replacement of sealed-beam units.

Among the factors contributing to misaim, the process of lamp replacement appears to play an important role. Our tests have shown that when a correctly aimed sealed-beam unit is replaced by a new one, without adjustment, there is only about a 50 percent probability that the new unit will also be within correct aim requirement. Although it is true that the motor vehicle industry and law enforcement agencies have stressed in their extensive educational efforts the importance of checking and readjusting aim after head-lamp replacement, actual practice still falls far short of the desired goals. Thus, for example, many motorists tend to replace malfunctioning head-lamp units at night, when the problem is most obvious, at a conveniently located service station that more than likely is not equipped to perform a proper aim adjustment. Such a motorist is also likely to forget to have the new units checked and adjusted at a subsequent opportunity.

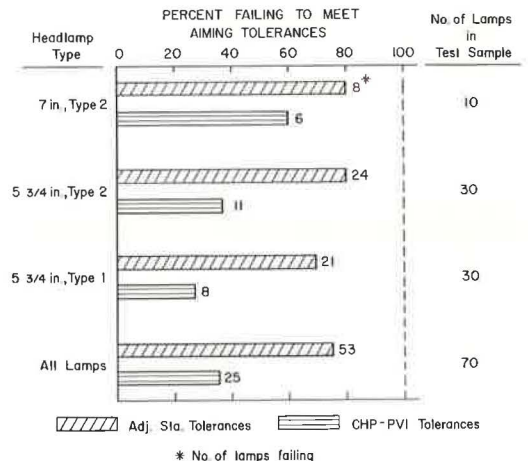
loads that might be encountered by the inspection teams. The results of our examination are shown in Figure 1.

Figure 1. Results of pretest head-lamp aim inspection of test vehicles.

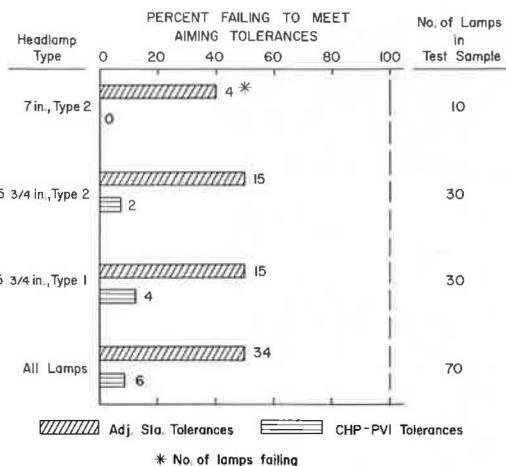
All head lamps were once more adjusted for correct aim, and the vehicles were returned to normal use for a period of 90 days. At the end of that time, a check of the lamp aim on all test vehicles yielded the results shown in Figure 3. The mile-age registered by the test vehicles ranged from 1,000 to 25,000 miles, with a mean value of 12,762 miles for the 20 vehicles. No record was kept of the type or severity of service in the test period. However, at the conclusion of the test, none of the vehicles showed any signs of physical damage that could have affected the head-lamp aim settings.

Figure 3. Aim of head lamps on test vehicles after 90 days of normal service.

Our tests have shown, also, that there is only about a 50 percent probability that a correctly aimed head lamp will, after 90 days of service, still be in correct aim. This situation appears to be the result largely of inadequately constructed mounting assemblies and housings stemming, possibly, from a desire on the part of the manufacturers to keep down production costs. We believe that the importance and desirability of providing much more stable designs make such economies false ones. Head-lamp housings can and should be made less vulnerable to vibration and shock and more resistant to damage from light impact.

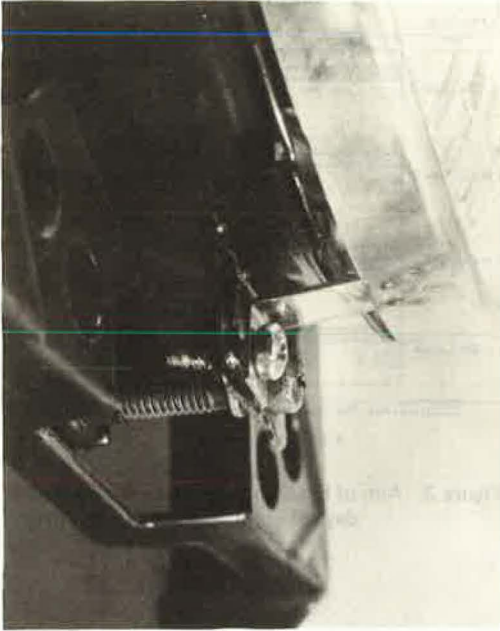
Another example of poor design encountered among head-lamp assemblies involves the arrangement for fastening the lamp retaining ring to the mounting ring. The retaining ring, sometimes called the trim ring, is the part that holds the sealed-beam unit firmly in place within the mounting ring so that the entire lamp assembly pivots in unison as the aim-adjustment screws are turned. In one type of design, the sheet metal screws holding the trim ring in place must be completely removed and reinserted each time the head-lamp unit is replaced. This makes the few threads in the holes of the sheet-metal mounting ring highly susceptible to stripping, particularly when improperly started screws produce cross-threading. If the mounting hole threads strip, the trim ring can pop out enough to throw the lamp badly out of aim (Fig. 4). A much more preferable design uses slotted ears on the retaining ring or figure-eight clearance holes (Fig. 5) so that the sheet-metal mounting screws do not have to be taken out entirely to remove or replace the ring.

Figure 4. This fastening arrangement for the head-lamp retaining ring can lead to the stripping of threads in the mounting hole and consequent loosening of the assembly as shown.

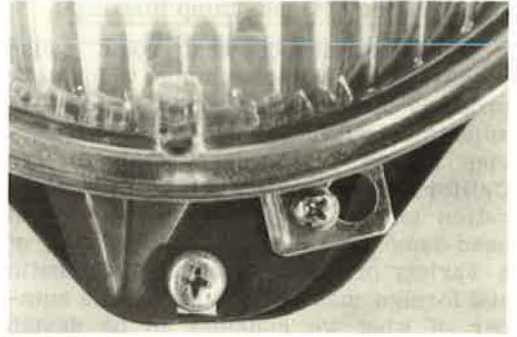
Figure 5. This preferred type of fastening arrangement for the head-lamp retaining ring permits replacement of the sealed-beam unit without complete removal of the mounting screws.

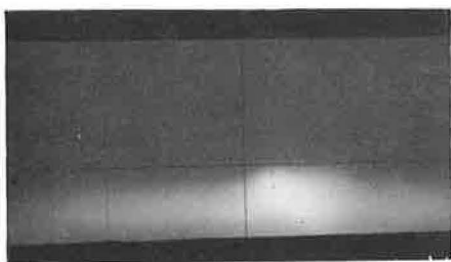
a.

Lamp set for correct mechanical aim; fails to meet SAE photometric and visual-aim requirements under these conditions.

Figure 6. Low-beam patterns produced by head lamp (type 4002) on aiming 25 ft away (lines represent horizontal and vertical aiming axes, crosses indicate SAE photometric test points): (a) lamp set for correct mechanical aim fails to meet SAE photometric and visual-aim requirements under these conditions; (b) with aiming plane of lamp shifted for correct visual aim, lamp still fails to meet photometric requirements; (c) with aiming plane shifted to point at which beam meets photometric requirements, lamp fails to meet visual aim requirements.

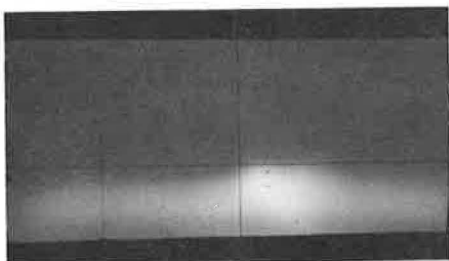
b.

Aiming plane of lamp shifted for correct visual aim; lamp still fails to meet photometric requirements.

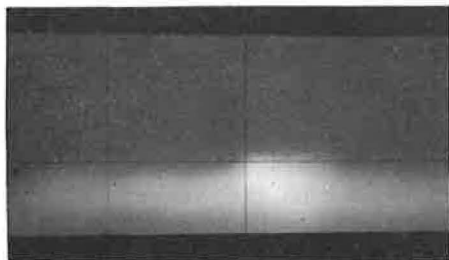
c.

Aiming plane shifted to point at which beam meets photometric requirements; lamp fails to meet visual-aim requirements at this setting.
