# GLASS BEADS IN PAINT

Carl F. Crumpton and George A. McCaskill, State Highway Commission of Kansas

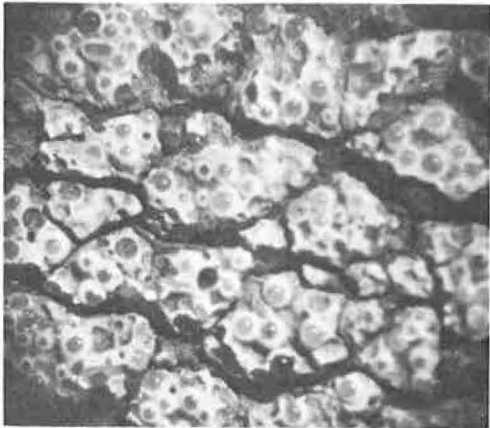
In our early studies, transverse stripes were utilized for comparison of different paints and different bead gradations. Some stripes placed on concrete pavement showed a slight dulling over the hot-poured joint filler after a few weeks. This was at first interpreted to be due to bleeding of the joint filler material through the paint stripes. The nighttime appearance of these areas, however, was not diminished and, in fact, seemed brighter than the rest of the same stripe. A microscope examination revealed that the joint sealer had expanded causing the paint over it to crack (Fig. 1). The cracks were small and could not be readily seen without magnification. The effect of a series of subparallel microscopic cracks, however, was a slight but noticeable daytime dulling of the stripe over the joint filler. The increase in nighttime visibility over the joint filler was due to the exposure of the full sides of beads that were adjacent to cracks. Enhanced reflection is usually short-lived because as the filler expands it exudes from the joint and breaks through the paint stripe (13).

**Figure 1.** Subparallel microscopic cracks in paint caused by expansion of joint filler.

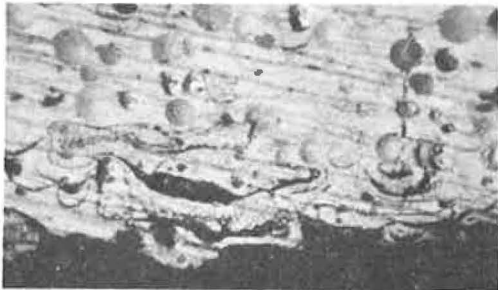
In another instance, centerline stripes on bituminous pavement patches were observed to be dulling prematurely. Microscopic examination revealed that asphalt was bleeding through the paint or being tracked onto it. Samples of the paint stripes were removed for study. They were sawed vertically through the layers of paint, and the sawed surfaces were polished on a lap wheel.

Microscopic study of the polished surface showed that the paint had many horizontal and vertical cracks that were filled with asphalt (Fig. 2). The asphalt was bleeding through cracks in the paint. The section of road in question, however, was scheduled for a new maintenance seal. After the seal was applied, no bleeding occurred, and the new stripes did not get prematurely dull.

**Figure 2.** Vertical cross section through several layers of glass-beaded paint stripe with asphalt-filled vertical cracks and subhorizontal planes.

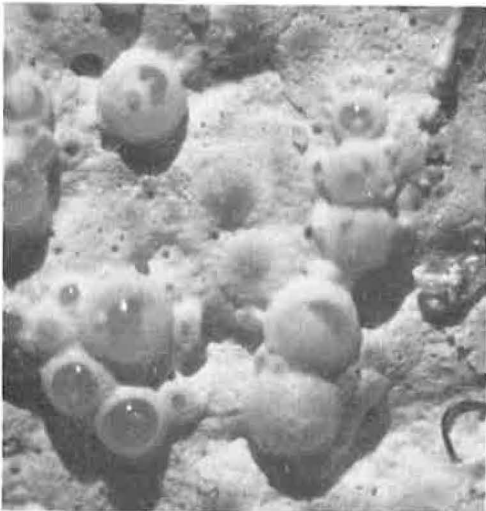
We were asked why some newly painted stripes were not reflecting at night so well as usual. We microscopically examined the stripes and found an overspray of paint on many beads (Fig. 3). Too much spray pressure or painting into a heavy wind might cause overspray. The operator was using higher spray pressure than recommended by the manufacturer. When he reduced the pressure the problem was solved.

**Figure 3.** Beads coated with paint because of too much spray pressure on paint gun.

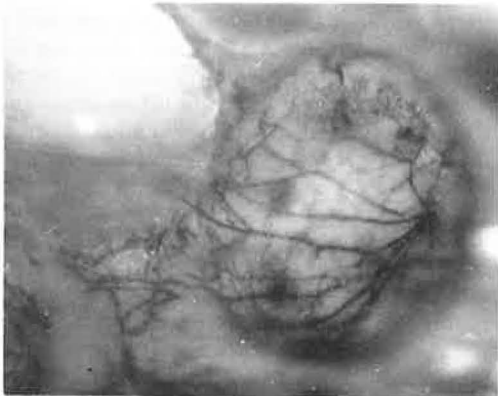
A large number of beads were lost from one section of 18-month old paint stripes. Microscopic study revealed a mold growing in the empty bead sockets (Fig. 4). Several loose beads in the paint were pried out, and mold was present under the bead. We believe the mold growth caused loosening of the beads previously lost. This is not considered a problem because we observed the phenomenon only on one section of reasonably old paint. Most of our centerline stripes are repainted yearly, and we doubt that much mold would grow in the paint during this time. Mold was observed in the lower part of the thick buildup of old paint layers previously discussed. Mold may contribute to the adhesion loss of paint stripes inasmuch as growth was observed in a number of old paint layers from several locations. The newer, upper paint layers seldom exhibited mold growth.

**Figure 4.** Mold growth in empty bead socket.

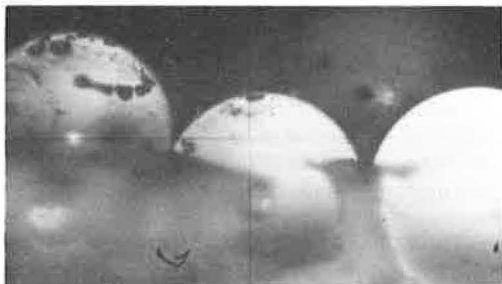
There are many possible pitfalls in interpreting the results. For instance, the 3 beads shown in Figure 6 appear to reflect light differently depending on the amount of bubbles present. The bead on the left apparently contains the most bubbles and reflects the least light. The center bead contains a few bubbles and reflects light intermediate to the amount reflected by the other 2 beads. This would seem to demonstrate that air bubbles in the beads diminish their light-reflecting properties. Our studies, however, have shown that the amount of the bead exposed usually has more effect on its retroreflection than bubble inclusions (this assumes that the back of the bead is covered with paint to more than 50 percent of its diameter). In Figure 6, the bead that reflects the most light has its entire side exposed to the light beam and this is why it reflects more light than the other 2 beads. The center bead has part of its bottom half exposed and, therefore, reflects more light than the left bead that has only its upper half exposed.

**Figure 6.** Three beads that retroreflect different amounts of light.

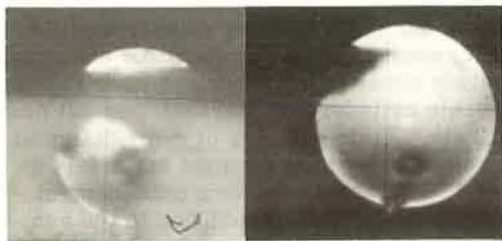
Figure 7 shows the effect of exposing more bead surface. The bead is about 85 percent buried in paint. About one-third of the buried portion is exposed on the left. On the right, most of the paint film has been removed from the front of the bead increasing its retroreflection by exposing more surface area. Some chipping of paint to expose the sides of beads can thus improve retroreflection.

The gas bubble on the surface of the bead shown in Figure 7 appears to be a small dark spot but does not prevent reflection. Gas bubbles reduce retroreflection roughly by the amount of the surface area they comprise. This is an estimate based on a study of thousands of beads with various sizes and numbers of gas bubbles and not an accurately measured quantity of light reflection. In fact, the terms reflection and retroreflection as applied to glass beads may be misnomers. A bead more or less lights up like a diffusion light globe. There is no distinct beam of light reflecting back from a bead.

**Figure 7.** Bead 0.012 in. wide buried in paint (left) and then exposed (right).

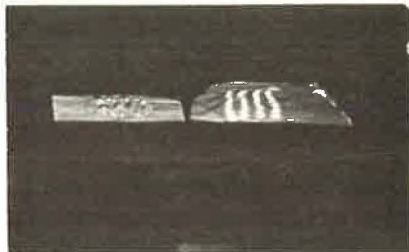
Our microscope studies show that internal fractures affect retroreflection considerably (Fig. 8). The beads shown in the paint panel on the left have been heated and then dropped into iced water to create internal fractures (the same procedure used in making "fried marble" jewelry). The beads on the right have not been internally fractured. The nonfractured beads reflect light, but the fractured beads do not.

**Figure 8.** Beads with (left) and without (right) internal fractures.

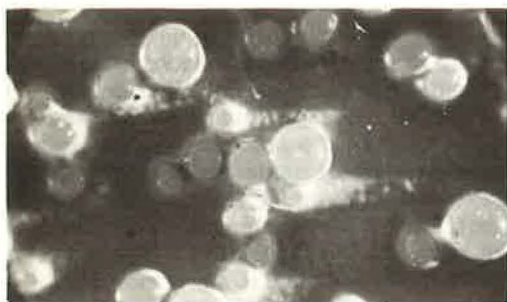
laid flat on the stage of the microscope. The light was beamed in from the side at the approximate headlight angle. The researcher viewed the beads from above to see their back or shadow side. Many small beads fall in the shadows of larger beads and, thus, do not retroreflect (Fig. 9). The fact that beads cast shadows, however, indicates that they are retroreflecting. If light passed through a bead with no retroreflection, there would be little or no shadow. A bright spot at the back (left) of several beads shown in Figure 9 indicates that some light gets through.

**Figure 9.** Effect of shadows cast by large beads.

The shadow effect is reduced when beads of only one size are used in a paint film that covers about 60 percent of the bead diameter. Using fewer beads reduces shadow problems too. Floating beads also reduce the shadow effect because of a more uniform size and because nearly half of each bead is exposed. The Colorado highway department (3, 4) reported benefits and savings when it used floating beads. Our studies indicate that the floating principle is important if a thick paint film is used. If, however, the wet thickness of the paint film is engineered to the diameter of a single-sized bead, then the results are much the same. The wet paint film thickness should cover 55 to 60 percent of the diameter of the beads used (6, 7, 8).

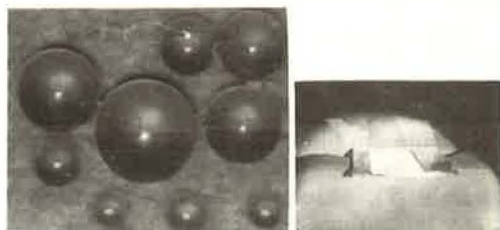
In one of our studies we put beads into black paint. The beads appeared black when viewed directly from above (Fig. 10, left). When the panel was viewed at ordinary headlight angles, however, the beads reflected white (Fig. 10, right). Inasmuch as we did not foresee much benefit for Kansas, we did not pursue the research. If beads are found to reflect well in black paint, then states that use black lines between their white lines might wish to pursue the research and consider putting the beads in the black paint so that the white paint would remain cleaner and brighter in the daytime. Dale (7) stated that marking materials with dropped-on beads exhibit a far greater tendency to pick up road film than do unbeaded materials. These markings with heavy road film can be 100 percent intact and reflect at night yet fail in terms of delineation of the roadway in daytime. The road film would not show on black paint, and the unbeaded white lines would remain brighter for daytime use. We do not know why the beads reflected in black paint but wonder whether internal bubbles might act as small beads and actually enhance reflection in some cases. More research is needed on the reflectivity of beads in black paint to determine why they reflect for us but not for others.

**Figure 10.** Beads in black paint where light strikes directly from above (left) and at average headlight angle (right).

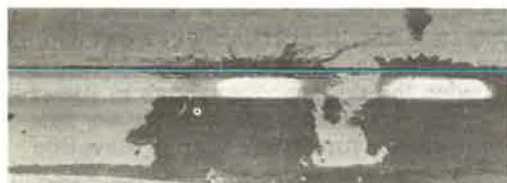
Some paint stripes on new and old pavement sections in a city lost effectiveness rapidly during daylight but were satisfactory during nighttime. The city was subject to rather high traffic dust, and the roads were swept daily. We repainted the pavements and studied the new stripes. Less than 4 hours after placement, the stripes were noticeably duller. In one week the stripes had low daytime effectiveness but still reflected well at night. Using the microscope, we found traffic dust and grime covering the stripes even though they were swept a few minutes earlier. Figure 11 shows a 1-week old stripe. The brighter white spots are areas where the stripe was brushed with soap and water and then rinsed. A means of washing these stripes would improve their daylight effectiveness but perhaps only temporarily. The traffic grime and dust problem is usually worse in cities than in rural areas where faster traffic blows the dust away

**Figure 11.** Week old paint stripe dulled in daylight by traffic dust and grime.

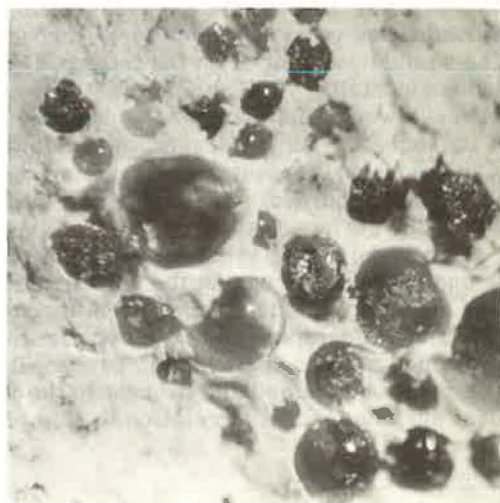
Paint and bead wear is increased if in areas similar to those just mentioned the traffic dust is coarse and harder than the beads. McCaskill and Crumpton (12, 13) reported paint and bead wear where sand- or gravel-surfaced roads intersected pavements with paint stripes. We studied this phenomenon in our laboratory by using a modified California surface abrasion device. Our asphalt research section uses it for evaluating slurry seal materials, but it has been used to study accelerated pavement wear (11) and paint stripes as well. Four-inch diameter concrete cylinders or Marshall asphalt plugs were painted and beaded on top for laboratory study. Field samples of 4-in. diameter pavement cores through a paint stripe can be used to study the pavement materials as well as the surface texture and beaded-paint layer. Figure 12 shows a beaded-paint film that has been subjected to 5 min in the abrasion machine. In addition to the rubber balls (17) used to evaluate asphalt slurry materials, a small amount of fine sand was added to simulate abrasive traffic material. Most of the beads abraded as badly as the paint. These surface-abraded beads are of little value as reflectors. The condition of the paint and beads shown in Figure 12 is almost identical to that of actual in-service paint stripes that are subject to abrasion.

**Figure 12.** Beaded-paint stripe abraded for 5 min.
