DETERIORATION OF 249 BRIDGE DECKS

R. E. Carrier and P. D. Cady, Pennsylvania State University, University Park

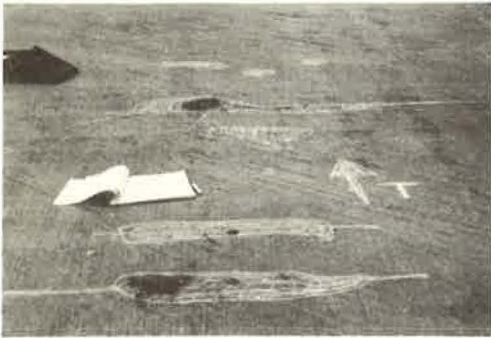
No special equipment was required for the deck surveys other than the aforementioned pachometer and a unique chain drag device used to detect fracture planes (Fig. 2). Although fractured areas are incipient spalls, they are usually not discernible at the road surface even upon close inspection. The chain drag device comprises a timber member with 2-ft lengths of ordinary snow-tire chains attached at 4-in. intervals along the member. As the device is traversed over a fracture plane on the deck, the chains produce a hollow sound. Tape recordings of several of these soundings were quite distinct. When a fracture plane was encountered, it was delineated, and its area and depth to reinforcing steel were measured (Fig. 3).

Figure 3. Delineation of fracture plane.

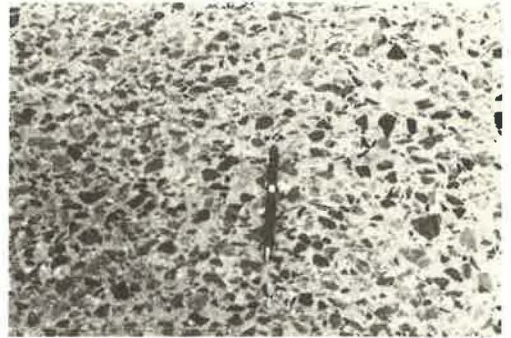
From the standpoint of skid resistance, wear is the most serious form of deterioration (Fig. 4). Ninety-five percent of these relatively young decks exhibited surface mortar deterioration (wear plus general mortar deterioration), with 97 percent of the affected area attributed to wear and only 3 percent attributed to disintegration of weak mortar (not polished and frequently not in the wheel zones).

Figure 4. Surface wear deterioration.

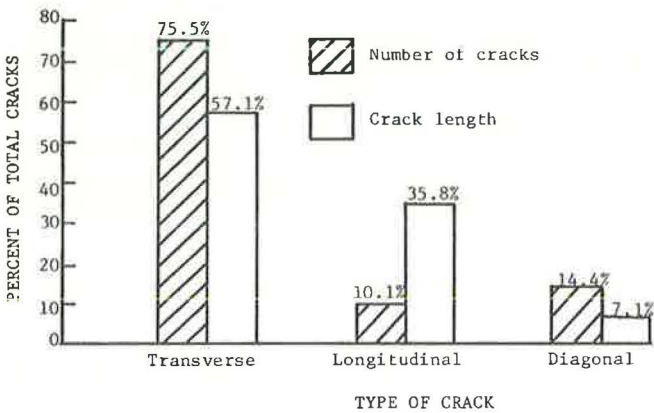
In total, about 6.7 miles of cracks were encountered on the 21½ lane-miles of deck surface observed during the study. The distribution of the three types of cracks is shown in Figure 5. Note that, by number and length, transverse cracks occurred more frequently than did other types. In essentially every case, these cracks occurred directly over the transverse reinforcing bars.

Figure 5. Distribution of types of cracks.

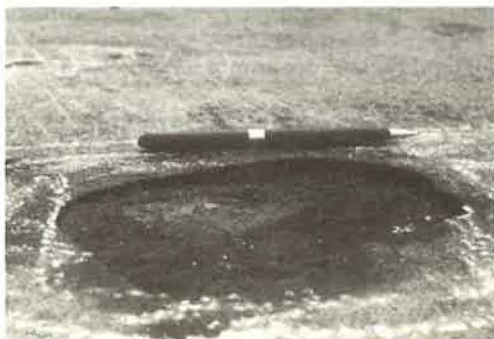
Of the two decks having spalls where steel depth was adequate, one exhibited delaminations of a latex-modified concrete overlay. The second deck had 12 fracture plane areas, totaling 4½ sq ft, and eight spalls, totaling 10⅞ sq ft. These were distributed in many locations on the deck. The spalls were uniformly ¼ to ½ in. deep (Fig. 6), but the depth of steel in both deteriorated and sound areas was 2½ to 3 in. Many of the smaller fracture planes were at least initiated by patching of the screed rail holes, whereas others appeared to be due to overfinishing. Extensive areas of map cracking (perhaps associated with rapid drying) were also noted on this deck.

Figure 6. Example of 1/4- to 1/2-in. deep spall.

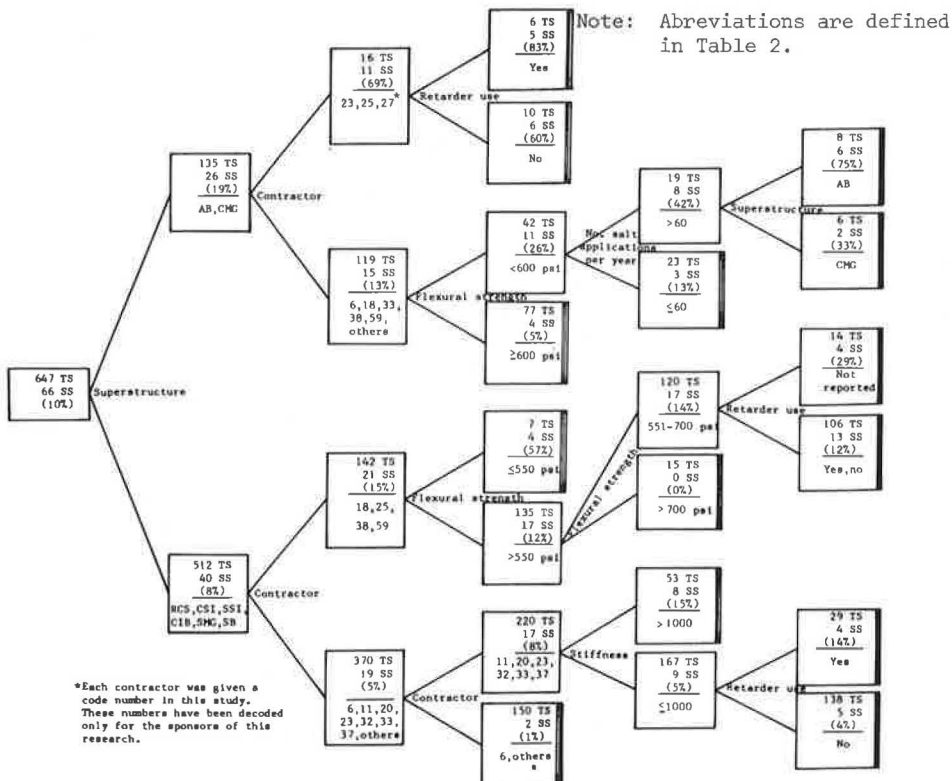
Figure 7. Effects of six causal factors on spalls and fracture planes.

It can be seen from the figure that the most important single variable explaining variation in the occurrence of spalls is superstructure type (recall that it was not possible to include steel depth as a variance). That is to say, of all the possible combinations in each of the nine predictor variables, the grouping of adjacent box and continuous multigirder superstructures against all other superstructures did the best job of explaining whether fracture planes or spalls or both occurred in the 647 total spans, i.e., explaining variance of the data. (Although 813 total spans were surveyed for deterioration, it was not possible to get complete data on each of the 32 causal factors. So we reduced the number of spans to 647 for the fracture plane and spall analysis, 623 for the transverse crack analysis, and 624 for the SMD analysis.) Of 135 adjacent box beams or continuous multigirder spans, 26, or 19 percent, had at least one spall, whereas all other superstructure types exhibited only 40 spalled spans of 512, or 8 percent. The grouping of two types against the remaining six allowed the greatest divergence between occurrences, i.e., 19 percent versus 8 percent. Any other combination of superstructure types would have given less than the 11 percent difference.

Of the 135 adjacent box beam and continuous multigirder spans, 16 spans, of which 69 percent had spalled, were built by only three contractors. Only 15 spalled spans, or 13 percent, occurred on the 119 remaining spans, built by all of the other contractors. Adjacent box beam and continuous multigirder bridges built by the better contractors performed well (about a 5 percent spall occurrence rate) when concrete with a flexural strength greater than 600 psi was used. Lower strength decks spalled more frequently, especially adjacent box beam decks when more than 60 salt applications per year were made. This last analysis is an excellent example of the ability of the AID technique to illustrate the effect of interactions. Of eight spans having adjacent box beam superstructures, greater than 60 salt applications per year, and a flexural strength of less than 600 psi, six spalled.

From the lower branch of the tree, 512 spans were built with superstructures other than adjacent box beams or continuous multigirders. Again, the contractor was the most important single factor associated with fracture planes and spalls. Contractor 6 and "others" (a group of 48 contractors who built fewer than six bridges in 1966) accounted for only two spalled spans out of 150. This excellent performance indicates that bridges resistant to fracture planes and spalls can be built. An intermediate group of contractors, 11, 20, 23, 32, 33, and 37, had 8 percent spall failures, and the poorest group, 18, 25, 38, and 59, had a spall occurrence rate of 15 percent. Among the spans constructed by the poorer contractors, four of seven with flexural test values of 500 psi or less exhibited spalls. It is also significant to note that no span having a flexural test strength greater than 700 psi spalled even though built by the poorer group of contractors. This speaks strongly for higher strength concrete (low water content or high cement factor or both) for bridge decks. The influence of retarder use on the 120 intermediate strength spans appears minimal, inasmuch as the AID program grouped "yes" and "no" against "not reported."

contractor, and flexural strength are the primary factors controlling whether fracture planes and spalls occur. Unfortunately, the decisions to use adjacent box beam and continuous multigirder superstructures are usually dictated by physical constraints and are not subject to change. However, flexural strength can be altered by specification, and construction practices, as indicated by the contractor variable in this study, can and should be closely regulated. These analyses clearly show that, under the same specifications and at the same time, different contractors can produce durable and non-durable bridge decks.

For these study bridges, early spalling was almost always associated with inadequate concrete cover. Provision of sufficient cover is absolutely essential to durable bridge decks. The authors, therefore, recommend that provision of the specified cover be made a basis-of-payment item, similar to the slab thickness basis-of-payment for highway pavements. Also, in view of the improved performance of high-strength decks, the authors recommend that flexural strength requirements be increased to 700 psi for bridge deck concrete.

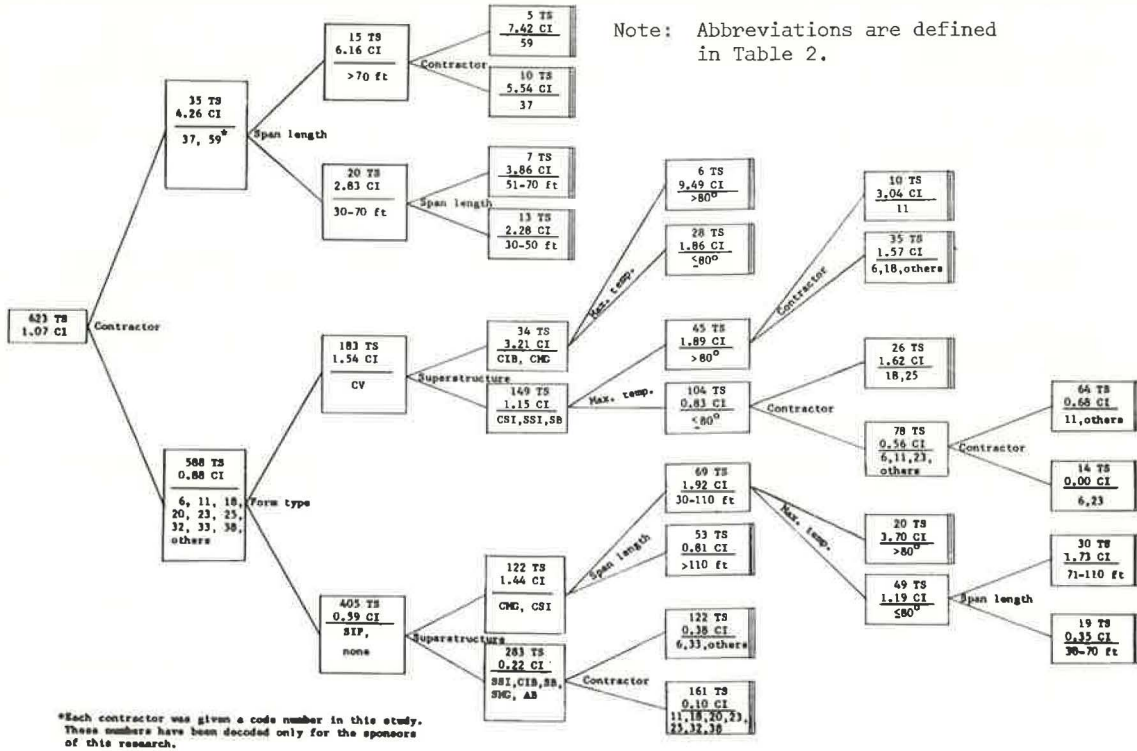
Similar analyses performed on crack data resulted in another tree diagram, shown in Figure 8. Although detailed interpretation of this analysis is left to the reader, note that again several variables proved important: contractor, form type (stay-in-place metal corrugated or conventional removable wooden forms), superstructure type, span length, and others.

Figure 8. Effects of five causal factors on crack intensity.

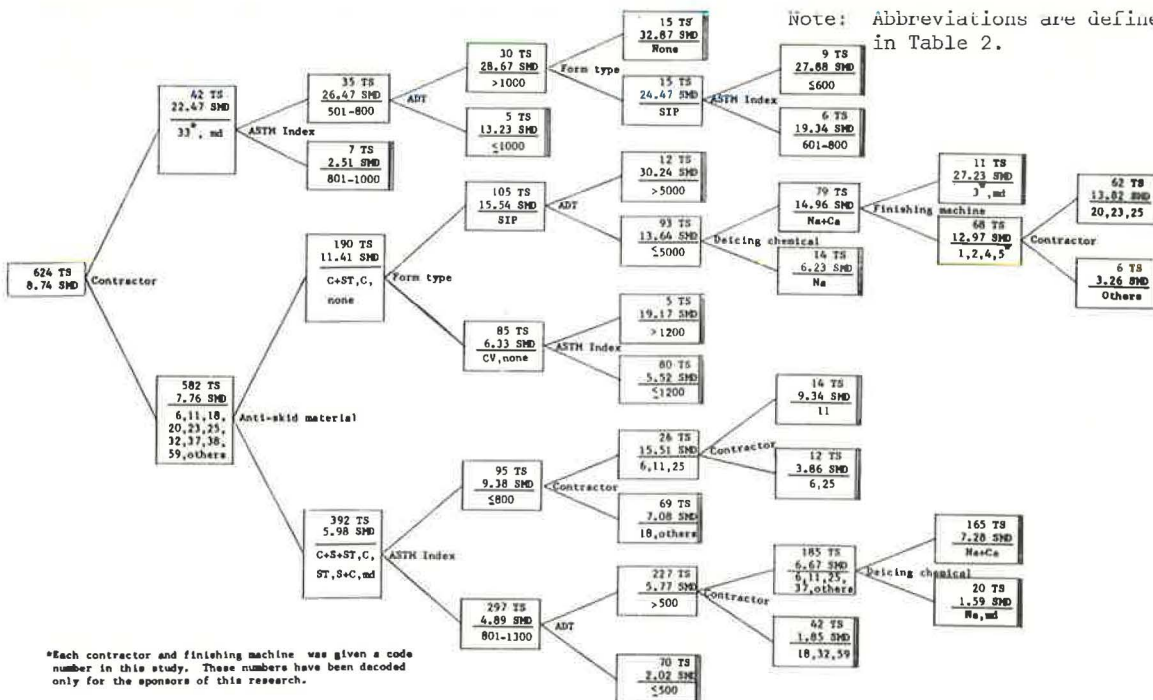
The surface mortar deterioration tree diagram is shown in Figure 9. Again the importance of the variable contractor is evident as is form type, different antiskid materials, average daily traffic, and others.

Figure 9. Effects of seven causal factors on surface mortar deterioration.
