CORROSION AUTOPSY OF A STRUCTURALLY UNSOUND BRIDGE DECK

Richard F. Stratfull, California Division of Highways

An investigation was performed on a 12-year old salt-contaminated, reinforced concrete bridge deck that had to be replaced because of its deteriorated condition. In this investigation, the electrical half-cell potential measurements and effect of chlorides present seem to be related to some threshold amount that changes the steel from a passive to an active state. Beyond this point, the amount of salt present has little or no effect except as it might influence the area of corrosion involved. The chaining or sounding of the deck to locate delaminated concrete performed the function very well but did not necessarily locate the corroded steel. From the observation of the type of cracking, it appeared that the final mode of distress was concrete fatigue. An investigation of actual concrete cover disclosed that there was reinforcing steel corrosion at depths greater than 3 in. It was determined that estimating the pit depth of steel by visually estimating the thickness of rust is not a very useful inspection technique. In this highly salt-contaminated bridge deck, no relation

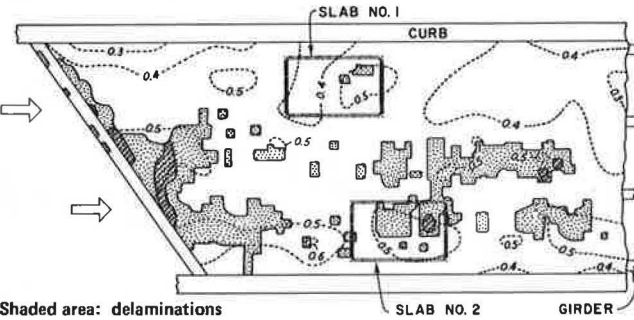
Figure 1. Part of span 1.

Electrical potential measurements using a saturated copper-copper sulfate half-cell were taken on the 4-ft grid pattern on the top of the deck with additional readings at anomalies. These readings were reduced to contours and overlaid on the plot showing the delaminated areas. Figures 1 and 2 show these contours as a dashed line.

Figures 1 and 2 show that the high potential measurements on nearly the whole deck surface indicated a massive area of active corrosion of the steel. Although not shown in Figures 1 and 2, visual observations of the steel during the concrete removal show significant areas of rusting steel even though the concrete in these areas showed no indication of spalling or delamination.

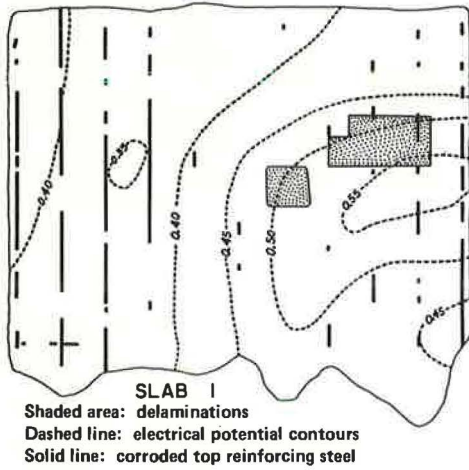
Figure 3. Slab showing little delamination.

Figure 3 shows the electrical potentials and the concrete delamination that were measured on the relatively good slab. All of the half-cell potentials are in the active range of -0.35 to -0.55 V and denote the likelihood of significant corrosion of the steel. In Figures 3, 4, and 5, the locations of steel that had visible rust were plotted as solid lines. If the top mat of reinforcing had no rust, it was not shown.

Figure 3 shows an undersurface delamination that apparently is in a location of un-rusted steel. Because this area of concrete still had the epoxy-aggregate membrane on the surface, it is believed that the hollow sound that caused a recording of a concrete delamination might have been the result of disbonding between the epoxy membrane and the underlying concrete surface.

As shown in Figures 3, 4, and 5, the relation between rusted steel and concrete delaminations can be poor. This is not to say that the corroding steel does not cause delaminations, but it does indicate that the amount of rust that forms on steel causing a spall can be highly variable. It is obvious that the sounding of concrete only relates to the condition of the concrete and not necessarily to the condition of the steel.

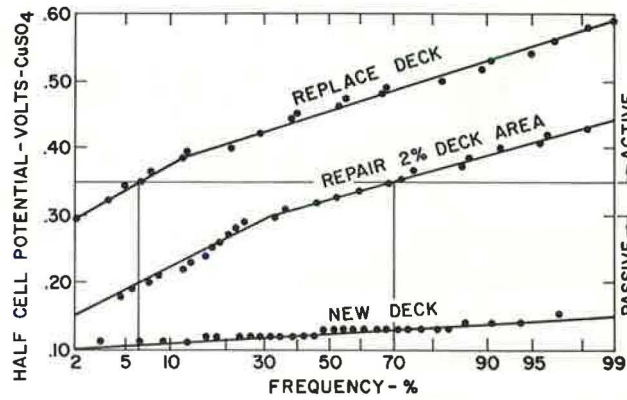
Figure 6. Distribution of half-cell potentials.

Figure 6 relates the half-cell potential measurements to the observed condition of the bridge by showing the cumulative frequency distribution on three bridges. The upper

distribution curve shown in Figure 6 is for the bridge under investigation; the middle distribution curve is for another bridge. For the bridge deck that required replacement (lower curve, Fig. 6), about 94 percent of all of the potential measurements made showed that the steel was active (more negative than -0.35 V, $\text{Cu} \cdot \text{CuSO}_4$) or corroding. For the deck that was repaired, only 30 percent of the measurements showed active half-cell potentials, and the new deck had no measured active potentials.

The data shown in Figure 6 may reflect a means for "logging" the condition of a bridge according to the percentage of active or passive potentials. However, the distribution curve can have a break; therefore, one must exercise caution in mathematically calculating a mean or standard deviation for the half-cell potentials.
