# OBSERVATIONS ON THE CAUSES OF BRIDGE DAMAGE IN PENNSYLVANIA AND NEW YORK DUE TO HURRICANE AGNES

Charles L. O'Donnell, Office of Engineering and Traffic Operations,  
Federal Highway Administration

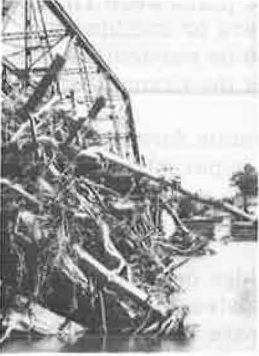
Figure 2. Cracked pier cap on Towanda Creek bridge in Powell, Penn.

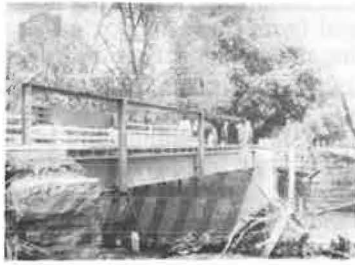
Figure 3. Arch bridges, such as the Market Street bridge in Wilkes Barre, Penn., were most damage-resistant.

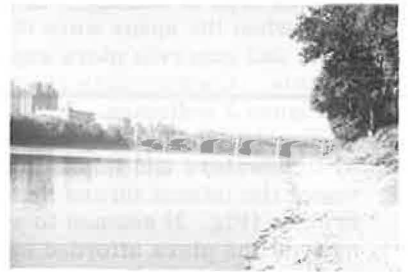
Figure 4. Large deflection of (a) the upstream truss and (b) the downstream truss of the James Street bridge in North Towanda, Penn.

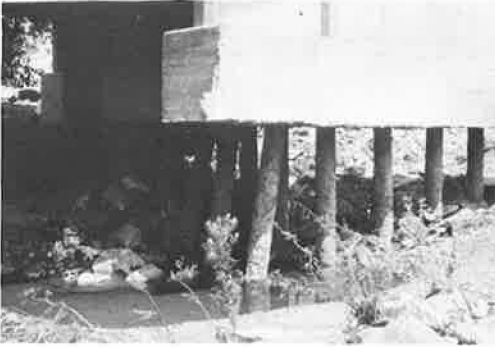
Figure 8. Approach damaged by overflow on Tioga River bridge.

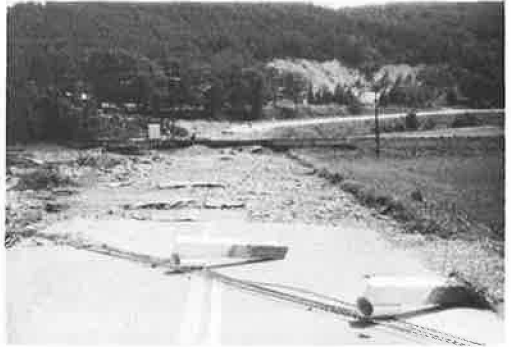
Figure 9. Location and alignment of highways at bridge site. Canisteo River bridge is indicated by circle.

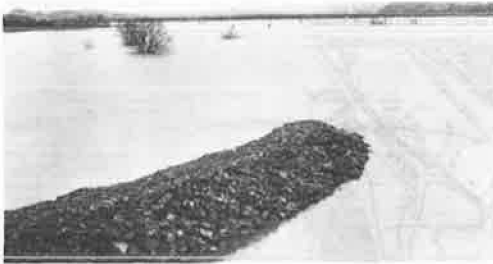
**Figure 15. Post-flood condition of floodplain between abutment and adjacent pier of Susquehanna bridge.**

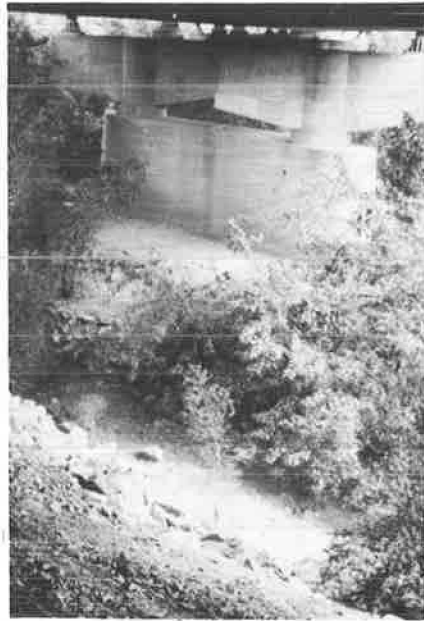
**Figure 16. Remnants of earthfill spur dike near Chemung River bridge near Lowman, N.Y.**

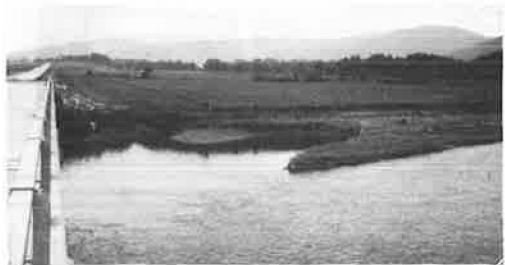
survived because the steel superstructure prevented collapse. The structure was closed to traffic and braced by timber cribbing until the footings could be underpinned.

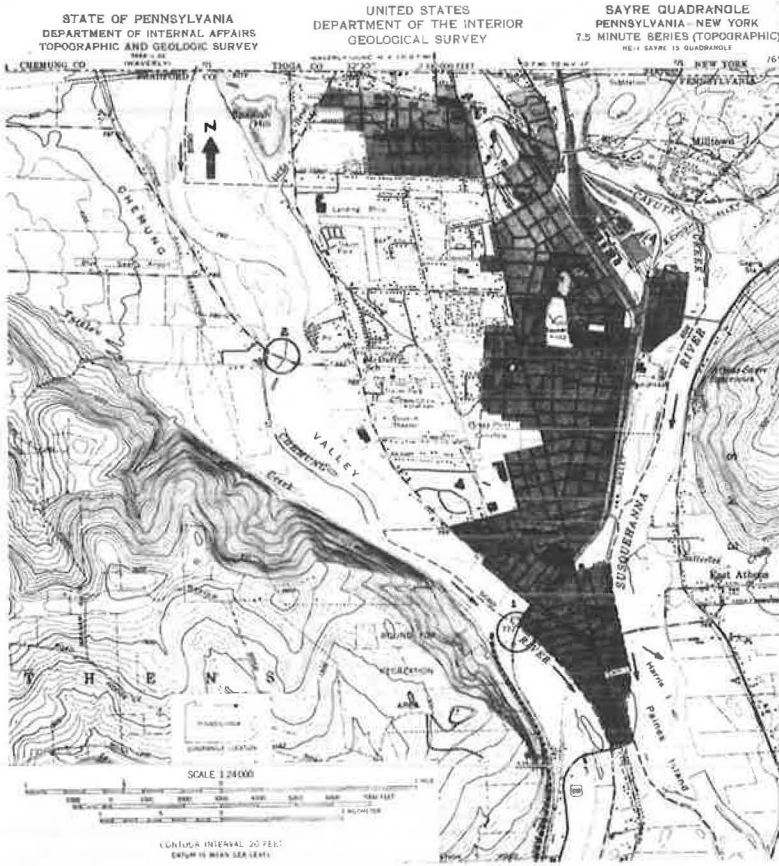
**Figure 19. Upstream scour hole, eroded approach embankment, and damaged abutment of Lehigh Valley Railroad bridge.**

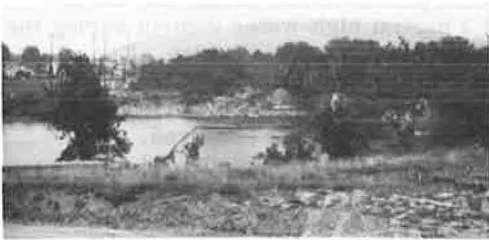
**Figure 20. Downstream view of Lehigh Valley Railroad bridge showing pier settlement.**

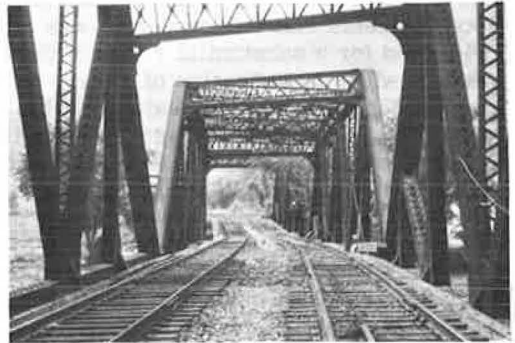
flood. Historic flood profiles are very useful in the design of replacement and new structures.

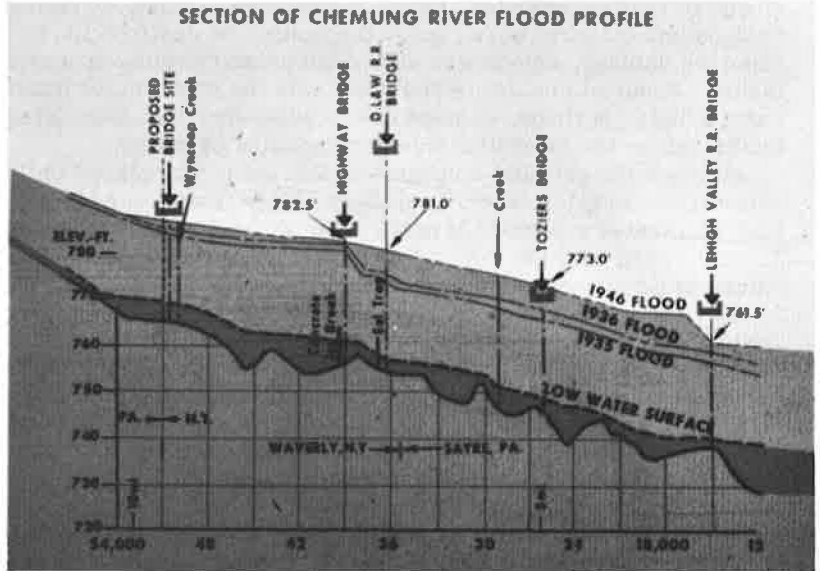
Figure 22. Undermined roadway slab and scoured embankment fill adjacent to Tioga River.

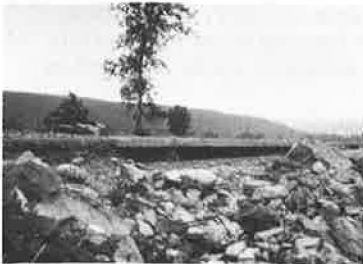
Figure 23. Cracked pier shaft supporting a county bridge on Schrader Branch of Towanda Creek.

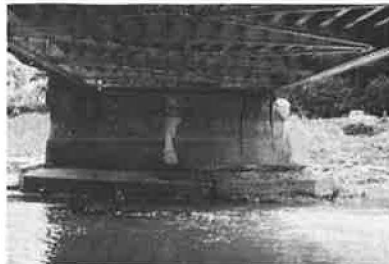
Figure 24. Front view of cracked pier shaft and broken pier footing.

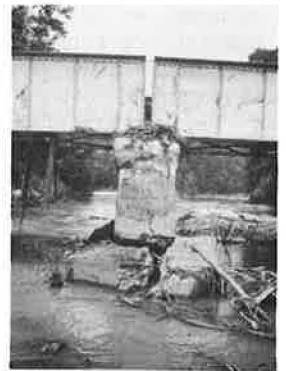
closed to traffic; however, many others were extensively damaged. (A total of 694 bridges and culverts were reported damaged or destroyed.) In virtually every case of reported damage, debris was either the primary cause or a significant contributing factor. Scour at abutments and piers was the other major cause of damage. Somewhat surprisingly, perhaps, damage due to superstructure inundation was not a significant factor unless the inundation was accompanied by debris.
