NATIONAL COOPERATIVE
HIGHWAY RESEARCH PROGRAM REPORT

336

**DISTORTION-INDUCED FATIGUE
CRACKING
IN STEEL BRIDGES**

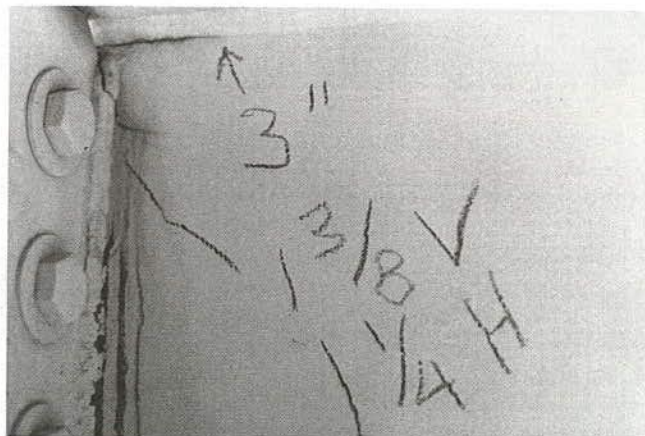
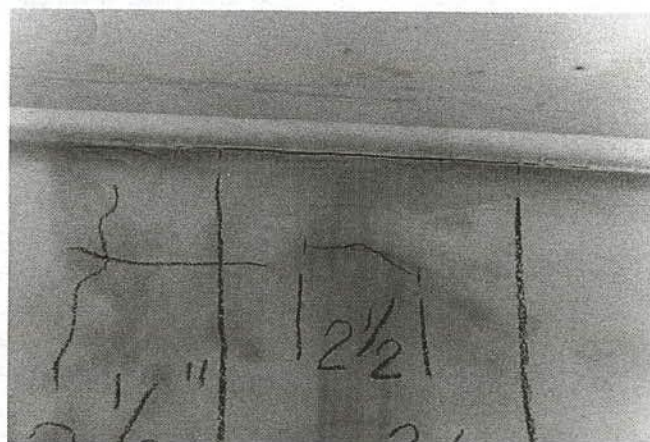
Figure 2. Top photograph shows web gap fatigue cracking at the transverse connection plate for a floorbeam; bottom photograph shows web gap cracking on the exterior girder web face.

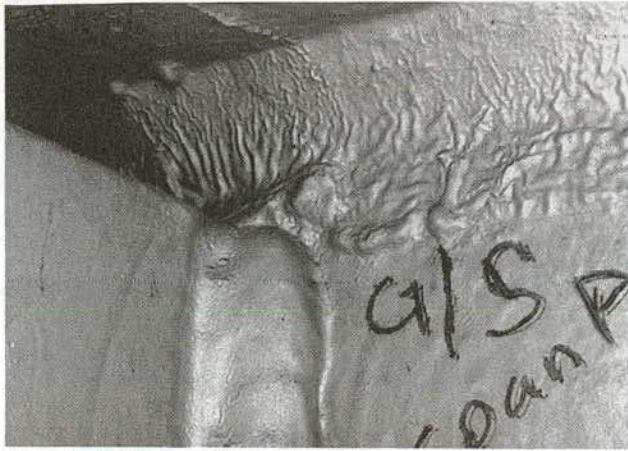
On inspection, small cracks were found along both the web-flange weld and the transverse connection plate weld in many diaphragm connection plate web gaps. The cracks were parallel to the longitudinal axis of the main girder and, therefore, are parallel to the primary bending stresses in the web plate. The

Figure 17. Cracking at connection plates, Beaver Creek Bridge. (Source: Ref. 18)

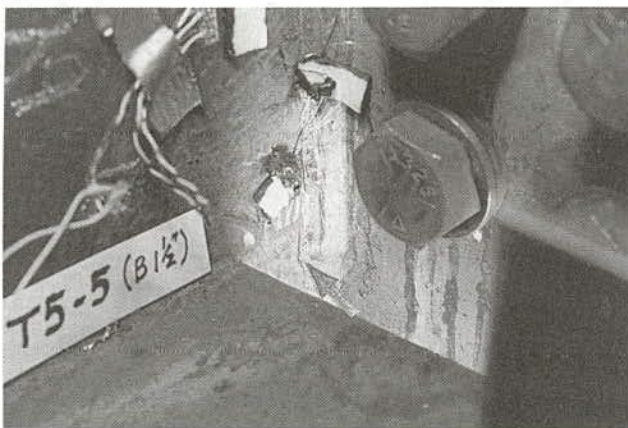
Figure 30. Fatigue cracking at Detail T5-5 (Type B), west web gap.

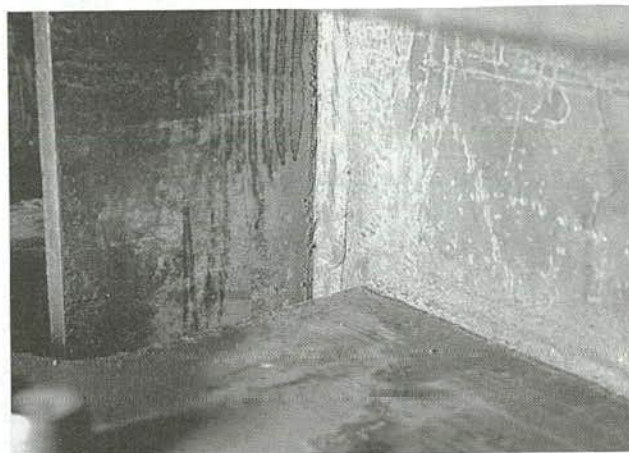
Figure 33. Cracking along vertical weld toe in the horizontal web gap.

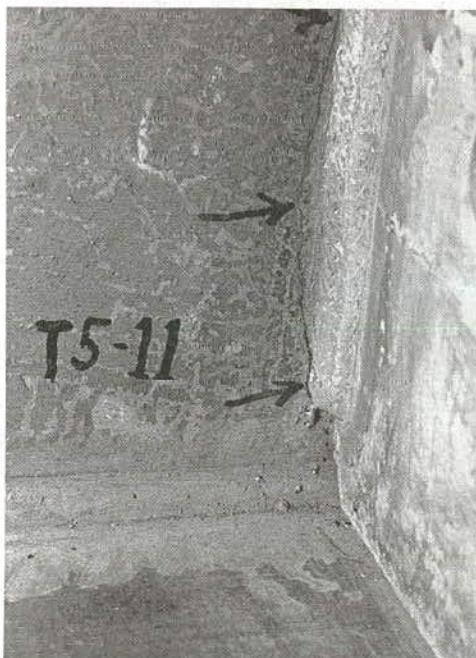
The fatigue cracks that developed in the transverse connection plate web gap first developed at the fillet weld toe of the transverse connection plate, as illustrated in Figure 44. As can be seen in Figure 44, the crack extended for a distance up the girder web along the transverse weld toe and then grew away from the weld toe into the web plate.

Figure 42. Photograph shows crack along vertical connection plate weld.

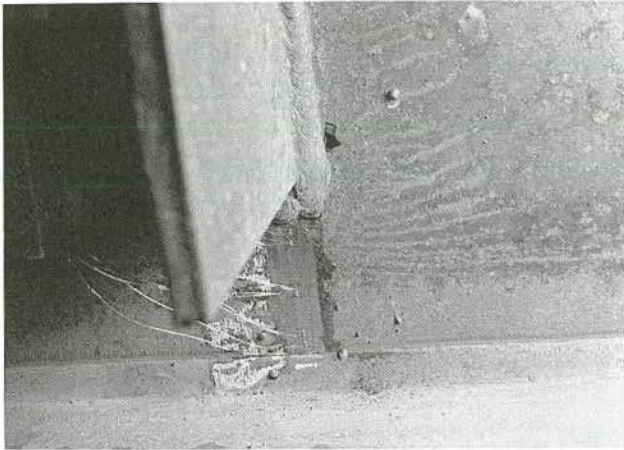
Figure 44. Photograph shows crack forming at end of connection plate weld and extending up the transverse weld in (T2-L1) 3-in. gap.

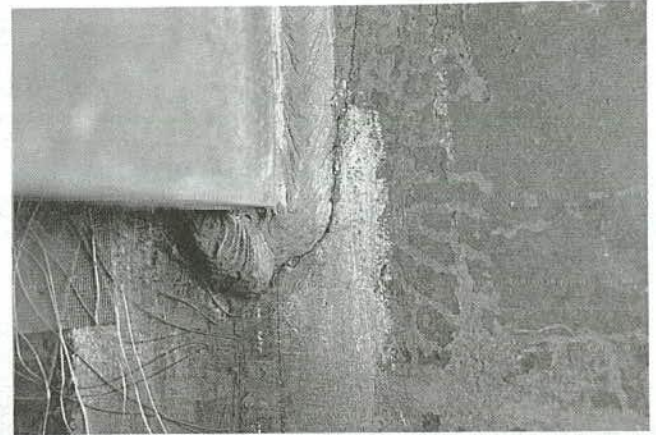
Figure 45. Close-up view of crack at end of transverse connection plate welds (3-in. detail).

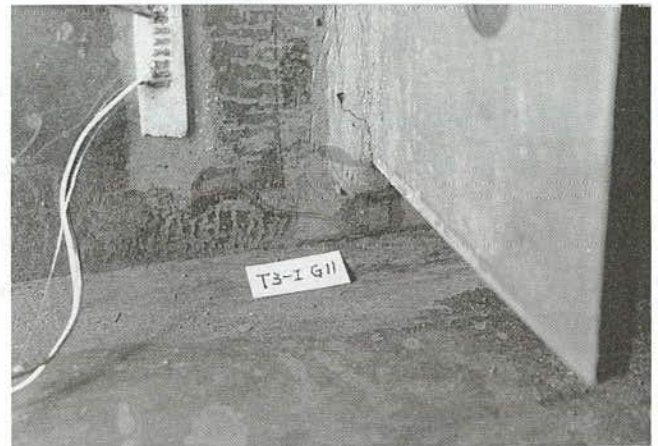
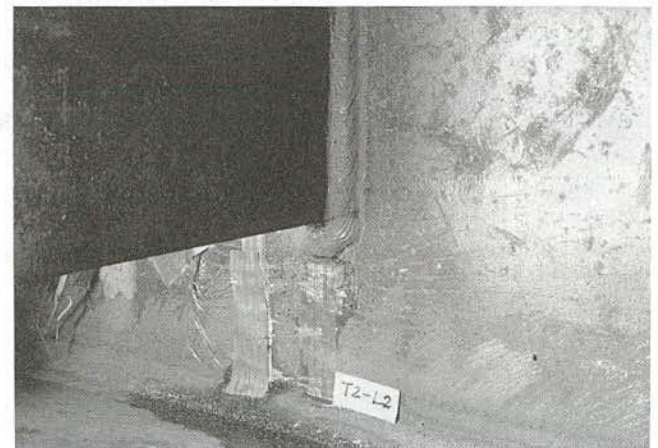
Figure 46. Photographs show cracks forming at ends of connection plates. Top photograph: branching crack at end of connection plate with $1\frac{1}{2}$ -in. web gap; bottom photograph: small crack in weld after completion of test at a 3-in. web gap.
