Repair and Rehabilitation of Bridge Components Containing Epoxy-Coated Reinforcement

**National Cooperative Highway Research Program
Transportation Research Board
National Research Council**

**Ali Akbar Sohangpurwala
CONCORR, Inc.
Sterling, Virginia**

August 2002

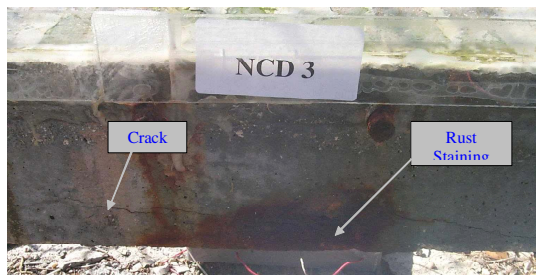
Figure B-12: Photograph of one side of Specimen NCD-3 showing a crack induced by corrosion of the bottom mat reinforcement and associated rust staining.

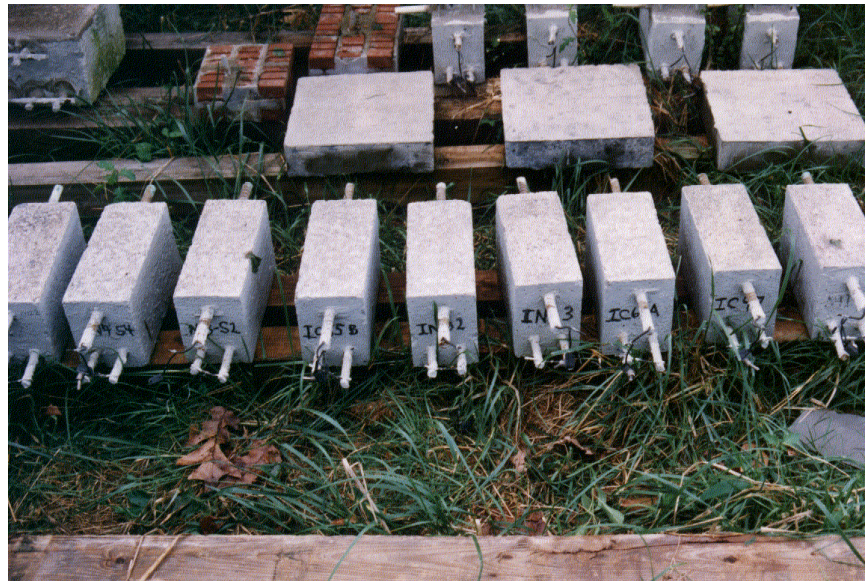
Figure C-2: Photograph of old G-109 specimen as received.

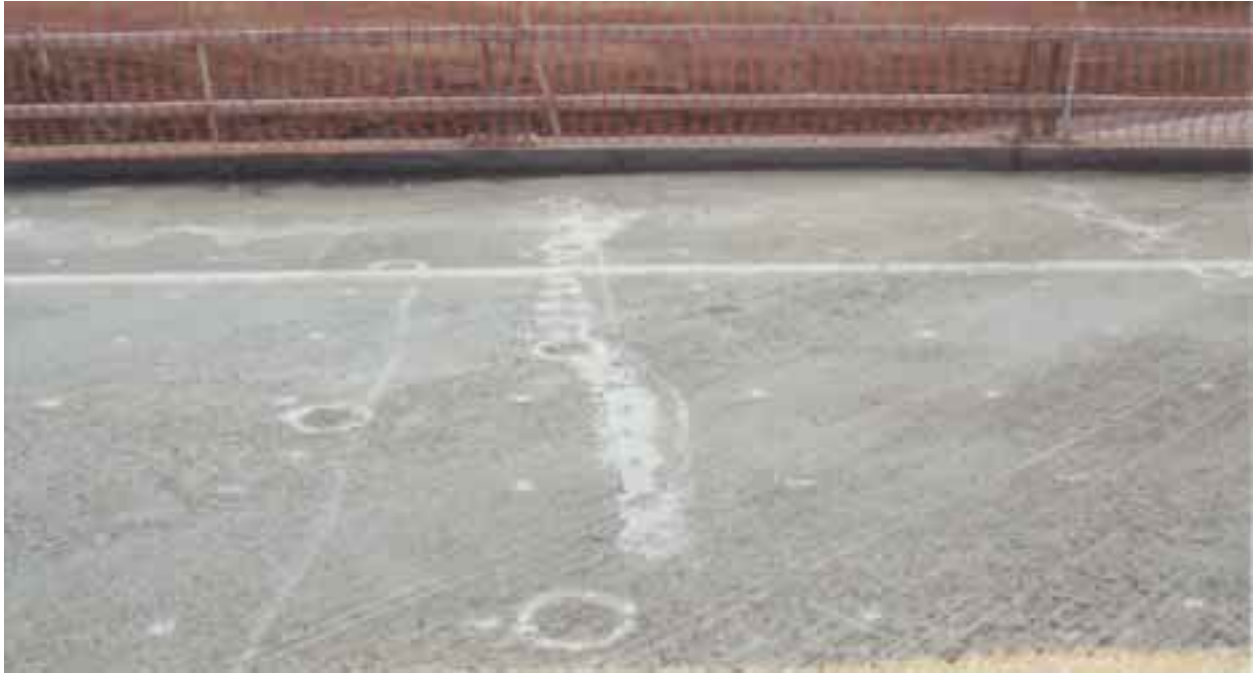
During the first post-repair survey (12 months after repairs were installed), one of the cracks not included in the study had grown in length by about 305 mm (1 ft.), a large rust stain developed a less than a meter to the side of crack C9, and a new shallow spall was found. No new changes were recorded during the 25 month evaluation. After 34.5 months, a large diagonal crack and a new delaminated area with several small, shallow spalls were observed. In addition, a new delamination developed along a crack that had another delamination (in a different area) since the start of the study.

Figure C-22: Overview of repaired crack on the bridge.

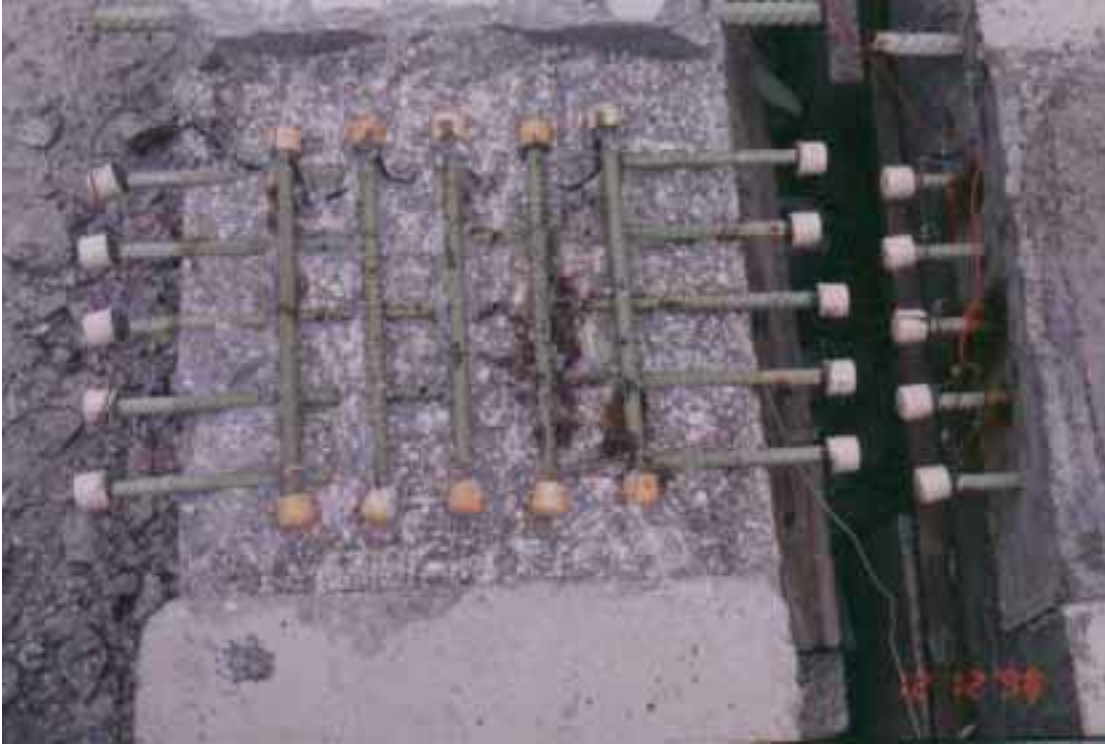
Figure D-5: Photograph of the ECR mat from a PCS specimen after removing the cracked and spalled concrete.
