A FIELD INVESTIGATION OF CONCRETE PAVEMENT IN TEXAS

W. B. Ledbetter and Alvin H. Meyer, Texas Transportation Institute; and
Harvey J. Treybig, Austin Research Engineers, Inc.

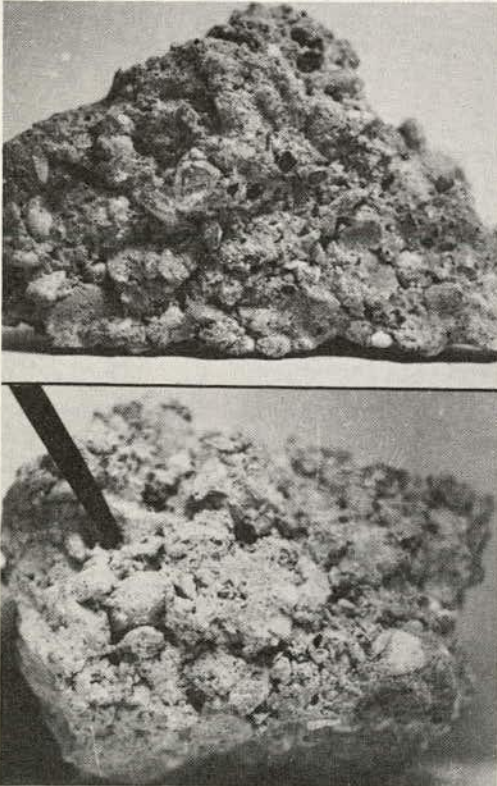
Figure 2. Honeycombed concrete taken from bottom side of continuously reinforced concrete pavement.

occurred because of improperly consolidated concrete (Fig. 2). It is hypothesized that, in a concrete matrix such as this, very little tensile strength could be expected from the concrete.

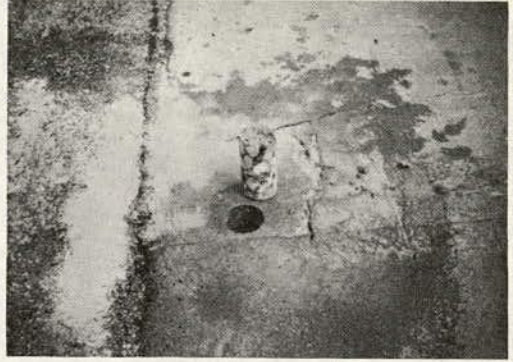
One location that has been particularly troublesome for CRCP is the area adjacent to construction joints, or headers as they are sometimes termed. As shown in Figure 1, the concrete adjacent to the joint is badly cracked and the bottom is honeycombed, as seen on the core turned upside down to show the honeycombing. Such areas that appear to indicate this type of distress are rather prevalent in the older paving projects throughout the state.

Figure 1. Areas of distress adjacent to a construction joint in CRCP (core upside down to show honeycombing).

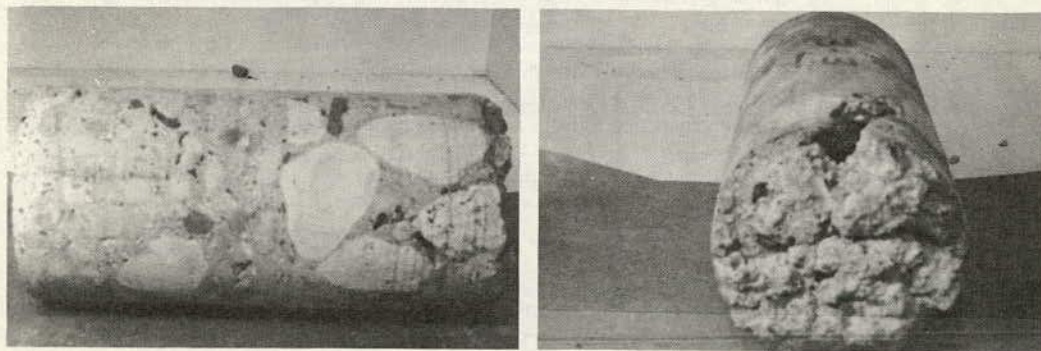
Figure 4. Core 3-3 from area B.

Pictures of selected cores are shown in Figures 4 and 5. Figure 4 depicts a suspected honeycombed area in the bottom of the core resulting from improper consolidation, and Figure 5 shows concrete segregation with the top 2 in. devoid of any coarse aggregate. A fourth area of the state (area D) contained a CRCP project in which extensive honeycombing occurred. Although this area was investigated and reported in another investigation (11, 12), the data concerning the evaluation of the cores are included here.
