THE ROLE OF FIELD INSTRUMENTATION IN CORRECTION OF THE "FOUNTAIN SLIDE"

Andy Muñoz, Jr., Federal Highway Administration, Portland, Oregon; and Dan Gano, Oregon State Highway Division

The reliability and usefulness of field instrumentation in providing design data for landslide correction are clearly illustrated in the case history of the Fountain landslide. The area known as the Fountain Slide affects an approximately $\frac{3}{4}$ -mile (1-km) section of I-80N just north of Mt. Hood about 45 miles (72 km) east of Portland, Oregon. This section of highway is flanked on one side by a railroad and the Columbia River and on the other side by the unstable and ancient landslide, which extends for several thousand feet (more than 1 km) to a sheer rock face some hundreds of feet (more than 200 m) above the lower slopes. Construction of I-80N required cutting into the unstable area a substantial distance and resulted in increased slide activity. Since the construction of the Interstate, several efforts have been made to stabilize the Fountain Slide. None have been totally successful, largely because the cause of the failure was not fully understood. In 1968 field instrumentation was inst

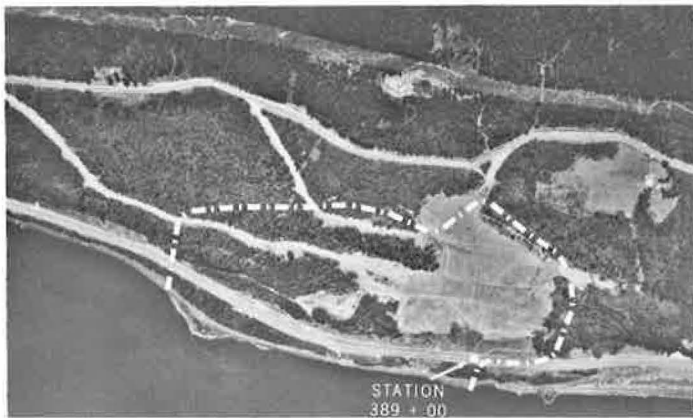
Figure 2. 1973 aerial photo showing existing landslide limits.

Since completion of the Interstate Highway in 1968, several attempts have been made to stabilize the sliding mass. In December 1969, a contract was awarded for the removal of 1,700,000 yd³ (1,300,000 m³) of the sliding soil matrix, plus provision for drainage by installation of horizontal drains (Fig. 2). This work was completed in the fall of 1970 at a cost of approximately \$1.7 million. Eleven slope indicators were installed to monitor and assist in evaluating the stabilizing effect of the unloading work.

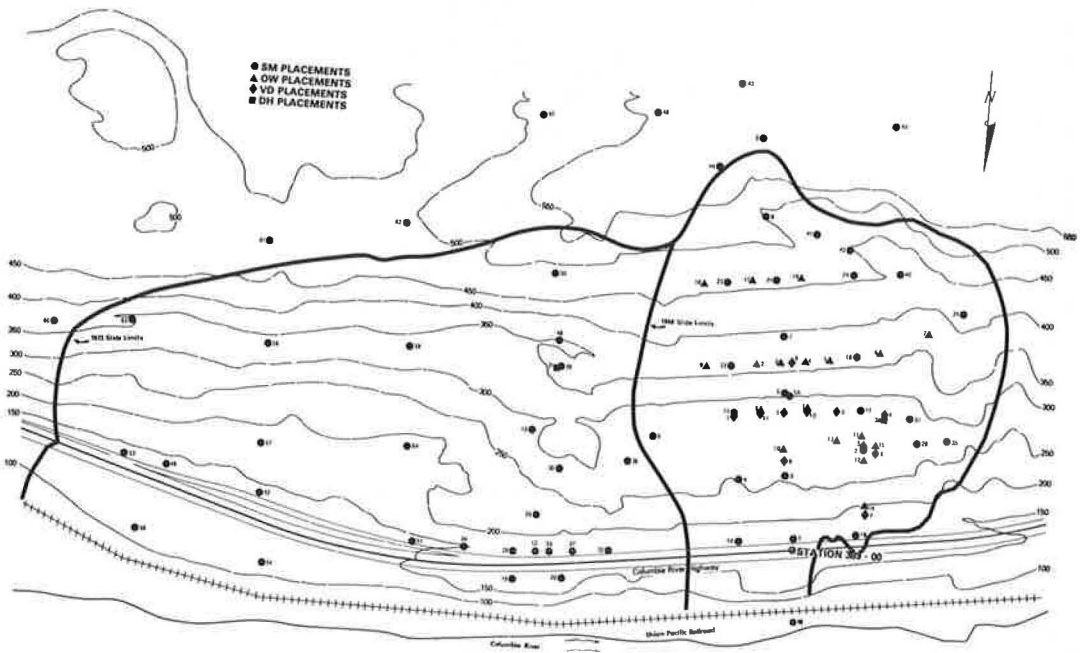
Figure 3. Plan of Fountain Slide showing instrumentation locations and limits of landslide. Contour intervals are 50 ft (15.24 m). SM = Slope Meter or Slope Indicator; OW = observation well; VD = vertical drain; DH = drill hole.

Unfortunately, slide activity since completion of the project has required extensive maintenance work on the highway and railroad grade. During periods of movement, shifts in the railroad grade or alignment were corrected on a day-to-day frequency. Figure 3 shows the many inclinometers that have been installed because of the magnitude of movements and the scarp as it exists now along with the landslide limits of 1968. The present total area of sliding extends along the highway approximately ³/₄ mile (1 km).

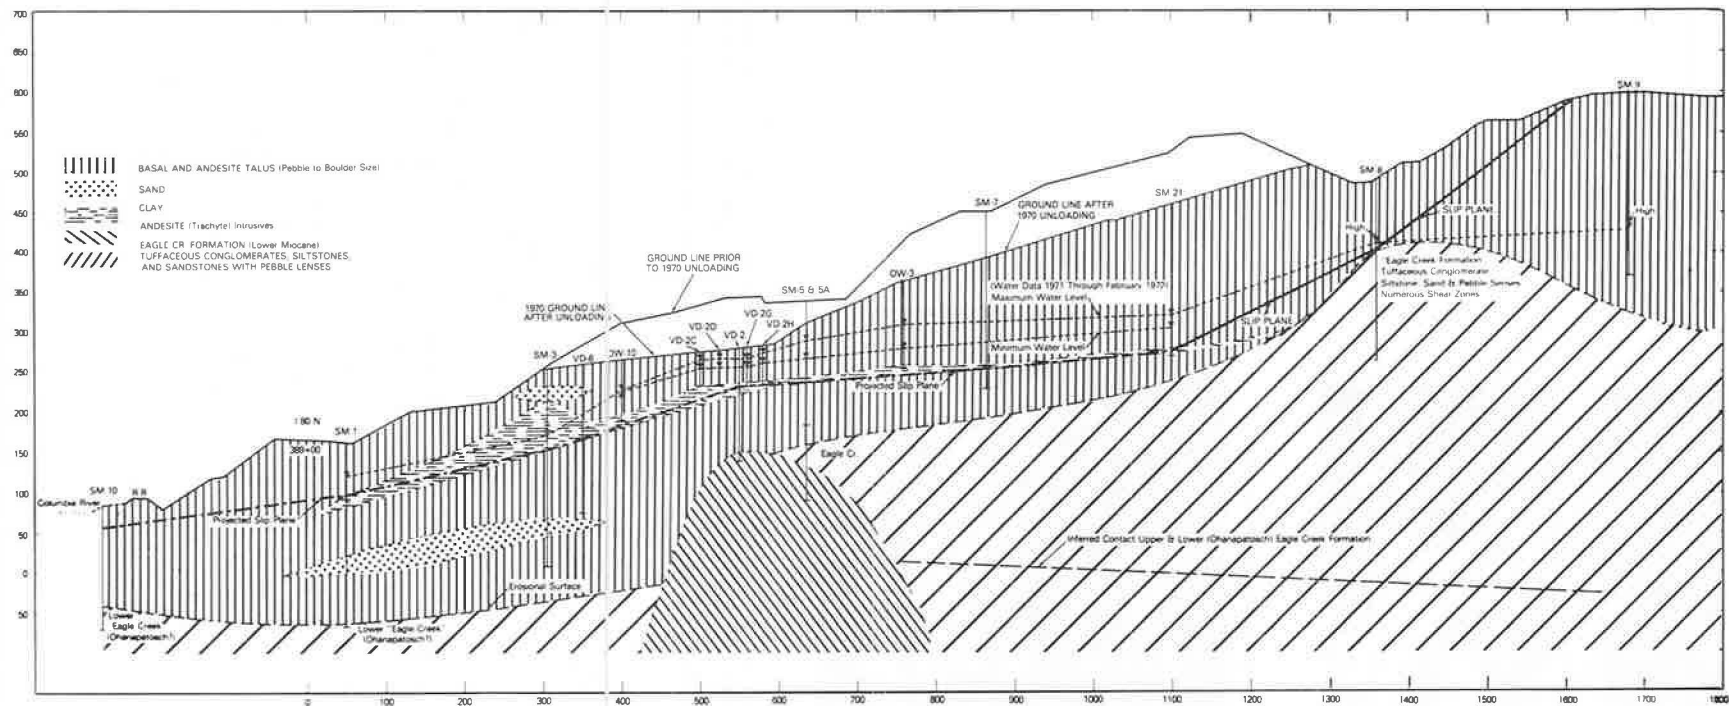
Figure 4. Cross section of Fountain Slide showing soil profile and slip plane as defined by slope inclinometers. Horizontal and vertical scales are in feet (1 ft = 0.3 m). SM = Slope Meter or Slope Indicator; OW = observation well; VD =vertical drain.

The slide is moving along generally uniform slip planes with inclinations ranging from 4 to 16 deg from the horizontal. As Figure 4 shows, the slope inclinometers indicate a classic example of planar movement. The depth of movement varies throughout the landslide area, with the deepest movements 200 ft (61 m) at boring hole number SM-7. Lateral movement was quite restricted vertically in many of the inclinometer casings. Most of the bending took place on a 2 to 4-ft (0.6 to 1.2-m) interval that corresponded to the thickness of the clay-mudstone layer. The movement was generally in a northerly direction toward the Columbia River.

During the period from November 1971 to February 1972, the slope inclinometer movement ranged from 2 to 7 in. (5 to 18 cm), depending on the location of the tube. This movement clearly defined the slip plane, as shown in Figure 4. With the location and angle of the slip plane now clearly defined, a stability study was undertaken and an elaborate remedial scheme proposed. This scheme proposed to (a) reduce the driving forces at the head of the slide by unloading where the inclination of the failure surface was greater than the angle of internal friction and (b) construct drainage trenches perpendicular to the highway centerline. The purpose of the trenches would be to improve drainage and accommodate construction of a rock buttress. The cost for this remedial scheme was estimated at \$3.2 million, and construction was scheduled to begin in June 1973. During March 1973, surface observations indicated slide activity approximately 2,000 ft (600 m) east of the slide limits that were used for the remedial cost estimate. This newly observed areal extension of the landslide limits approximately doubled the sliding mass. Fifteen slope inclinometers were installed during April to June 1973 in the new area of sliding to monitor the movements and determine the slip plane. Because of the size of this sliding mass, a decision was made to wait on the proposed remedial work until the new area of sliding could be fully evaluated.

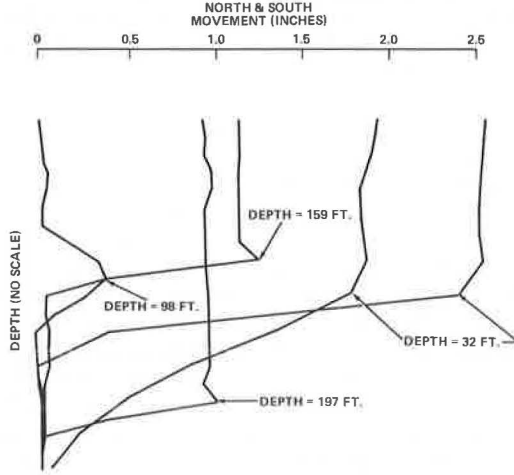
Figure 5. Typical slope inclinometer plots (1 in. = 2.54 cm).

Figure 5 is representative of the lateral movements that have taken place from 1968

to 1972. Several slope inclinometer plots have been superimposed on the same graph to show the different types of plots from different areas of the slide. An observation that can be made from the plot is that when the movement was within a 0.5-in. (1.3-cm) range, the movement was pretty well confined to the soft zone, but once the magnitude of movement went beyond that range, the mass above the sliding plane would show uniform movement equal to the movement at the soft zone.

Instrumentation data showed that a movement pattern then developed in which ground movements occurred in the fall and winter during the rainy season and stopped during the dry summer months (Fig. 5). Movement had occurred both summer and winter prior to the 1970 unloading, which indicated that the unloading work had some stabilizing effect. Field instrumentation detected continued ground movements, and a decision was made to further attempt to drain the slide. The horizontal drains that were installed earlier gave very poor results; therefore, vertical test wells were proposed before proceeding with a well system to drain the slide. Four vertical test wells were installed during June 1971. Eight piezometers were installed around each of the vertical test wells to monitor groundwater fluctuations. Boring data had indicated that permeable talus material existed below the impermeable soft clay material (Fig. 2). The idea was to provide an escape for the trapped water through the impermeable clay into the permeable talus material below the slip plane.

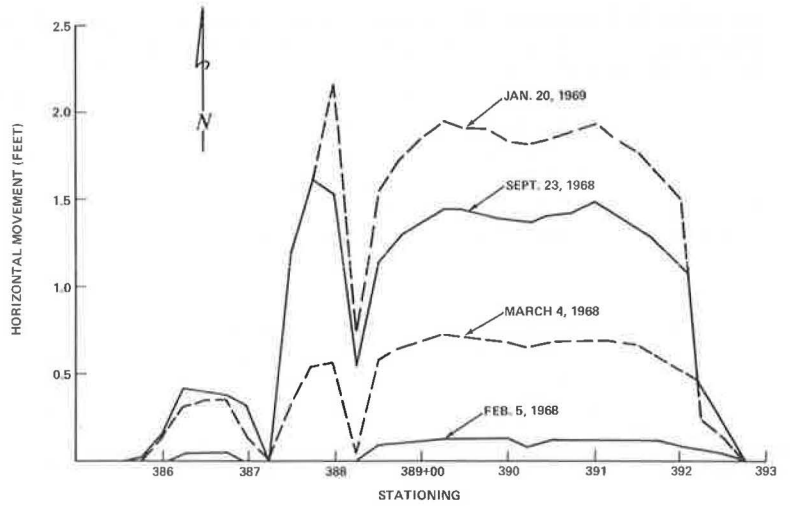
Figure 6. Highway horizontal movement.

To date a total of 63 slope inclinometer casings have been installed. Many graphs have been prepared from Slope Indicator and Slope Meter data relating lateral movement to time and rainfall. Because of the excessive amounts of these movements, most of the slope inclinometer casing installed during the initial exploration has been sheared off. Prior to 1970, measured movement was at a rate of 2 ft (0.6 m) per year horizontally and 1.5 ft (0.5 m) vertically. Resurfacing of the existing pavement required a horizontal line shift of up to 5 ft (1.5 m) in some areas. This resulted in removal of some of the existing rock buttress and explains the increased rate of movement that occurred shortly thereafter. As can be seen from Figure 6, the rate of movement differed considerably throughout the area of sliding.

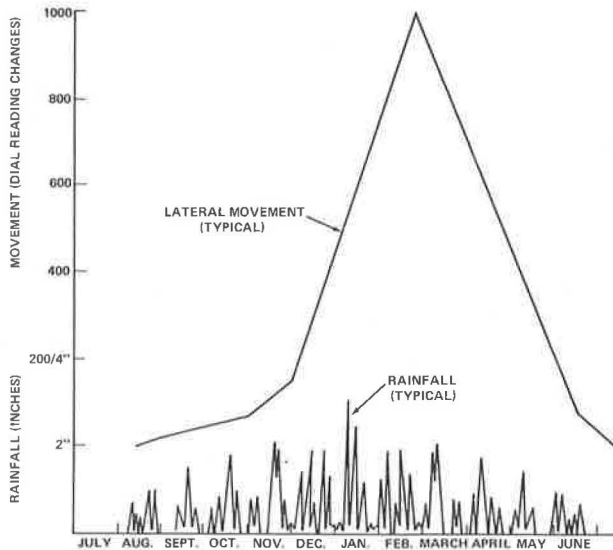
Figure 7. Rainfall versus movement.

Figure 7 correlates the rainfall and the corresponding movement in the slope inclinometers. The graph was put together by assembling and correlating monthly slope inclinometer readings for several instruments for the period between 1970 and 1972; therefore, the plots are not actual for any one year. They indicate what has always been obvious and what many engineers have stated in the literature: The increase in sliding movements is a direct function of increased rainfall activity. Groundwater conditions throughout the slide mass do not conform to any uniform pattern; therefore, groundwater conditions varied throughout the landslide area for stability analyses. Seasonal fluctuations at the boring locations have been very erratic, which gave an indication of the variable permeability throughout. There are many zones of trapped or perched water tables through the sliding mass.
