SLOPE INSTRUMENTATION USING MULTIPLE-POSITION BOREHOLE EXTENSOMETERS

Howard B. Dutro, Teledyne Geotech, Golden, Colorado; and
R. O. Dickinson, Public Service Company of Colorado, Denver

An unstable slope encountered during construction posed a serious hazard to men and equipment in the lower dam area of the Cabin Creek hydroelectric complex in Colorado. Following a series of rock slides, remedial work was undertaken to reinforce and stabilize the slope. As a part of the remedial program, multiple-position borehole extensometers were installed to permit the measurement of slope behavior and to provide safety monitoring for the protection of activities and facilities in the downslope construction area. The extensometers were read continuously when men and equipment were in the downslope area and intermittently at other times. All readings were immediately scanned to identify unusual or accelerating slope deformation. The readings were later processed by computer to permit a more detailed analysis of the nature, distribution, rate, and acceleration of displacements in each drill hole and an interpretation of the general behavior of the slope in the unstable area. Early in the Cabin

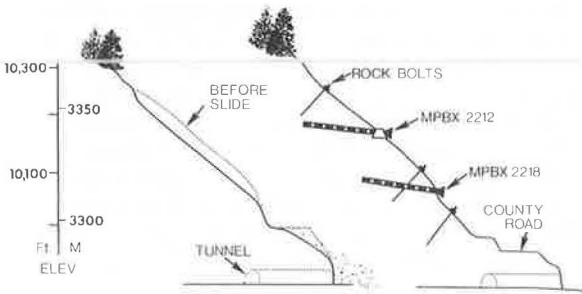
Figure 2. Generalized section of project.

The main features of the remedial work are shown in Figure 2. The remainder of this paper is a description of the measurement and monitoring program and of the principles developed for evaluation of the stability and general safety of the slope area both during construction and during the subsequent operation of the completed Cabin Creek facility.

1. Removal of the slide debris and reshaping of the slope to the most favorable possible attitude.
2. Installation of rock bolts to varying depths in the slope, the bolting to be accomplished as the slide debris was removed and the slope reshaped.

3. Diversion of surface drainage away from the slope, particularly in the area immediately above the slide. This was accomplished by the relocation of one small stream to drain to the downstream side of the dam, by the construction of paved drainage ditches upslope and downslope from the slide, and by drain holes drilled in the slope itself.

4. Redesign of the spillway intake structure to withstand greater earth loads and to protect valve controls and operators from falling rock.
5. Relocation of the inlet to the spillway structure 150 ft (46 m) out into the reservoir. This was accomplished by using two 6-ft (2-m) diameter steel pipes.

6. Construction of a load surcharge at the toe of the valley slope below the slide area. The surcharge was formed by wrapping the upstream side of the dam around the spillway structure and extending it for a short distance upstream from the slide area. The surcharge also served to cover and protect the inlet pipes leading to the intake structure.

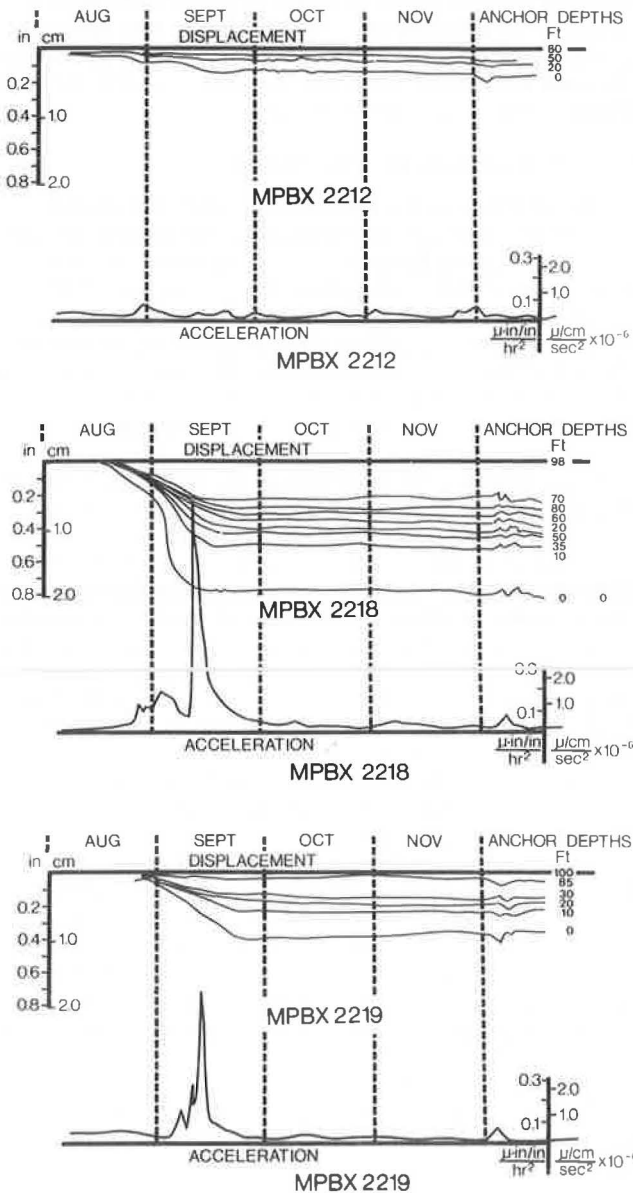
Figure 4. Displacement and acceleration graphs.

Figure 4 is a displacement-acceleration representation of data obtained from MPBX 2212, MPBX 2218, and MPBX 2219 during the Cabin Creek instrumentation program. For MPBX 2218, the zero displacement ordinate is the trace of the deepest 98-ft (30 m) anchor. Each of the other traces is labeled with a notation of the interval it represents; i.e., the 98-80 ft (30-24 m) trace defines the displacement of the 80-ft (24-m) anchor relative to the 98-ft (30-m) anchor. The 98-0 ft (30-0 m) anchor, by this token, defines the displacement of the instrument head at 0 ft relative to the 98-ft anchor. The abscissa is elapsed time (months) since instrument installation.

At an ET of approximately 8.0 days, the slope received over 4 in. (100 mm) of rain in a 24-hour period. Shortly thereafter, at ET 11.9 days, displacements rapidly accelerated, accelerating still further at about ET 13.1 days. Soon after the onset of the accelerated displacements, some surficial slumping and considerable rolling rock could be seen on the slope. By this time men and equipment had already been removed from the downslope area, the judgment having been made on the basis of the instrument data at about 12.3 days ET.

The displacement rate reached a maximum at about 14.5 days, thereafter subsiding gradually until about 16.9 days, at which time a relatively constant low gradient was reestablished. The new gradient was at an appreciably lower rate than the gradient measured prior to the rainfall. By about ET 31.2 days, displacements in the vicinity of MPBX 2218 had essentially ceased. The perturbations in the curves at about 85.4 days resulted from ice accumulation in the instrument head following an interruption of electric power to the heated instrument enclosure and hence do not reflect real data.

A quick inspection of the displacement curves from MPBX 2218 indicates that about half of the total displacement measured in the MPBX 2218 drill hole was localized in the interval between the 98-0 ft (30-0 m) and 98-10 ft (30-3 m) traces; i.e., in the surface 10 feet (3 m) of the hole, a condition strongly suggestive of surficial slumping in the disturbed slope material.

The presence of an appreciable interval between the zero ordinate and the 98-80 ft (30-24 m) and 98-70 ft (30-21 m) traces indicates that the deep part of the drill hole, at least to the location of the 80-ft (24 m) anchor, is not beyond the zone affected by the slope deformation. The progression of these deep displacements from ET 2 days appears, however, to be generally consistent with rebound rather than with the accelerating pattern of displacements registered by the shallower anchors after the 4-in. (100 mm) rainfall.

After the rainfall, a succession of accelerating displacements was registered, the largest occurring at ET 14.6 days. The acceleration at ET 14.6 days was equivalent, in a 98-ft hole, to a strain change rate of 8.25 microin. per in. per hour per hour (6.35×10^{-5} μm per cm per second per second). Thereafter, the acceleration decreased gradually, approaching zero at about ET 23 days.

The displacement curves alone are quite ambiguous, particularly in regard to the events following the rainfall. One instrument, MPBX 2218, registered the very appreciable displacements already described. Another, MPBX 2212, registered little activity. The remaining instrument, MPBX 2219, indicated an intermediate low level of displacement. Although the curves develop a considerable amount of useful information in regard to possible rebound adjustments, possible surficial slumping, and the stability or instability of specific local areas of the slope—those areas in which each instrument was specifically located—the general progression and nature of the data offers little basis for evaluation of the probable stability of the entire slope. The best that can be said is that, in point of displacement magnitude and distribution in space, there is no definitive indication of the concerted movement of a single block of any appreciable size. The suggestion is, however, that the various parts of the slope responded to the same stimuli at about the same times and that only the magnitude of the response differed from hole to hole. This would imply that, given an adequately intense stimulus, the entire slope might respond in a violent or hazardous manner.

The acceleration curves, on the other hand, provide a substantially different view of the same events. On the basis of these curves the faintly ominous displacement events are seen to be spread in time. Neither the distribution nor sequence of the acceleration peaks—at least those associated with the rainfall—suggests a systematic dislocation of a block of any appreciable size. In other words, the overall response of the slope with respect to both displacement and average acceleration was substantially less disturbing than the displacement curves alone would have suggested.

A less reassuring aspect of the acceleration curves is a pattern of accelerations registered in late August and early November by MPBX 2212 and MPBX 2218 and at
