LANDSLIDE INSTRUMENTATION FOR THE MINNEAPOLIS FREEWAY

Stanley D. Wilson, Shannon and Wilson, Inc., Seattle

In 1967 a landslide developed along a section of freeway under construction in Minneapolis. The following procedure was undertaken to ensure the stabilization of the landslide and completion of the project: Instruments were installed to detect the depth and rate of movement, and exploration was undertaken to determine the properties of the material in the failure zone; a temporary buttress was placed to control the movements while corrective treatment was being designed; additional instruments were installed to monitor movements during construction of the permanent treatment; and, after completion, all instruments were maintained and additional instruments were installed to monitor post-construction movements, if any. The corrective treatment consisted of a series of slit-trench concrete buttresses anchored into limestone below the failure plane. Details of exploration, instrumentation, testing, and design are included in the paper.

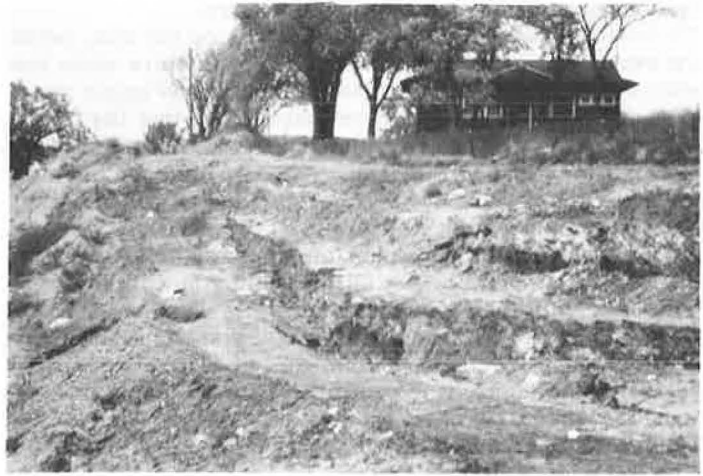
Figure 2. At Slope Indicator no. 4 looking toward railroad bridge and park.

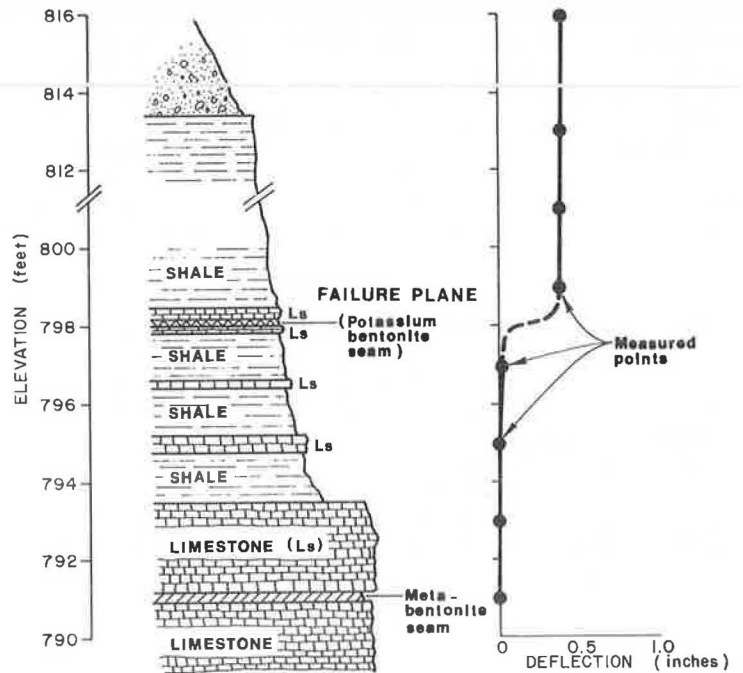
Several of the Slope Indicators detected movement within a few days, and within a month it was apparent that slope failure was occurring as a result of stretching along a near horizontal plane at elevation 798 ± 1.0 ft. Figure 3 shows the geologic profile and the detailed movements as recorded by one of the Slope Indicators, and Figure 4 shows the distribution of these movements along a cross section, as well as the location of the failure plane.

Figure 3. Geologic profile and Slope Indicator observations at failure plane.

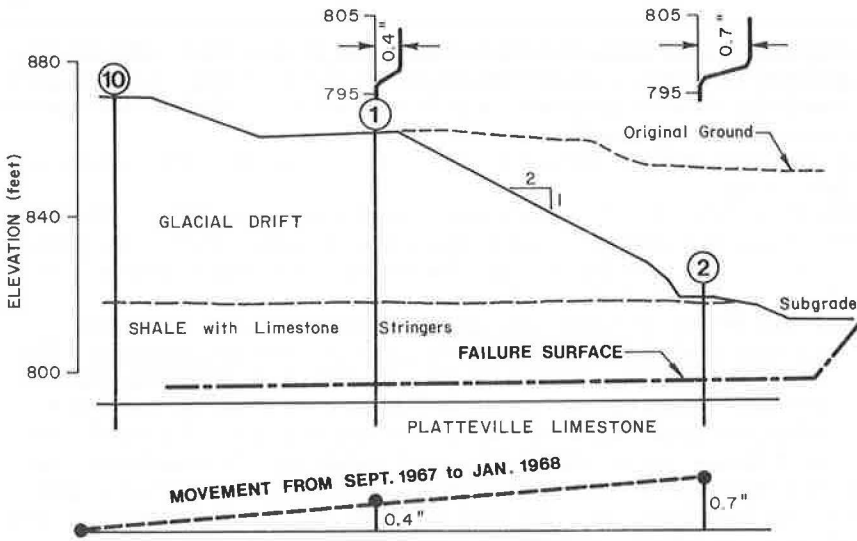
Between September 1967 and January 1968, movements were as shown in Figure 4. The data indicated that the slide was of a progressive nature and that further upslope deterioration might be expected. Since the movements were not slowing down but on the contrary were increasing, a temporary buttress of sand and gravel was placed at the toe of the slope to stop the movements while remedial measures were studied. Figure 5 shows how the sand berm placement caused the movements to stop almost immediately at three of the Slope Indicators.

Figure 4. Typical section showing failure plane and movement distribution.

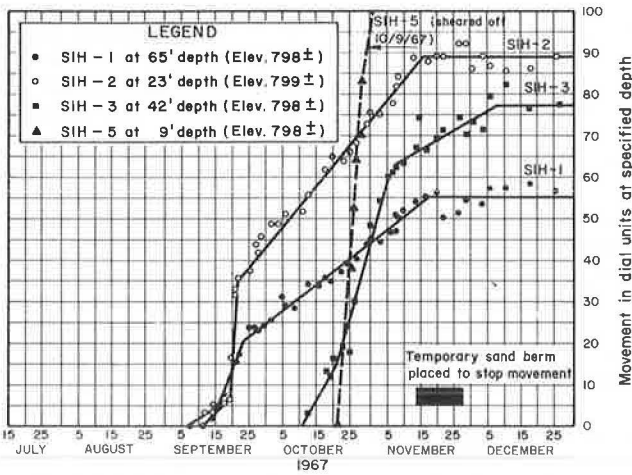
Figure 5. Slope Indicator dial changes with time.

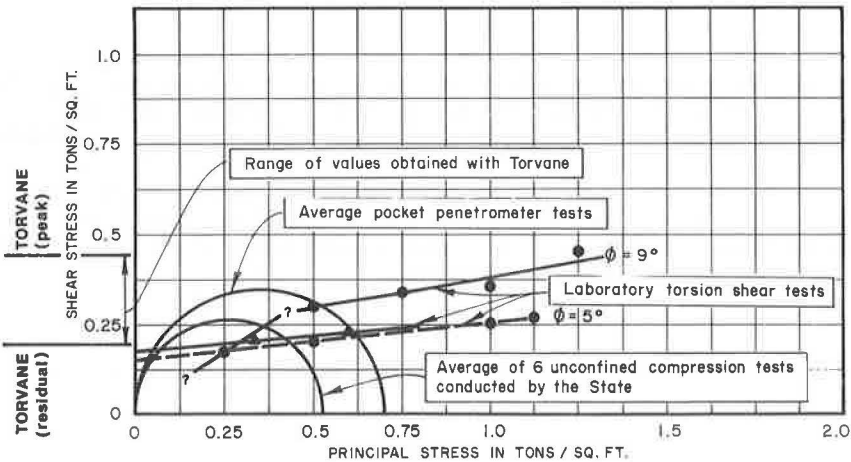
The results of the laboratory torsion shear tests are summarized in Figure 6. The results of numerous pocket penetrometer tests and Torvane tests conducted in the various test pits are also shown in Figure 6, as well as the average of results of six unconfined compression tests.

Figure 6. Summary of strength tests on failure zone materials.

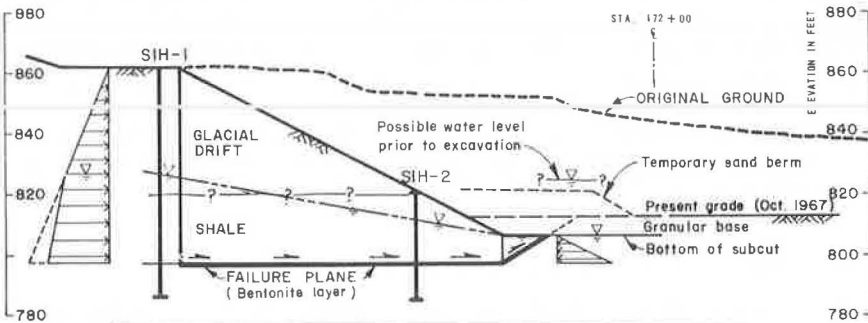
The parameters used for analyses, the general method of analysis, and the summary of results are shown in Figure 7. No seismic loadings were used in performing the stability analysis for this project.

Figure 7. Stability analysis.

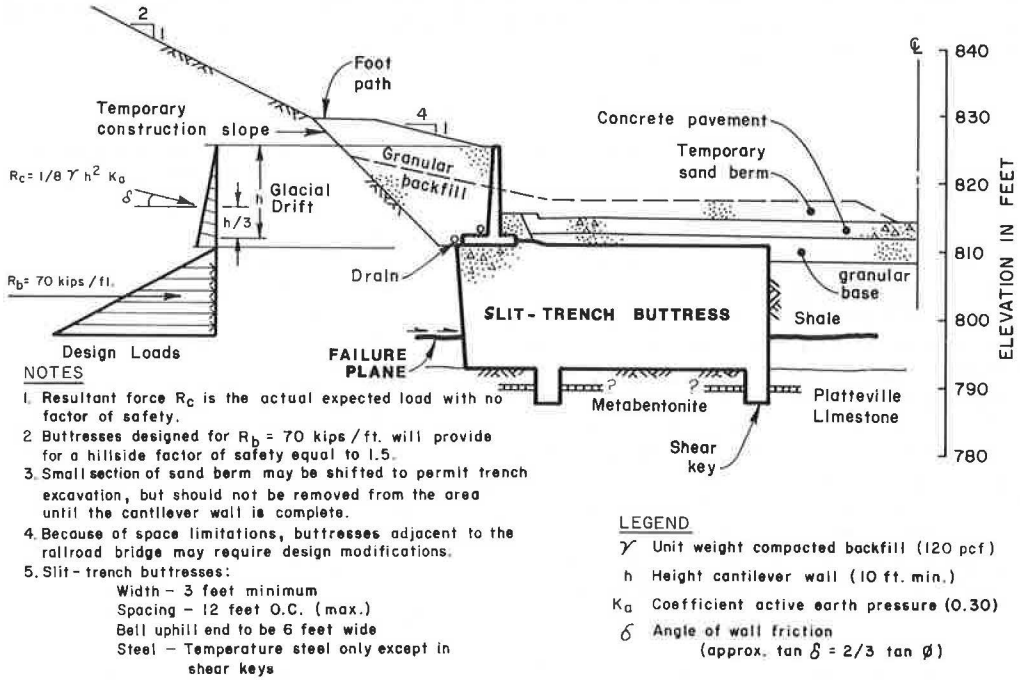
Figure 8. Typical section of recommended remedial slit-trench buttresses.

The remedial scheme finally recommended and adopted utilized reinforced concrete buttresses cast in narrow slit trenches excavated normal to the roadway centerline (Fig. 8). The design loadings on the buttresses are also shown in Figure 8. These buttresses were 3 ft (1 m) thick and spaced 12 ft (4 m) center to center and were designed as gravity sections. Each buttress was founded on the top of the Platteville limestone but was keyed into the Platteville with two 3-ft (1-m) diameter concrete filled calyx holes, heavily reinforced for shear. The horizontal load was transferred to the upper layer of the Platteville limestone, which was assumed to act as a start, and

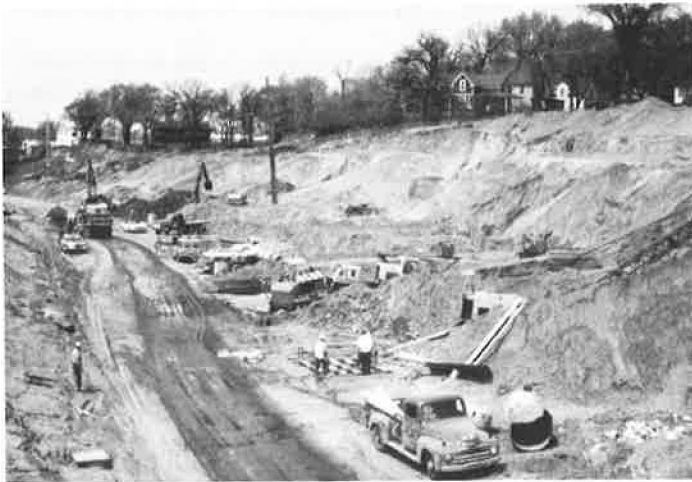
Figure 9. During construction, May 4, 1968.
