TRANSPORTATION RESEARCH RECORD
482

Landslide Instrumentation

**5 reports prepared for the 53rd Annual Meeting
of the Highway Research Board**

Washington, D. C., 1974

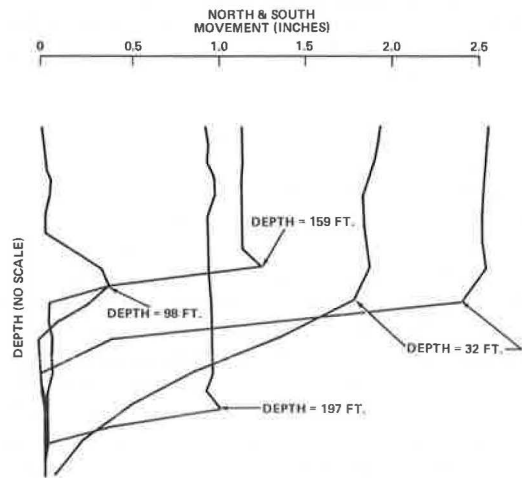
Figure 5. Typical slope inclinometer plots (1 in. = 2.54 cm).

Figure 5 is representative of the lateral movements that have taken place from 1968

to 1972. Several slope inclinometer plots have been superimposed on the same graph to show the different types of plots from different areas of the slide. An observation that can be made from the plot is that when the movement was within a 0.5-in. (1.3-cm) range, the movement was pretty well confined to the soft zone, but once the magnitude of movement went beyond that range, the mass above the sliding plane would show uniform movement equal to the movement at the soft zone.

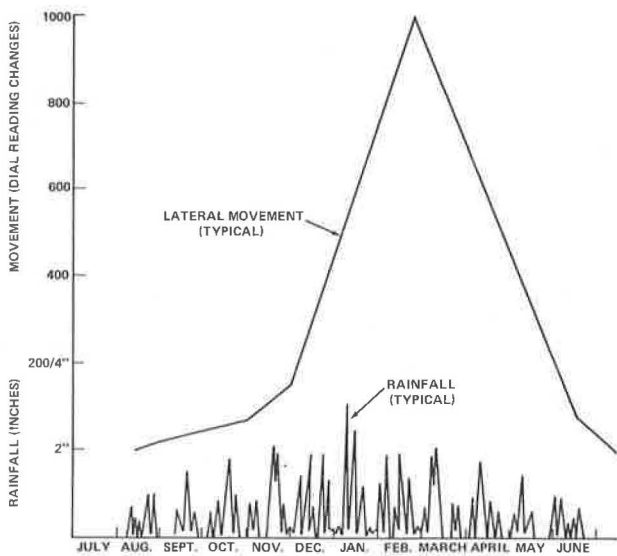
Figure 7. Rainfall versus movement.

Figure 7 correlates the rainfall and the corresponding movement in the slope inclinometers. The graph was put together by assembling and correlating monthly slope inclinometer readings for several instruments for the period between 1970 and 1972; therefore, the plots are not actual for any one year. They indicate what has always been obvious and what many engineers have stated in the literature: The increase in sliding movements is a direct function of increased rainfall activity. Groundwater conditions throughout the slide mass do not conform to any uniform pattern; therefore, groundwater conditions varied throughout the landslide area for stability analyses. Seasonal fluctuations at the boring locations have been very erratic, which gave an indication of the variable permeability throughout. There are many zones of trapped or perched water tables through the sliding mass.

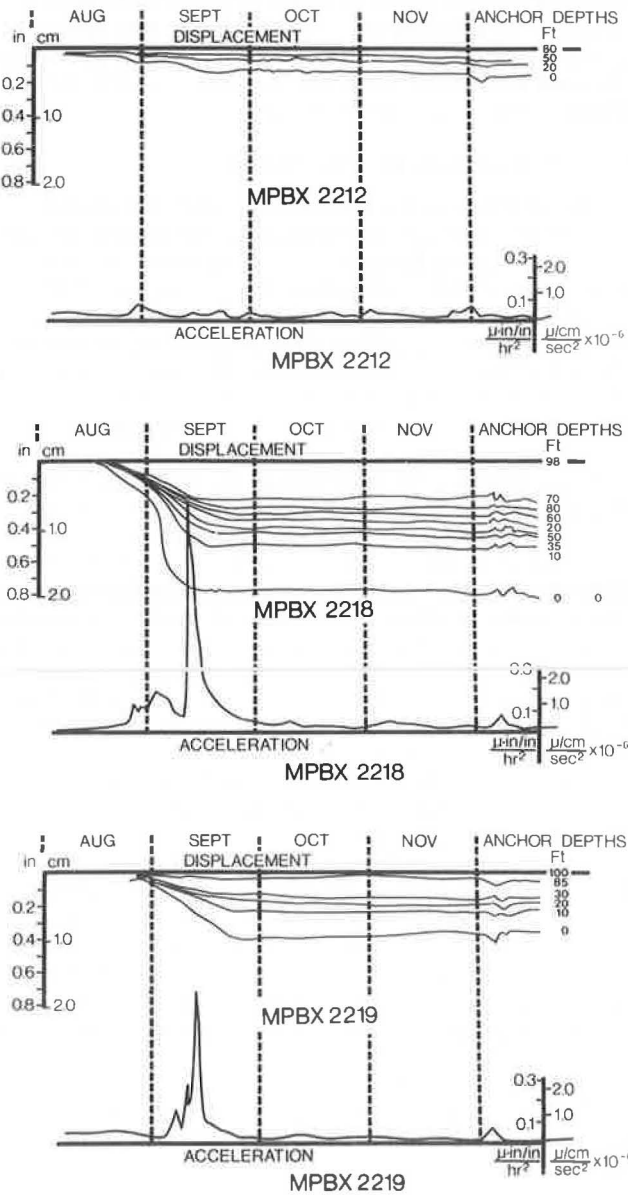
Figure 4. Displacement and acceleration graphs.

The MPBX 2218 representations are cited as an informative example because of an unusually complete pattern of responses initiated by a heavy 4-in. (100 mm) rainfall to which the slope was exposed prior to completion of the remedial program. Referring first to the displacement representation and then to the average acceleration curve, these responses were more or less as follows:

1. Displacement—The first active reading (FAR) of MPBX 2218 was made at an elapsed time (ET) of approximately 21 days. Subsequent early readings showed a pattern of continuing displacements, proceeding at a reasonably constant rate, which were attributed to rebound induced by the slide and by the additional removal of super-incumbent load during stripping and shaping of the slope. The displacement rate was about 4.0×10^{-4} in. per hour (3.0×10^{-4} μ m per second), equivalent, in a 98-ft (30-m) hole, to a strain rate of 0.3×10^{-6} in. per in. per hour (10 μ m per cm per second).

A quick inspection of the displacement curves from MPBX 2218 indicates that about half of the total displacement measured in the MPBX 2218 drill hole was localized in the interval between the 98-0 ft (30-0 m) and 98-10 ft (30-3 m) traces; i.e., in the surface 10 feet (3 m) of the hole, a condition strongly suggestive of surficial slumping in the disturbed slope material.

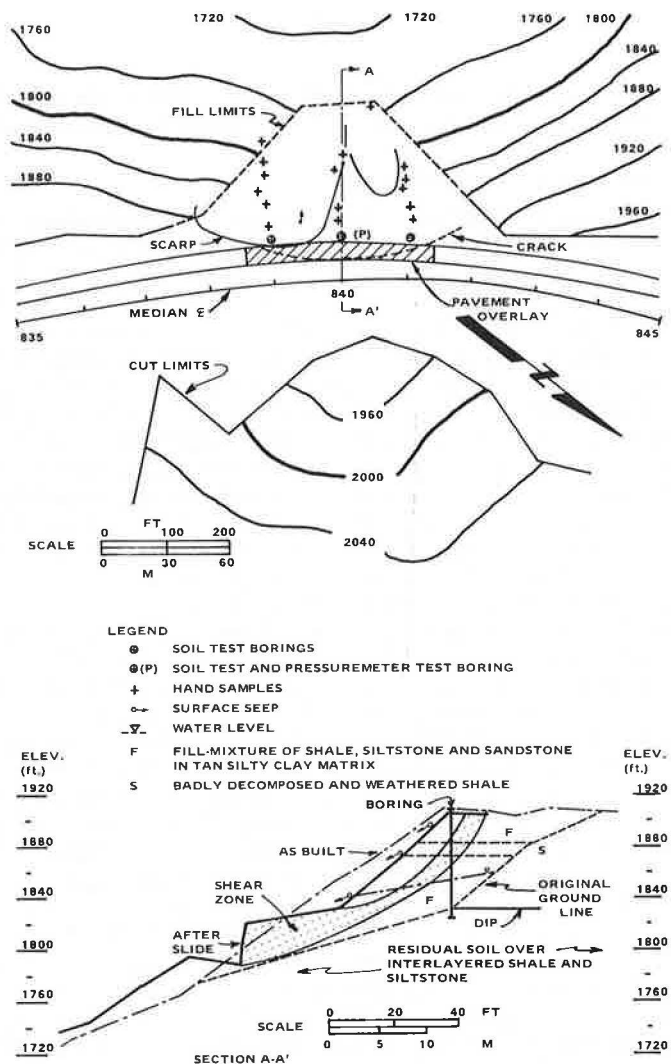
Figure 3. Plan and section of side-hill fill failure, I-75, Campbell County, Tennessee.

Figure 3 shows the general stratification within the fill and the natural ground. Groundwater was relatively high—a fact verified by observed seepage zones on the face of the fill. The seeps increased after rains and decreased during dry weather, indicating a possible relation to surface water inflow from the uphill side of the fill. The decomposition of the shale layers in the fill would create semi-impermeable zones across which surface water could flow through the fill.

During the analysis, a failure occurred in this fill near the pavement edge encompassing most of the upper portion of the fill face, generally near the calculated failure arc. The Pressuremeter strength data and the movements indicated by the inclinometers were used to evaluate the stability of the remaining fill so that steps could be taken to prepare a traffic detour if necessary. Analysis indicated that further movement involving the entire southbound lane was probable; this movement eventually occurred, but not before appropriate measures had been taken to detour traffic around the failure area.

After the second movement, vertical wells with submersible self-actuating pumps were installed in the median behind the scarp to intercept the flow of water into the slide area and prevent further extension of the slide zone. These wells proved very effective; they were later incorporated into the repair treatment.

The repair measures consisted of removing the failed soil and reconstructing the southbound lane portion of the fill. The vertical pumped wells were incorporated in the remedial scheme to remove water entering from the natural ground uphill from the fill. The strength data from the Pressuremeter tests were again used to determine the recommended slope of the excavation to remove the failed soil. The repaired fill was placed in service on April 28, 1973, and has performed well to date.

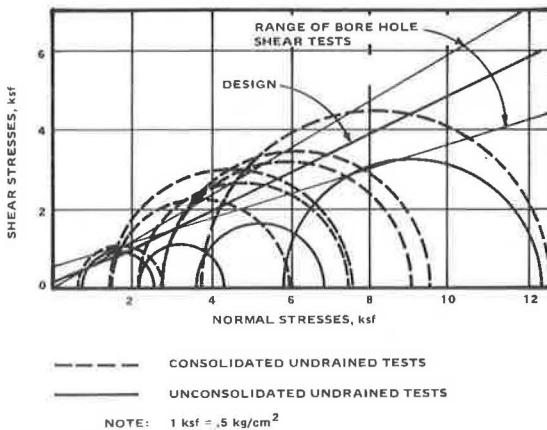
Figure 8. Comparison of Bore-Hole Direct-Shear results with laboratory triaxial test results.

The Bore-Hole Direct-Shear test data are summarized in Figure 8. For comparison, the laboratory triaxial shear strength tests performed on the fill are also shown. The strength parameters from the Bore-Hole Direct-Shear test compare well with the

available laboratory triaxial data and plot intermediate between undrained and consolidated undrained laboratory values.

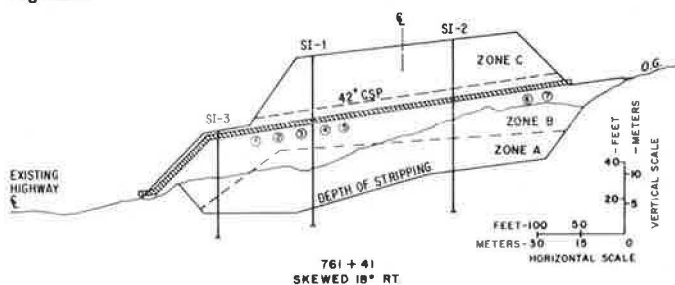
Construction of the embankment began during the summer of 1971. By the end of October the embankment had reached a height of about 50 ft (15 m) when some lateral movement was noticed on the strut. An inspection of the 42-in. (1.1-m) corrugated steel pipe (CSP) installed in the fill (Fig. 2) revealed that several of the joints had pulled apart, the locations of which are shown by the circled numbers in Figure 2. The amount of displacement is given in Table 1.

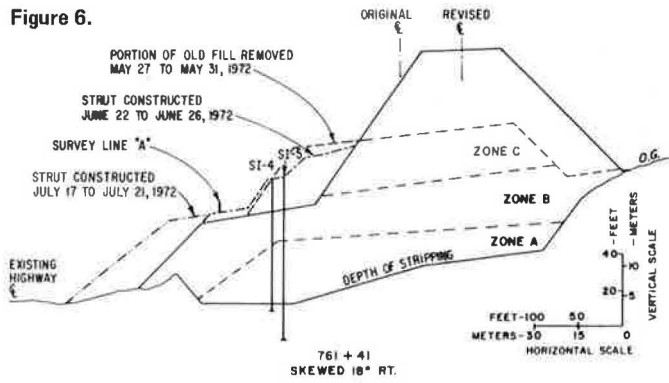
Figure 6.

With the end of the rainy season, construction was resumed in May 1972 on the revised alignment. The fill was widened 68 ft (21 m) on the right while 68 ft (21 m) of the existing fill on the left was removed (Fig. 6). As fill height increased, bulging was

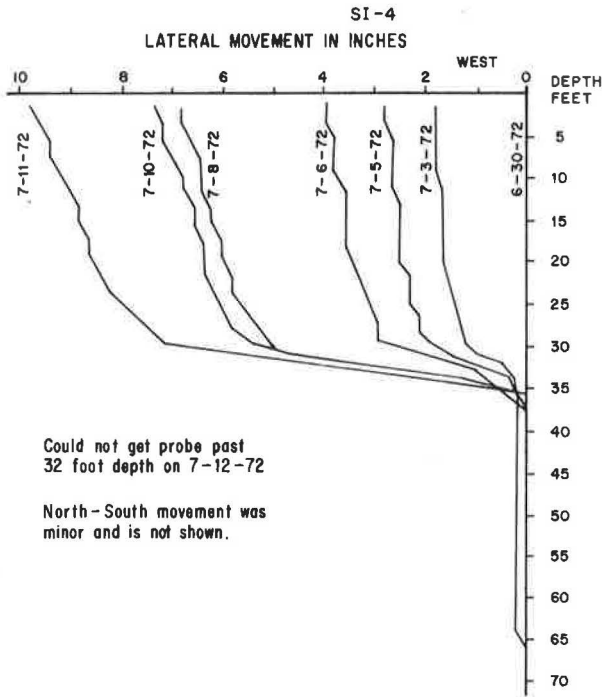
Figure 7.

Slope Indicators SI-4 and SI-5 (Figs. 7 and 8) were installed in this new strut to monitor the movement as construction continued. With the completion of the embankment in the second week of July, SI-5 continued to show an alarming rate of movement in Zone B. Survey line "A" (Figs. 6 and 9) on the new strut revealed that lateral movement and settlement were accelerating. This led to the decision to widen the original strut about 80 ft (24 m) to the edge of the existing highway. Lateral movement in Zone B continued but at a slightly slower rate. Also, survey line "A" stopped settling and began to rise, indicating that the movement had been shifted to a higher level in Zone B.
