# EXPERIENCE WITH CONTINUOUSLY REINFORCED CONCRETE PAVEMENTS IN VIRGINIA

K. H. McGhee, Virginia Highway Research Council

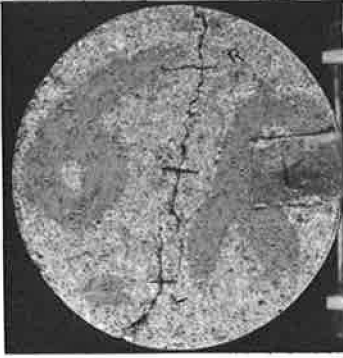
Figure 1. Top view of core 6.

In the laboratory, photographs were taken of the top and each side of each core. The same measuring microscope that was used in the field work was used to determine the crack width at the surface of each core. Then the cores were sawed horizontally at distances of first  $1\frac{1}{2}$  in. (3.8 cm) and then  $\frac{1}{2}$  in. (1.3 cm) above and below the longitudinal steel, and crack measurements were made at these levels after the cut surfaces had been polished. Photographs illustrating the appearance of a typical crack at the various surfaces are shown in Figures 1, 2, 3, 4, and 5. Finally, the measurement of horizontal and vertical components permitted the calculation of the straight-line distance from the surface of the main reinforcing steel to the point of crack measurement.

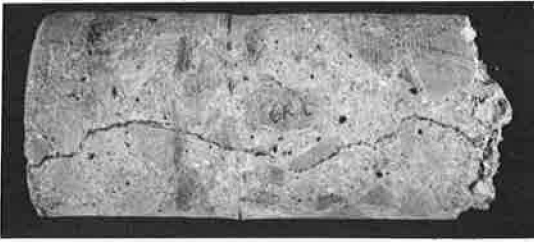
Figure 4. Left side view of core 6 showing continuous crack through core.

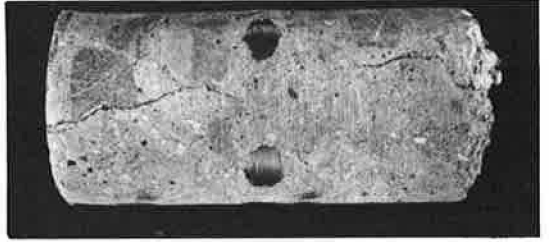
The results of crack measurements for 5 of the cores are shown in Figure 6. For the measured cracks, the width tends to decrease by approximately a factor of 2 as the distance from the surface of the steel changes from  $4\frac{1}{2}$  to  $\frac{3}{4}$  in. (11.4 to 1.9 cm). Although, as the scatter of points in Figure 6 shows, the correlation between crack width and distance from the steel is not high, definite trends can be seen in both the figure and in the visual examination of the cores. Projecting the crack measurements shown in Figure 6 to the surface of the steel suggests that at the steel a crack of approximately 0.003 in. (0.008 cm) still would exist. Visual examination (Fig. 5) showed that this was not the case and that no definite crack exists directly at the steel. Such a result has been reported in another paper (6) in which it was noted that in some cases cracks tend to diverge in the neighborhood of the steel and that it has been possible to find a zone around the steel where the concrete is not really cracked but is distended in a discontinuous manner. Such appears to have been the case with the cores in question. Figures 4 and 5 show that the cracks extend through the entire depth of the pavement but are discontinuous in the vicinity of the steel. Measurements indicated that whether cracks are located above or below the steel has little influence on the crack width and that the proximity of steel to the point of measurement is the determining factor.

Figure 5. Right side view of core 6 showing discontinuous crack in vicinity of steel.

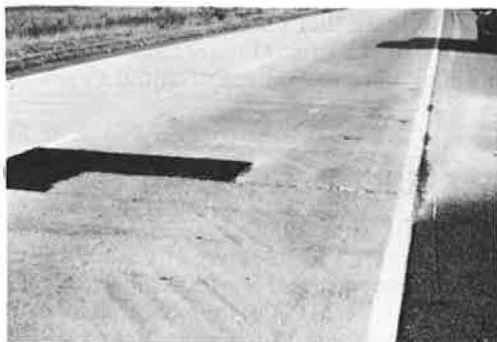
The most severe performance problem to occur in the CRCP to date is a result of honeycombing caused by inadequate consolidation of the paving concrete. An example of the most serious failure is shown in Figures 8 and 9. Figure 8 shows a segment of 8-in. (20-cm) thick by 24-ft (7.31-m) wide slip-formed CRCP from the group C pavements. A temporary bituminous concrete patch is evident in the picture. This type of failure is characterized by wide, arrow-straight cracks located directly above the transverse steel and by edge pumping, also shown in Figure 8.

This type of distress has progressed to a serious degree in several segments on one contract in the state. All paving was with a slip-form paver employing "spud" vibrators at an unknown spacing and frequency. Also, there are no records of paver speed through the failed sections.

**Figure 8. CRCP failure due to poor consolidation.**

The consolidation problems encountered in Virginia, although severe on only one contract, serve to point up the already recognized need for realistic vibration specifications for paving concrete.

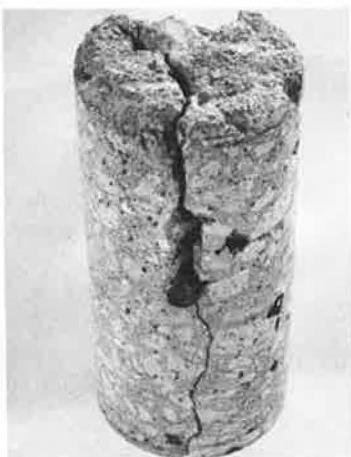
The cause of this type of failure was immediately revealed by full-depth cores taken through the transverse cracks and at intermediate points between cracks. Figure 9 shows a side view of one of the cores taken through a crack at the transverse steel. There is a noticeable lack of consolidation of the concrete directly below the steel. The result is a void directly under the steel with a very wide crack extending from the void downward to the bottom of the CRCP. No doubt the reduced cross section caused by the void under the steel has resulted in the wider than normal crack at the pavement surface and in the crack lying in the same vertical plane as the steel. Strangely, cores taken from between the transverse bars showed no visual evidence of poor consolidation. Edge pumping in the section appears to have resulted from surface water entering the wide transverse cracks and becoming trapped between the pavement and the cement-stabilized subbase. The stabilization has had the advantage of preventing the loss of significant amounts of subbase material.

**Figure 9. Core taken from a poorly consolidated pavement.**

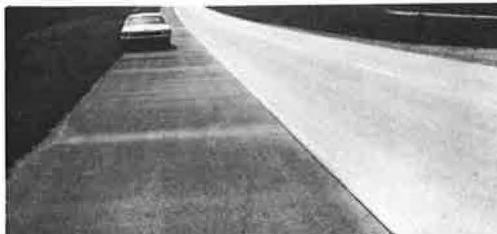
An example of edge pumping due to poor drainage is shown in Figure 10, where staining of the bituminous shoulder is evident. The problem has occurred on the group E projects where the subbase is cement stabilized and the shoulder base material is unstabilized sand and gravel with a 2 to 3 plasticity index. The condition exists primarily at the low point of sag verticals.

Trenching and edge deflection tests showed that no measurable void existed under the CRCP. It was concluded that the pumping resulted from surface water trapped at the interface between the CRCP and the impervious shoulder material. The stains were attributed to fines lost from shoulder material, as was further evidenced by a slight depression of the shoulder at its contact with the CRCP.

**Figure 10. CRCP edge pumping due to poor drainage of shoulder material.**

Corrective action is to take the form of trenching the shoulder at the pavement edge and backfilling with a highly pervious 1-sized aggregate. Water will be carried to the ditch lines with occasional side drains filled with the same pervious crushed stone.

Design standards are being revised to prevent recurrence of the problem by the provision of nonplastic, pervious shoulder material.
