# CORROSION AND KANSAS BRIDGES

Carl F. Crumpton and John E. Bukovatz, State Highway Commission of Kansas

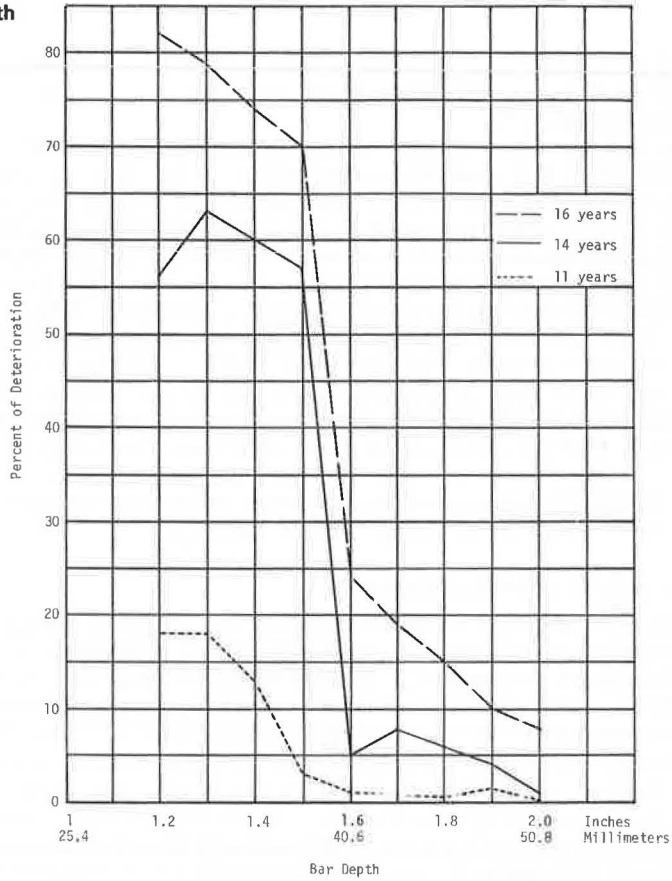
**Figure 3. Reinforcing bar depth related to the percentage of deterioration.**

Figure 3 shows more clearly the relation between the depth of the reinforcing steel and the amount of deterioration on the bridge deck. With passing time more deterioration occurred, and the percentage associated with deeper steel increased but not nearly so rapidly as with shallower steel. The 16-year curve shown in Figure 3 represents the deck surface area actually removed for repair purposes when a 2-in. (50.8-mm) bonded portland cement concrete overlay was placed on the deck (5). This figure shows the importance of placing the steel as deep as possible. Where the average steel depth was 2 in. (50.8 mm) on this deck, only 8 percent of the area was associated with deterioration after 16 years. Nearly all of that was related to expansive chert aggregate or to 1½-in. (38.1-mm) deep steel. Even though the average steel depth in this area of the bridge is 2 in. (50.8 mm), the normal distribution of variation in depth provided about 8 percent of the steel with a cover of 1½ in. (38.1 mm) or less. A cover of 3 in. (76.2 mm) rather than 2 in. (50.8 mm) over the steel on a properly designed deck with concrete of higher cement content and lower water-cement ratio than commonly used should provide many more years of protection (2).

Concrete deterioration associated with the corrosion of reinforcing steel can be reduced or delayed by increasing the depth of cover over the top reinforcement and by improving the quality of the concrete. Structural steel corrosion can be reduced by proper
