CASE STUDIES OF WRONG-WAY ENTRIES AT HIGHWAY INTERCHANGES IN VIRGINIA

N. K. Vaswani, Virginia Highway Research Council

An evaluation of a 2-year survey of wrong-way driving led to on-site investigations of a number of intersections and interchanges. The investigations showed a consistent pattern in wrong-way entry incidents that related to road geometrics, markings, and signs. Based on the findings of the investigations, five case studies were developed to show the effects of these variables. This paper discusses the results of the survey, some case studies, and measures for preventing wrong-way entries at selected interchanges. Some of the recommendations made are as follows: Channelize the left lane of the exit ramp and remove the left end flare; investigate the effectiveness of stop lines, the continuation of pavement edge lines across exit ramps, and the use of continuous double yellow lines; through the use of signs, provide intersection geometry information for drivers entering a 4-lane divided highway; and provide additional pavement marking and spotlighting to supplement signs.

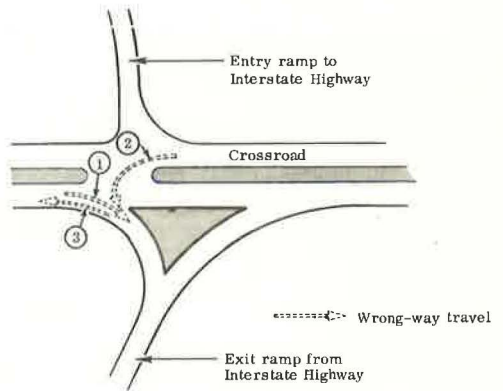
The reason that exit ramps on partial interchanges generate wrong-way entries is that these ramps, unlike the ones on non-partial interchanges that converge with right-hand traffic, meet the crossroad at about 90 degrees to accommodate both left and right turns (5, 6). Because of this design, the three wrong-way entries shown in Figure 1 are possible.

Figure 1. Wrong-way entry and egress on left lane of exit ramps.

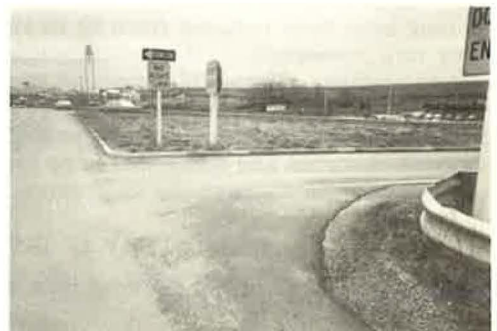
Figure 2. View from crossroad, with exit ramp on right, where wrong-way entry took place.

During this study it was observed that on almost all interchanges on which wrong-way entries had been made into the exit ramp or from the exit ramp into the crossroad, the left corner of the left lane of the exit ramp flared into the right pavement edge of the crossroad. An example of a flared end is shown in Figure 2.

Such a flared end (termed "flare" hereafter) provides for a very easy but incorrect right-hand turn. It is therefore possible that it would induce a driver to make a wrong-way entry from the crossroad into the exit lane. For a sharp, right-angled junction, the driver would have to reduce his speed and almost come to a stop before maneuvering into the exit lane.

Similarly, a driver coming upon the left flare from the exit ramp could be encouraged to make an improper left turn into the wrong lane of the crossroad. Again, a sharp, right-angled bend would not permit an easy left turn.

These flares may have been provided either as a matter of construction expediency or the design requirement for a left-turn curve from the exit ramp to the crossroad. It is recommended that the designs be checked and the flares be removed or their use be prevented when they have been provided to satisfy the left-turn curve requirements.

To discourage this type of wrong-way entry, pavement marking at the corner of the left lane of the exit ramp could be provided as shown in Figures 3 and 4. To make this turn difficult to negotiate, or to prevent the use of the shoulder, a physical barrier could be provided along lines AB and BC in Figures 3 and 4.

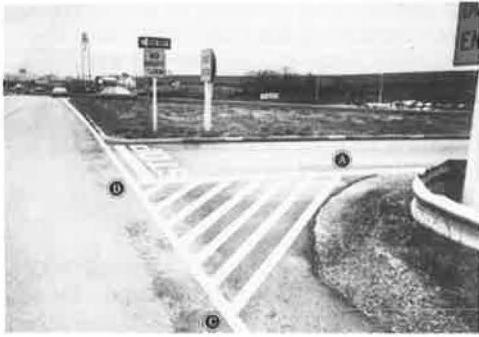
Figure 3. Suggested improvements of exit ramp shown in Figure 2 by marking pavement in flared corner, providing a stop line, and continuing the pavement edge line across the exit ramp junction.

It is therefore recommended that continuation of the pavement edge line—as shown in Figure 3—be tried. Continuation of the pavement edge line of the crossroad across the exit ramp would conform with the principle followed in continuing it across the deceleration and turning lanes from primary, arterial, and Interstate highways.

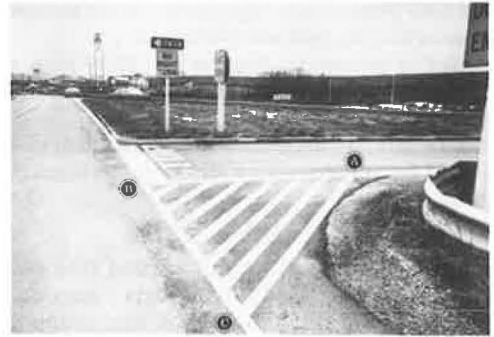
Figure 4. Suggested improvements of exit ramp shown in Figure 2 by marking pavement in flared corner and providing a very thick line—minimum of 24 in. (0.6 m)—with its outer edge in line with the pavement edge line.

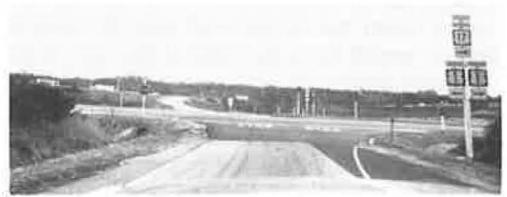
Figure 5. View of crossroad from exit ramp from which six wrong-way entries were made onto the crossroad.

This interchange was chosen because it is the only one in Virginia that had as high as six wrong-way entries onto the crossroad reported in the survey. Two of these six incidents happened between 10:30 and 11:30 a.m., and the other four during hours of darkness. All the entries were made by sober drivers, all were made from the same exit ramp, and all resulted from the drivers making their turns before rounding the nose of the crossroad median. As mentioned before, this type of maneuver accounts for 45 percent of the wrong-way entries in Virginia. The photograph of this intersection, shown in Figure 5, was taken from the exit ramp meeting the crossroad at its right.

In addition to the many geometric features that might be involved, it is possible that low visibility and a restricted sight distance may have contributed to the numerous wrong-way entries. The crossroad has a curve on the left of the exit ramp and the exit ramp is in a deep cut. To increase the sight distance up the crossroad from the exit ramp, the stop line should be brought closer to the edge of the crossroad, as recommended in case study 1. Figure 6 shows a suggested revised location of the stop line and the marking of the flared end at this junction.

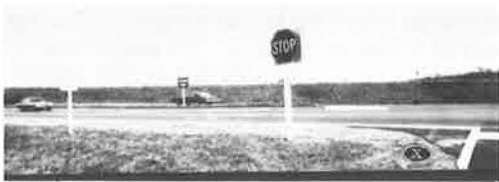
Figure 6. Suggested improvements on exit ramp and crossroad shown in Figure 5 by improving sight distance for left turns, providing intersection geometry sign at X, moving stop line closer to edge of crossroad, marking left corner flare, decreasing width of crossover, providing median nose delineators, and bringing signs on median closer to nose.

The "do not enter" and "wrong way" signs, as can be seen in Figure 6, are placed very far from the ends of the medians of the 4-lane divided crossroad and are not easily read from the junction. Figure 6 also shows the setback of the nose of the medians (not considering the extension marked in white) from the exit ramp. This setback, and hence the width of the crossover, seems to be too long and should be reduced to minimum requirements. If this width cannot be reduced, pavement nose markings as shown in Figure 6 (by a white mark) and in Figure 7 would help. The nose markings should be applied to provide the minimum width of crossover needed for lighter vehicles, which form a large percentage of the total traffic.

The information-decision-action (IDA) sequence developed by Taylor and McGhee (9) shows that, for a left turn, nine actions are needed. In order to execute these actions the driver needs the following information: (a) destination/direction, (b) advance warning of intersection, and (c) intersection geometry. Preferably this information should be given to the driver during his first action, i.e., in the "approach vicinity of the intersection". In the present system of signing, drivers are unaware of the intersection geometry, and while taking the third action, i.e., "entering the appropriate lane", some make a faulty maneuver and enter the wrong lane. It is therefore necessary that the driver be supplied information on the intersection geometry before he takes the third action. Figure 8 shows one example of an intersection information sign to replace the direction sign shown in Figure 5. An enlarged view of this intersection information sign is shown in Figure 9. An alternative arrangement is to provide a sign such as shown in Figure 9 at the corner of the exit ramp shown by X in Figure 6.

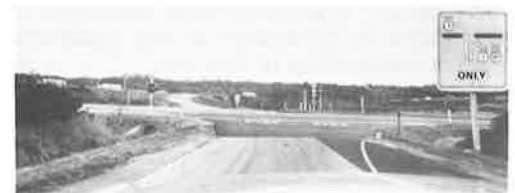
Figure 8. Suggested improvement on exit ramp shown in Figure 5 by use of intersection geometry sign.

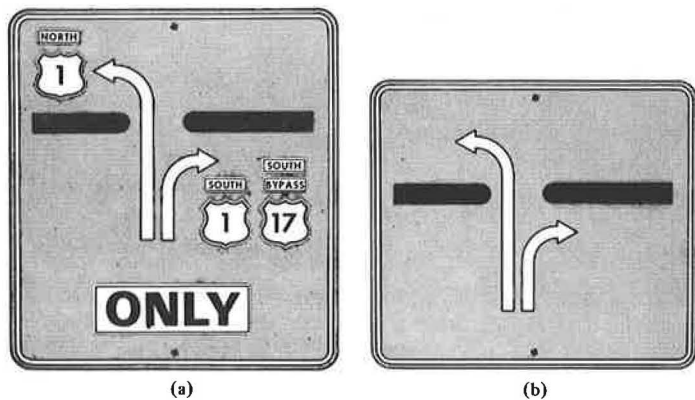
Figure 9. Recommended geometry signs for installation on exit ramps to 4-lane divided crossroads; provide sign (b) on left corner as shown by X in Figure 6.

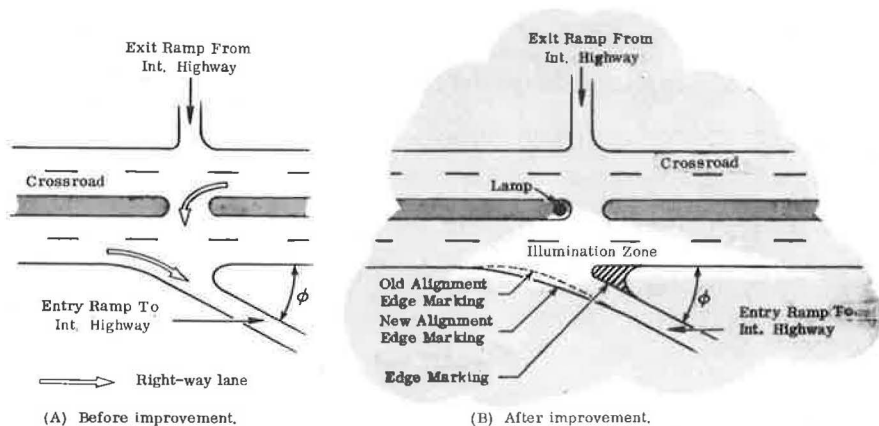
Figure 10. Recommended improvement of an entry ramp.

The possibility of spot illumination of the far lane to help drivers make a left turn could also be considered. An example of such spotlighting is shown in Figure 10. This spotlighting would also illuminate the entry ramp junction and thus make it more conspicuous so as to reduce the likelihood of its being missed by normal as well as impaired drivers.

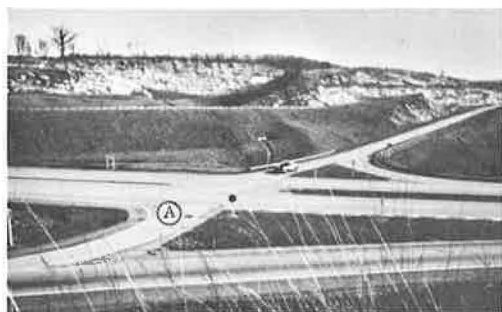
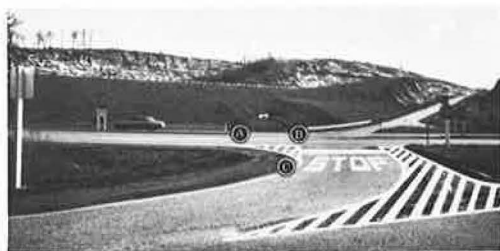
The interchange was chosen mainly to emphasize the need for channelization on the left lane of the exit ramp. In this case, as shown in Figure 11, "do not enter", "one way", and "wrong way" signs—to discourage wrong-way entry from the exit ramp for left-turning vehicles—are not provided on the median.

The disadvantages of flares were discussed in case study 1. The present case study shows that on 4-lane divided crossroads the flares are not in use and have been found to collect dust. Figure 11 shows at A the left lane of the I-81 exit ramp. A dark patch in the flared corner shows the collection of dust, which exemplifies its disuse.

Figure 11. View of exit ramp with its left lane and junction with crossroad, marked A. Note the dark patches of unused pavement at flare and left edge and absence of one-way, do not enter, and wrong-way signs for the crossroad.

Figure 12. Suggested improvements of left lane shown in Figure 11 by channelizing left lane by marking or by providing physical barrier along ABC and reducing pavement width, providing stop line, continuing pavement edge line of crossroad across exit ramp, providing missing signs, and providing geometry sign shown in Figure 9(b).

A right-angled junction of the left lane of the exit ramp with the crossroad, without a flare, would reduce wrong-way entries and exits. This design would provide a minimum width of the left lane of the exit ramp and make it difficult for a driver from the right lane of the crossroad to maneuver onto the ramp. Most of the left lanes are at right angles with the crossroads; hence, after the flare is removed, the minimum width would automatically be obtained. An example is shown in Figure 12.

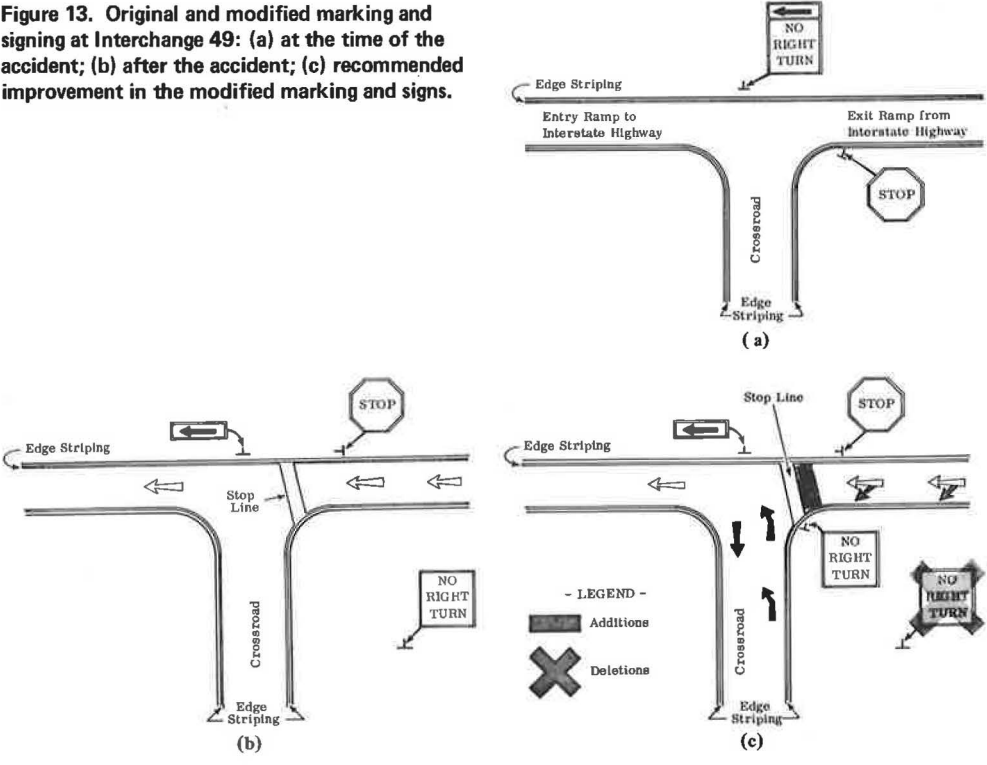
Figure 13(a) shows the plan of the T-junction at the time of the accident. At that time there was no pavement marking and the "no right turn" sign was so low that it could be hidden by a car coming from the exit ramp on the right across the field of vision of the driver intending to turn left onto the entry ramp for the Interstate highway.

Figure 13. Original and modified marking and signing at Interchange 49: (a) at the time of the accident; (b) after the accident; (c) recommended improvement in the modified marking and signs.

The signing system has since been changed and pavement marking provided as shown in Figure 13(b). This junction is now less likely to be the scene of wrong-way entries.

Provision of arrows is recommended as an improvement on the modified marking system as shown in Figure 13. The recommended improvement of the modified system also includes the provision of the "no right turn" sign within the cone of the driver's vision and in such a place that the driver sees it at the time he can most effectively utilize the information it imparts. There appears to be a need for a revision of the specifications for the location of signs in the Virginia Manual (7). The revised specifications should be based on the cone of vision and the size and effectiveness of the sign.

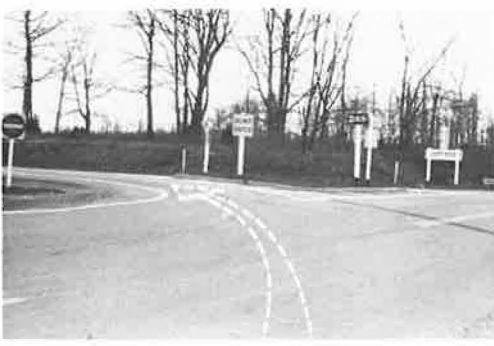
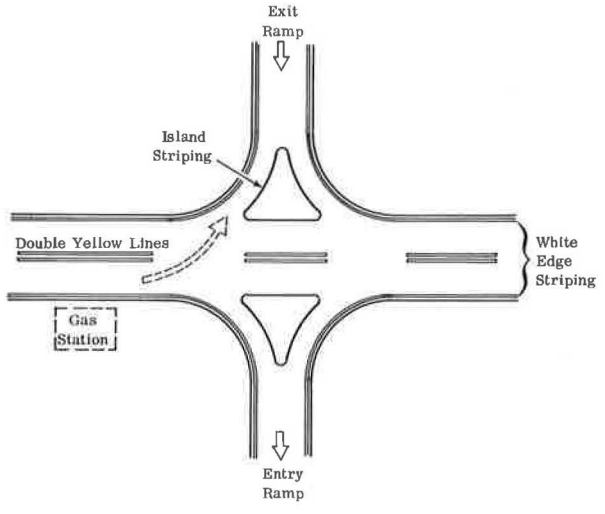
Figure 14 shows a photograph of the junction of the right-hand lane of the exit ramp and the crossroad, with the opening between the yellow lines. A drunken driver coming from a gas station went through this opening into the right lane of the exit ramp as shown by the arrow superimposed on the photograph.

Figure 14. The driver went through the opening in the double yellow lines and entered the wrong way through the right lane of the exit ramp as shown by the arrow.

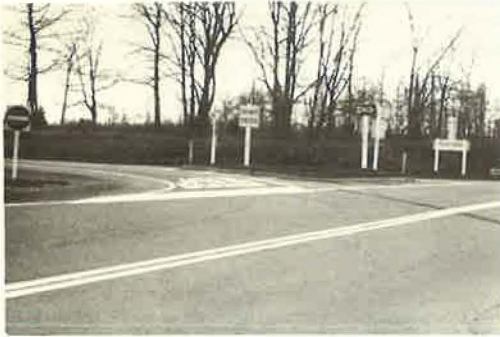
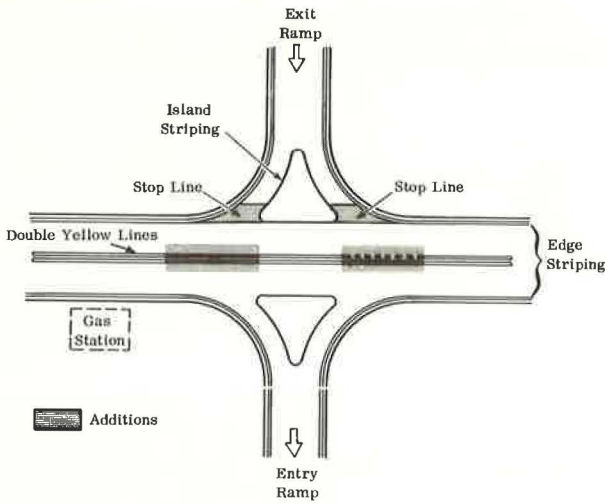
If there had been no gap in these yellow lines the driver may not have crossed them. Further, if a stop line were provided at the junction of the right lane of the exit ramp and the crossroad it might have further discouraged this driver from entering the exit lane. The yellow line and white line are shown in Figure 15.

Figure 15. Suggested improvement on the exit ramp shown in Figure 14 by continuing the yellow lines and providing about a 24-in.-wide stop line. The island at the entry ramp is unnecessary.

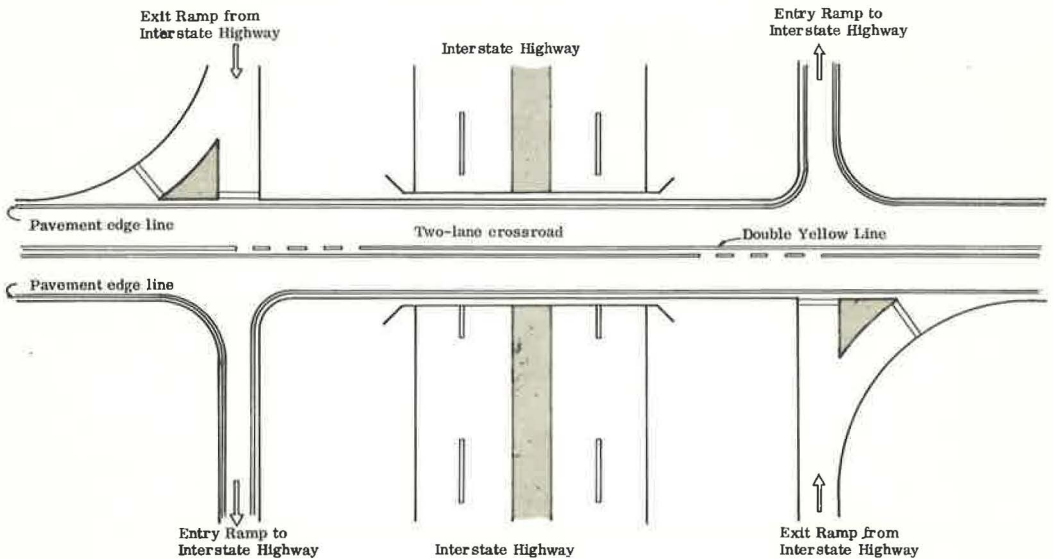
Figure 16. Recommended marking on undivided crossroad.

A scheme for the use of double yellow lines to discourage wrong-way entries by a left turn from the crossroad into the exit lane is shown in Figure 16, where only two entries

are provided for left turns. The openings made for these entries extend up to a point facing the center of the left lane of the exit ramp. In the opening provided, only one line is broken for the left turn while the second line is solid. Yellow lines thicker than the normal width might increase the effectiveness of the markings. If provision is to be made in the yellow lines for direct connection between the exit and the entry ramp across the crossroad, a slight adjustment in the position of the broken yellow line might sometimes be necessary.
