NEW YORK'S EXPERIENCE WITH PLASTIC-COATED DOWELS

James E. Bryden and Richard G. Phillips,
Engineering Research and Development Bureau,
New York State Department of Transportation

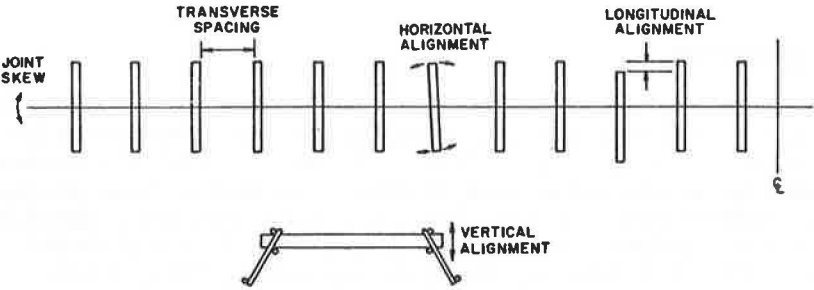
The joint assemblies were checked carefully before paving for misalignment or other problems; the types of alignment checked are shown in Figure 2. Because the dowels were shop-fabricated into baskets, both transverse spacing and horizontal alignment were extremely consistent. No assemblies were found with any appreciable error in either respect. Vertical alignment, however, did present minor problems. A number of joints were checked on each job, with the results given in Table 2. Generally, no more than 1 or 2 dowels per joint were misaligned, although in a few cases there were several, generally near the ends of the assembly and probably due to rough handling during transportation and installation. The vertical alignment errors detected could have been prevented by more careful handling or corrected before paving, which was effectively accomplished on the 3 contracts having few vertical alignment errors.

Figure 2. Dowel alignment errors.

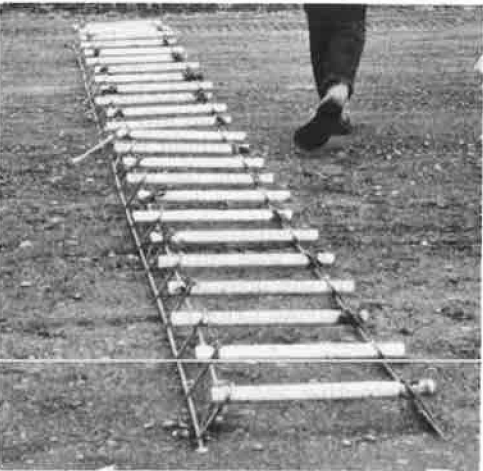
At Point Breeze, longitudinal alignment of the dowels was poor. Variations of up to 2 in. (51 mm) were noted in a few instances, and errors of 1 in. (25 mm) occurred in nearly every assembly; this can be seen in Figure 3, which shows a typical joint assembly (one dowel near the center of this assembly is also vertically misaligned). Bowing of the basket assembly (Figure 4) was common at Oneonta and to a lesser degree at the other 3 locations. Both problems resulted in the same defect—decreased embedment length of some dowels.

Figure 3. Dowel assembly installed on grade at Point Breeze.

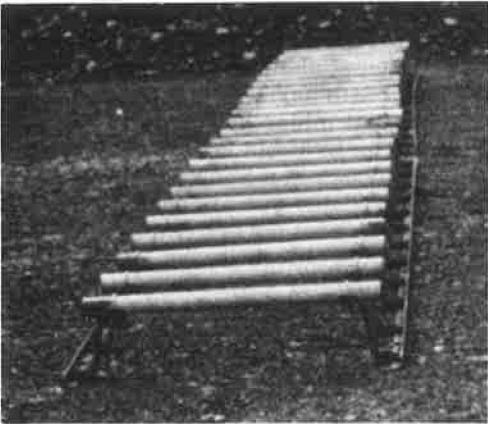
Figure 4. Bowed dowel assembly at Oneonta.

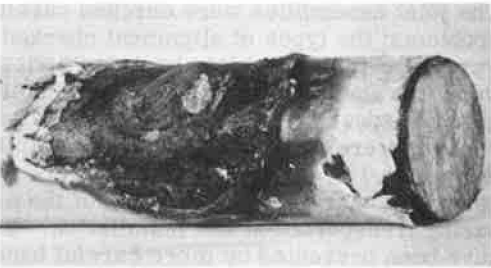
Figure 5. Coating damaged by welding.

A second type of deficiency was damage to the plastic coating, which was most severe on the welded baskets. The weld was designed to be placed approximately 1 in. (25 mm) from one end of each dowel so, when placed properly, only $1\frac{1}{2}$ to 2 in. (38 to 51 mm) of plastic on the end of the dowel was damaged by the weld. However, if the dowel was misaligned in the basket, as was the case at Point Breeze, the damaged coating extended as much as 3 or 4 in. (76 or 102 mm) into the length of the dowel. While most welds were properly placed, a few dowels in each basket at Point Breeze generally approached this extreme. Figure 5 shows a badly burned dowel. While the plastic coating on the clipped dowels was generally in very good condition, a few dowels in most assemblies had approximately 1 in. (25 mm) of coating missing from one end. The dowel bar stock was coated in 21-ft (6.40-m) lengths and the coating shrank about 1 in. (25 mm) on each end. When cut to 18-in. (457-mm) lengths, two dowels were left with short coatings and were painted with red lead primer to inhibit corrosion (Figure 6).

In conclusion, plastic-coated dowels show promise as a transverse-joint load-transfer device. However, adequate care must be taken to ensure that the dowels are properly aligned before paving. Furthermore, improved fabrication techniques are needed to lessen damage to the plastic coating due to welding, and steps are necessary to lessen slippage of the plastic coating on the dowel. Several years of performance under traffic will be necessary to determine the overall suitability of these devices, but, except for a few correctable deficiencies, it now can be concluded that these devices are satisfactory from a construction standpoint.

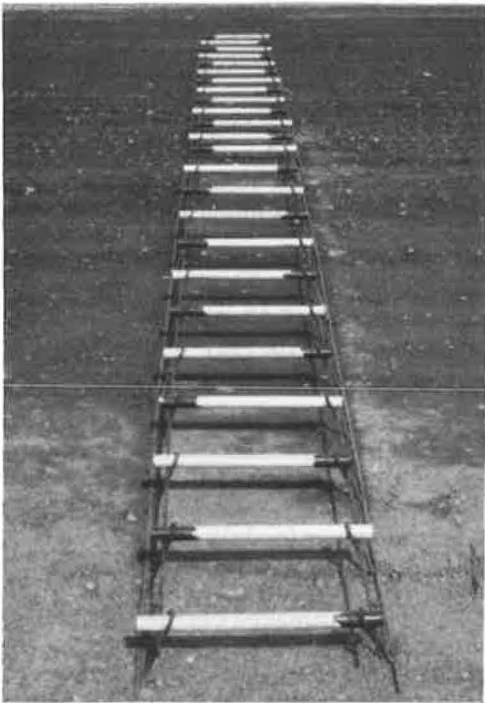
Figure 6. Bare dowel ends painted with red lead.
