CONCRETE PAVEMENT JOINTING AND SEALING METHODS

Raymond J. Brunner, Walter P. Kilaeski, and Dale B. Mellott,
Bureau of Materials, Testing and Research,
Pennsylvania Department of Transportation

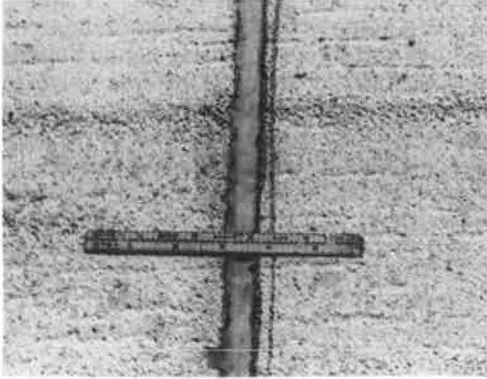
Figure 3. Polysulfide sealant ($\frac{1}{2} \times \frac{3}{4}$ in.).

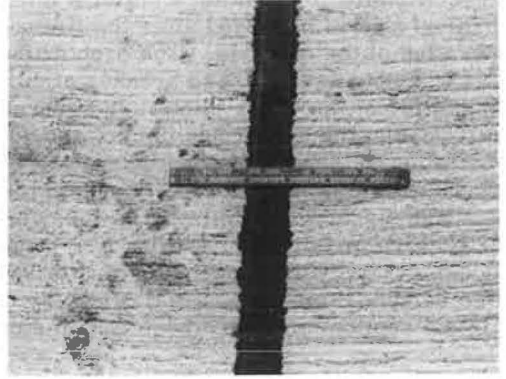
The remaining joints were completed with a uniform range of curing time. Sealant placed with this machine was characteristic of typical urethane materials (Figure 4). The sponge bond breaker was again used in most of the wider joints. Roving material was placed in the bottom of the conventional joints and a light application of sealer was applied and allowed to cure partially before the joint was fully sealed. Areas that required resealing did not bond as well as expected to the previously placed material. The urethane material flowed slightly on superelevated sections.

Figure 4. Urethane sealant ($\frac{3}{4} \times \frac{3}{4}$ in.).

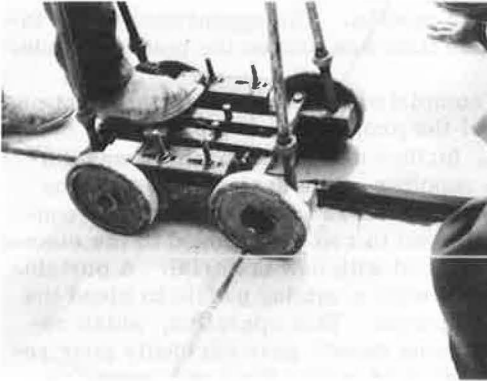
The lubricant-adhesive machine was inoperative and hand application was required. The machine used to place the seal was fast, efficient, and provided a uniformly placed seal (Figure 5). When a problem occurred, such as a twisted or deeply placed seal, the machine could be backed up and the nonuniform area could be extracted and reinserted with a minimum of effort. The ease of installation was superior to all other sealers placed during this evaluation (Figure 6).

Figure 5. Preformed neoprene seal installer.

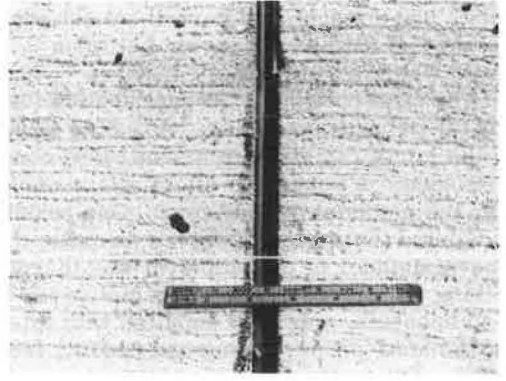
Figure 6. Completed preformed neoprene seal.

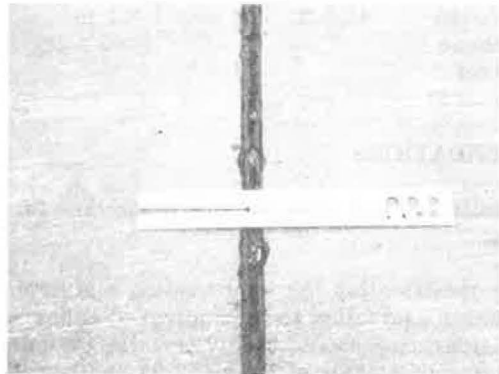
The control material was performing poorly in all joint size configurations and in all 3 pavement slab lengths (Figure 8). There was an excessive intrusion of debris into the material in the wider joint openings. Bond failure is prevalent between pavement joint and sealant (adhesion) and to some extent within the material itself (cohesion).

Figure 8. Control joint showing early failure.

1. The specification for joint sealing material should be upgraded to require the use of a sealer equivalent to the improved rubberized-asphalt material.
2. Consideration should be given to the potential savings that might be achieved in going from the conventional joint (\$2.27 to fill a $2\frac{1}{2} \times \frac{3}{8}$ -in. joint with conventional hot-pour sealer) to a $\frac{1}{2} \times \frac{3}{4}$ -in. joint (\$1.24 to fill with improved rubberized material). It would require some additional cost to make the second step-cut.

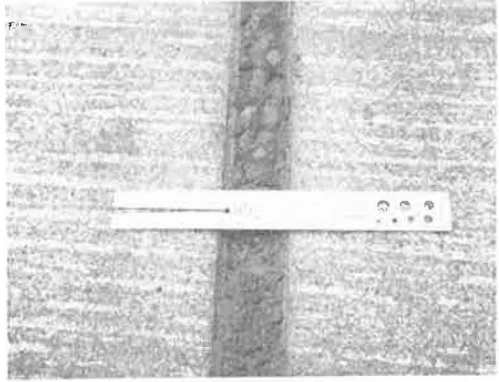
The improved rubberized-asphalt material was much better in appearance. It sealed the joints and rejected the intrusion of debris better than the control material (Figures 9 and 10). There was a minimal amount of debris even in the $\frac{3}{4}$ - and 1-in. joints.

Figure 9. Debris intrusion in control material (1 x 1 in.).

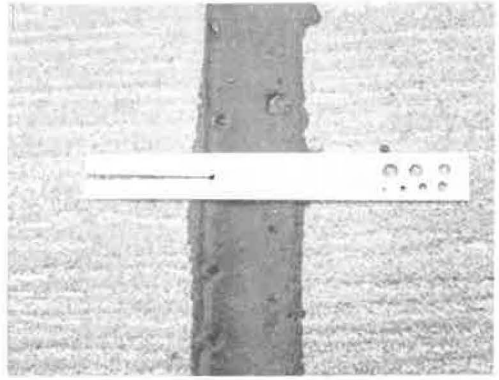
Figure 10. Minimal intrusion in improved rubberized-asphalt material (1 x 1 in.).

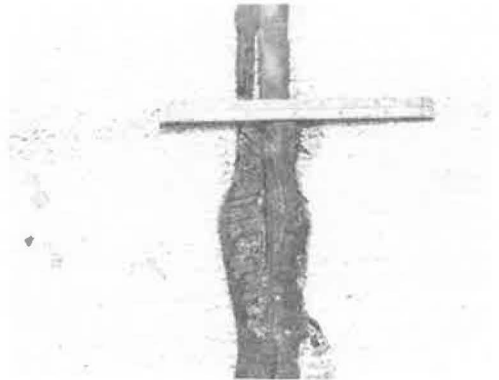
The practice of allowing construction equipment and traffic to use the pavement after the joints are sealed has led to poor joint performance. The shoulder placement and final clean-up operations have spalled the joint walls as a result of aggregate being "bladed" across or from the pavement surface (Figure 11). At the same time, debris is forced into the joint opening, and, if the sealer lacks characteristics to repel this intrusion, "solid" contamination occurs. A high joint failure rate can be expected from this practice. The occurrence of such damage on this job has served to lower the overall performance ratings.

Figure 11. Construction damage to completed urethane sealant.

3. Consideration should be given to specifying the joint sealing operation as the last construction operation on a new project. The use of step cutting would allow the first cut to be made at the required time and roving material could be maintained until the second cut is completed.
