PERFORMANCE EVALUATION OF UTAH'S CONCRETE PAVEMENT JOINT SEALS

Joseph C. McBride and Miles S. Decker, Materials and Tests Division,
Utah State Department of Highways

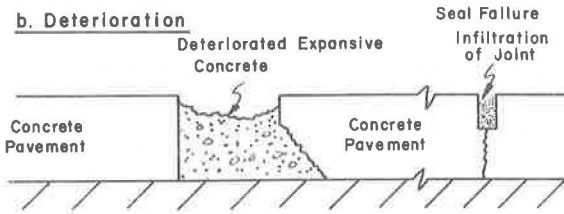
Figure 1. Repair, deterioration, and blowup sequence.

•DURING the summer of 1972 on I-15, between the 31st Street Exit in Ogden and the Layton Exit, 2 blowups occurred in the concrete pavement. These major pavement distress problems were the first such problems to occur on the state's Interstate highways since the concrete-paved sections were opened to traffic approximately 10 years ago. At the time of construction the contractor had failed to remove the wooden bulkheads laid at the end of each day's paving when he started to place concrete the next morning. When the pavement was nearly completed, the wooden bulks, which had been left in the pavement, were noticed. In removing the bulkheads the pavement was only partially cut and the remaining depth of pavement was broken with a jackhammer. Instead of having a vertical break, the remaining slab was undercut as in Figure 1a. The gap was then filled with expansive concrete containing iron filings. Several years later the expansive concrete had started to deteriorate rapidly due to rusting of the metal filings, leaving a depression in the pavement (Figure 1b).

Plans were made to remove the deteriorated concrete, but before this could be done the pavement blew up at the construction joints (Figure 1c). During the investigation of these blowups it was observed that the joint seals in this area had failed and the joints were being infiltrated by incompressibles. With the joints infiltrated the horizontal stresses resulting from thermal changes could not be relieved. When the forces became large the pavement was pushed up the ready-made ramps at the construction joints.

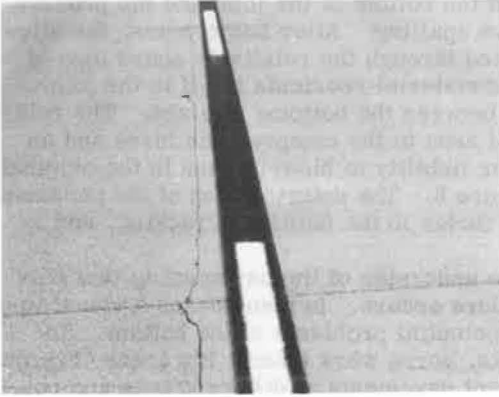
Figure 9. Longitudinal joint displacement in section 2.

The joints in section 2 were formed by use of a plastic strip and were 5 years old. A visual inspection of the joint surface indicated that the joint was open and being infiltrated with contaminants. The longitudinal joints, which were also formed with plastic strips, were displaced at each transverse joint intersection (Figure 9). This displacement has been noted in another report (3) and is a construction problem with plastic strips. The cores revealed that a dense layer of granular material 2 in. (5 cm) deep lay at the bottom (Figure 10). All of the joints sampled had cracked, affirming that the plastic strips do indeed produce an effective weakened plane in the pavement, giving a controlled crack location.

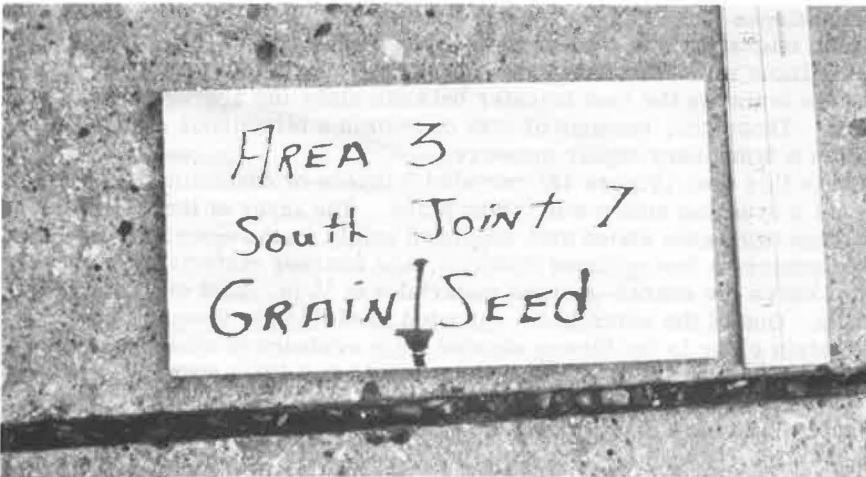
Figure 11. Joint containing grain seeds.

Section 3 had the most deteriorated joints of any test section. This section was also the section in which the pavement blowups had occurred. In the wider joint openings large aggregate was noted at the surface. Some grain dropped by passing trucks was also observed in the joints (Figure 11).

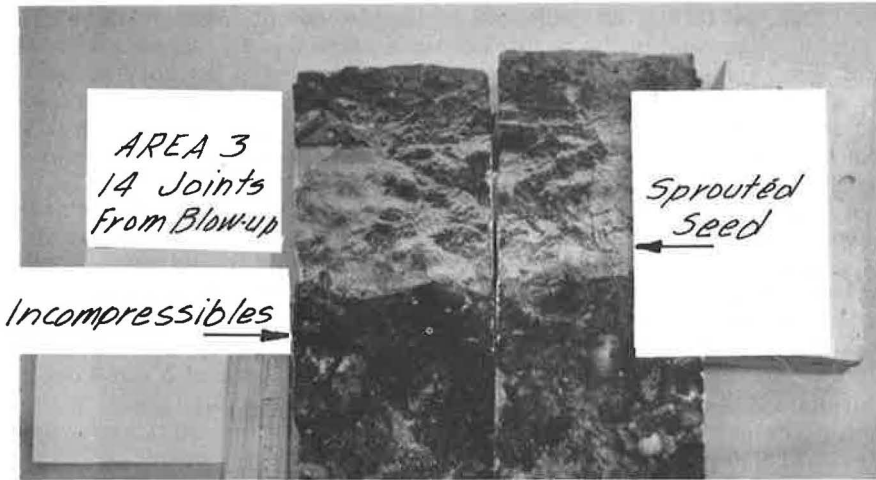
Figure 12. Cores from section 3.

The cores taken in this area (Figure 12) revealed 3 layers of contamination. These layers indicated that a crushing action was taking place. The layer at the top of the joint was mainly large aggregate whose size depended solely on the opening of the joint. The middle layer contained a fine-grained material, and coarser material was at the bottom. In several cores the coarse-grained material was $\frac{1}{4}$ in. (0.63 cm) thick and 5 in. (12.7 cm) deep. One of the cores had a sprouted seed midway down the core (Figure 12). The joints close to the blowup showed little evidence of contamination layering. While the cores were being taken it was noticed that little water was coming to the surface. It was felt that there was a void under the joint. If this was true, then the coarse aggregate would have dropped into the void, forming no aggregate layer in the joint.

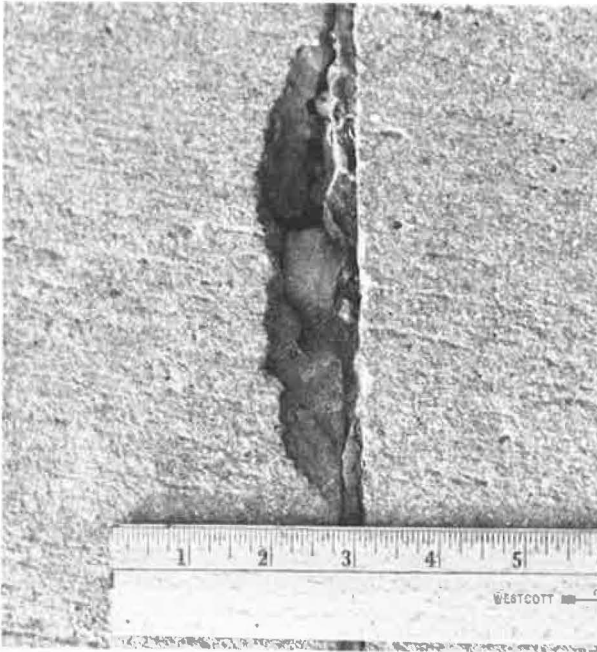
Figure 13. Spall at joint in section 4.

Section 4 was $1\frac{1}{2}$ years old and the surface of the joint showed some deterioration (Figure 13). Adhesion between the seal and the top of the joint walls had started to

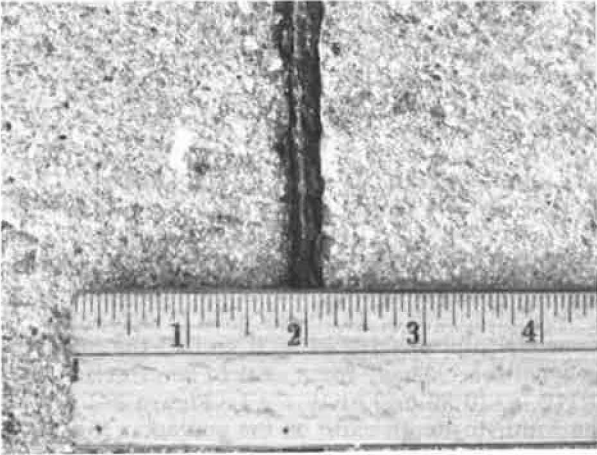
Figure 14. Sealing material in section 4.

fail (Figure 14). The cores revealed that some seals had failed where others had not. The 3 cores shown in Figure 15 are at different stages of failure. The core at the left contains a seal that has not failed, as evidenced by the absence of epoxy or other contaminants in the joint. The seal of the center core has started to fail as shown by the limited amount of epoxy that was able to pass the seal. The seal of the core at the right has failed, as shown by the epoxy and incompressibles found at the base of the core. In Figure 16 the problem of adhesion is apparent. The seal was adhering to the aggregate but not to the cement mortar. Cleaner joint walls may solve this type of adhesion problem.

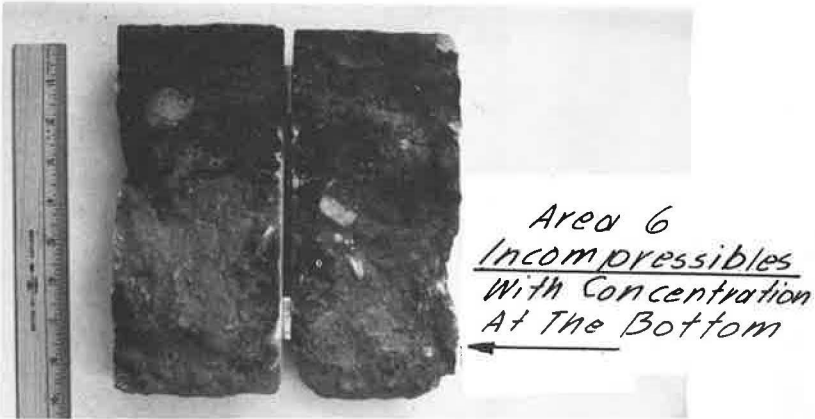
Figure 17. Core from section 6.

Sections 5 and 6 are respectively 8 and 10 years old. The surface conditions of the joints in these areas were about the same, with no apparent excessive deterioration. The lack of epoxy on the walls of the cores indicates that the joints were closed when the epoxy was poured (Figure 17). In the laboratory all of the cores separated easily, indicating there was no adhesion of the seal. The contamination in the joint was different from those joints sampled in sections 2 and 3 (Figure 18). In sections 2 and 3 the contamination formed layers, whereas the contaminants in sections 5 and 6 displayed a fairly even coating of very fine, clay-like material on the joint walls, with no apparent layering. The presence of contamination indicates that the joints are subject to infiltration, even though at the time of coring no infiltration was evident.

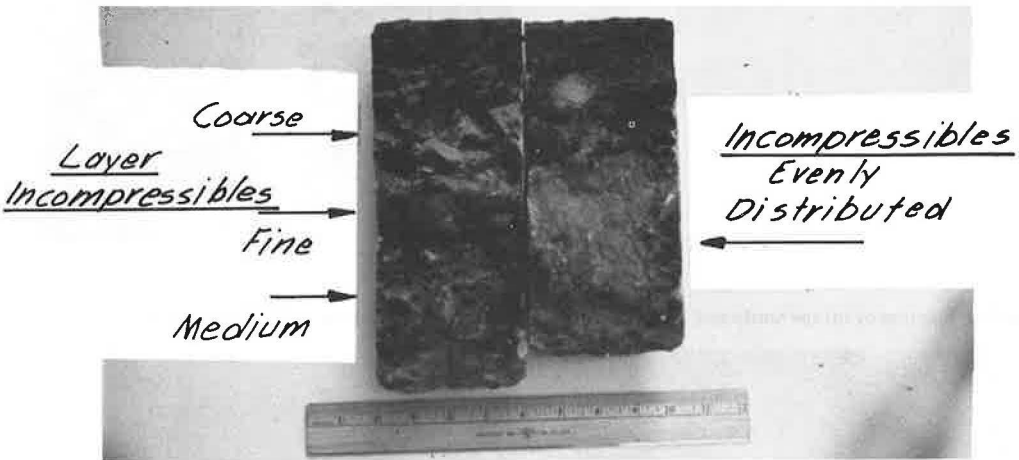
Figure 18. Cores from sections 3 and 6 showing different types of contamination.

One possible reason for the difference in the type of incompressible in sections 2 and 3 and 5 and 6 is the winter maintenance procedures in these areas. In the Ogden area, where sections 2 and 3 are located, sand and salt are used. In the Salt Lake City area, where sections 5 and 6 are located, only salt is used.

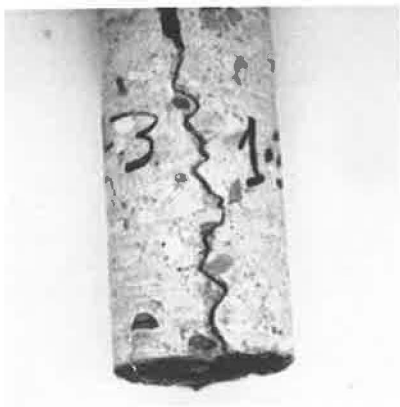
Figure 19. New pavement core with no spalling at the bottom.

Deterioration at the joint slab bottom was detected in all but the newest pavement. The bottoms of the joints in section 1 were square, with no spalling (Figure 19). Cores from the oldest sections (3 and 6) had spalling that was around 2 in. (5 cm) in height (Figure 20). The rate at which this spalling occurred was not investigated.

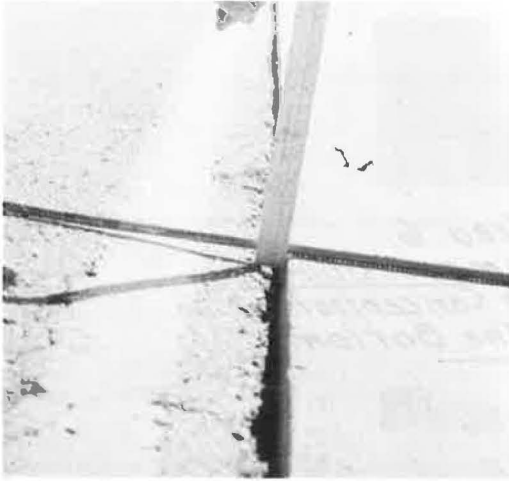
Figure 21. Trough formed between concrete pavement and asphalt shoulder.

During inspection of the transverse joints it was observed that the longitudinal joint between the pavement and asphalt shoulder was in a bad condition. In many cases a $\frac{1}{2}$ -in. (1.3-cm) horizontal gap existed between the 2 surfaces. Also, there was a depression forming a trough at the concrete pavement edge (Figure 21). Any water falling on the roadway would run off the pavement and into the longitudinal edge joint (Figure 22) instead of running off the pavement and over the shoulder. With the longitudinal edge joint badly in need of repair, the quantity of water entering the base material via the transverse joints is insignificant compared to the amount entering via the pavement edge joint. If watertightness was a serious problem, the longitudinal edge joint should be repaired before attending to the water-tightness of the transverse joint. To alleviate the pavement edge joint problem in the future, the concrete pavement will be widened so that the shoulders will be of concrete instead of asphalt.

During the coring of the joints it was noted that the pavement edge joint between the concrete and the asphalt shoulder was in very poor condition. Any runoff water would be funneled into the longitudinal edge joint instead of over the shoulder. This water entering the base and subbase could cause damage to the roadway foundation, eventually resulting in pavement distress problems. Resealing of the joint is important to retaining the integrity of the pavement.

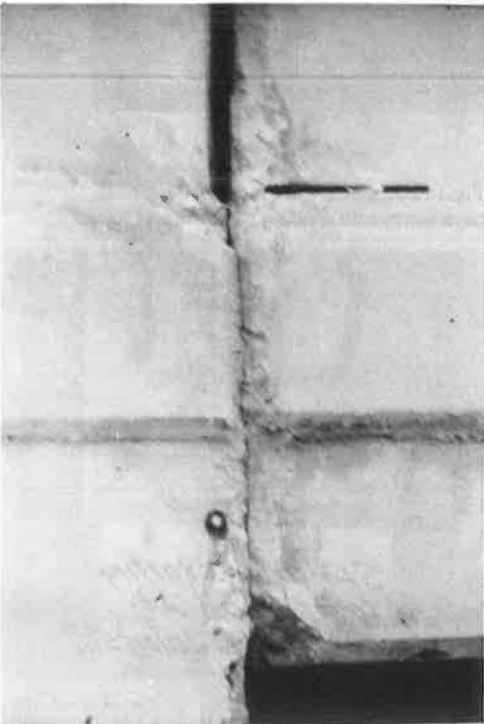
Figure 23. Spalling of bridge abutment joint.

A limited investigation was conducted to determine if any bridge pushing from pavement growth had occurred. The only evidence of possible pushing was found on the Bluffdale overpass on I-15. The abutment joint on the bridge had been closed and spalling on the abutment had occurred (Figure 23).

The visual inspection for pavement growth and bridge pushing found that no serious problem of this type existed. Only one possible example was found but this case was not serious.
