# CORROSION OF GALVANIZED METAL CULVERTS

R. W. Noyce, R. W. Ostrowski, and J. M. Ritchie,  
Geotechnical Services Unit, Michigan Department of State Highways  
and Transportation

Corrosion is a major factor in the life expectancy of metal culvert structures. Corrosion resistance, therefore, is of special interest to the user of galvanized culverts. A thorough investigation was conducted on 287 galvanized culverts located on the 56-mile (90-km) route of I-75 in the Upper Peninsula of Michigan. The service life of the culverts inspected ranged from 10 to 14 years. Visual observations and electrical tests were made at the culvert site to define the degree of corrosiveness. Water and soil were sampled and chemically analyzed to determine their relationship to or influence on deterioration. Significant corrosive attack was noted in 39 culverts. Test results revealed that major deterioration was occurring from the exterior (soil side) of the culvert. Exposure conditions found to cause excessive deterioration in uncoated galvanized culverts are dissimilar soil contacts, presence of organic soils, and differentials in aeration and soil moisture. Sulfates and chlorides were contributing f

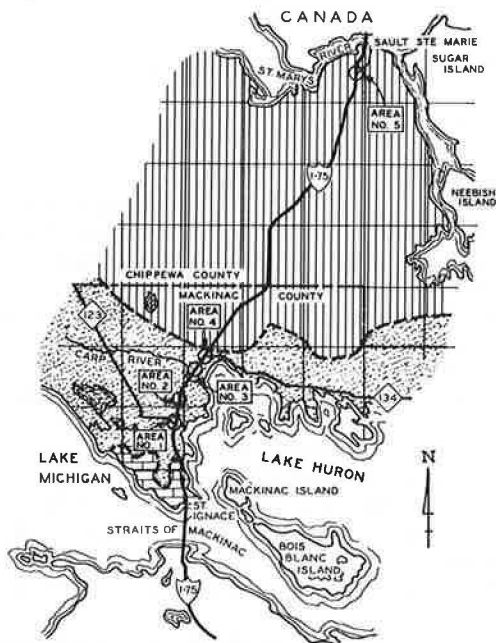
Figure 4. General soil survey.

FIVE MOST SEVERELY CORROSIVE AREAS
AREA NUMBER 1 - 5 severely deteriorated culverts.
AREA NUMBER 2 - 6 severely deteriorated culverts.
AREA NUMBER 3 - 12 severely deteriorated culverts.
AREA NUMBER 4 - 3 severely deteriorated culverts.
AREA NUMBER 5 - 4 severely deteriorated culverts.

The field inspection revealed rather large differences in culvert performance in spite of the small differential in the range of culvert ages. All the culverts classified in Table 1 have been in service for an average of 11 years. As seen in the table, 39 culverts classed as 0 or 25 exhibited signs of heavy metal loss. Most of the severely corroded culverts, 30 out of 39, are contained within 5 geographic areas (Figure 4).

Most of the severely corroded culverts were located within the 5 geographic areas shown in Figure 4. Mapping the native soil types shows that, of the 39 rapidly deteriorating culverts, 22 were in areas of very poorly drained mucks and peats. Poorly drained clays, loams, and sands were found at most of the remaining corrosive sites.

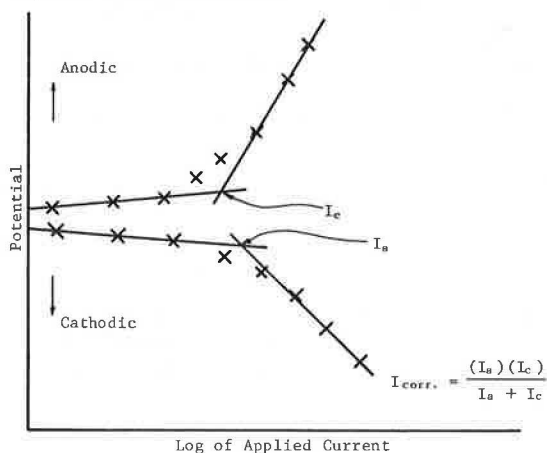
Figure 6. Polarization curves.

Time allowed only a preliminary trial of the polarization test in this study, and therefore the analysis is limited to the collection of measurements and plotting of polarization curves at 46 culvert sites. The corrosion current and calculated metal loss have been compared to the culvert ratings determined through visual inspection, and the results are given in Table 3. A correlation can be seen between the culvert rating and corrosion current. The mean value of the corrosion current, 3.25 ma, for culverts in good condition (90 rating) is relatively lower than the corrosion current, 11.18 ma, found at the perforated culverts (0 rating). A positive relation is not as evident when comparing metal loss per square foot with visual rating. This results from polarization data collected at culverts with large variations in surface areas.

Problems did arise from what appeared to be erroneous values. Several individual measurements obtained at various culvert sites could not realistically be assumed to occur for the duration of a year in view of the culvert's condition. The erratic values of the corrosion current measured at culverts with a 50 rating indicate this. Further refinement of equipment and test procedures, therefore, is necessary before meaningful service life determinations can be derived.
