PARTIAL-DEPTH PRECAST CONCRETE PATCHING

Marion F. Creech, Virginia Department of Highways and Transportation

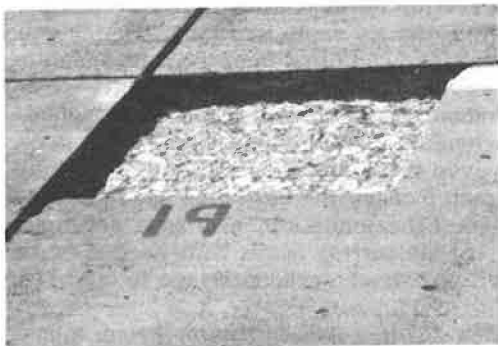
Figure 7. Hole prepared for precast patching.

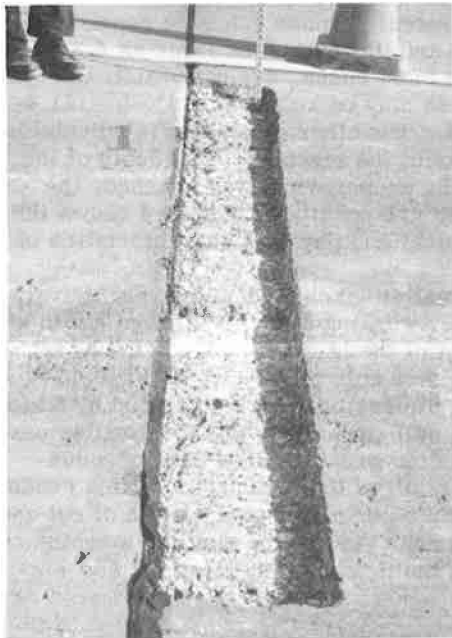
Figure 8. Hole 1 after cutting and cleaning.

The experiment was performed on 15 working days in June 1974, when 90 patches were placed. For the holes for some patches, such as patch 1 (Figure 8), the cutting machines had to be repositioned three times. For others only one setup was necessary (Figure 7). Repositioning the machine greatly increased the time necessary for cutting a hole; in fact, almost as much time was required to set up and adjust for the cutting operation as was required to cut the hole. In many cases, however, more than one setup was necessary, and more than one slab was needed to fill the hole (Figure 9). When a slab of a not-available size was needed, it was sawed from a larger slab as shown in Figure 10.

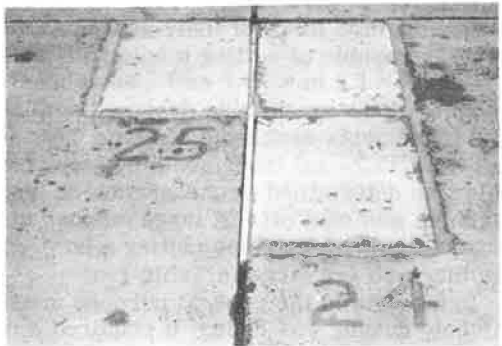
Figure 9. Patched area requiring more than one slab.

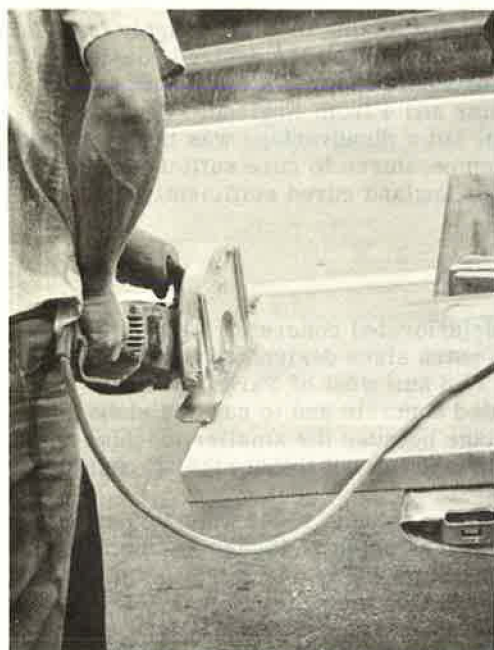
Figure 10. Precast slab being sawed to proper dimension.

6. Precast concrete patching projects should have a bench type of masonry saw on

the job site capable of sawing precast slabs to exact dimensions. It is not practical to try to cast all of the different size slabs that may be needed.

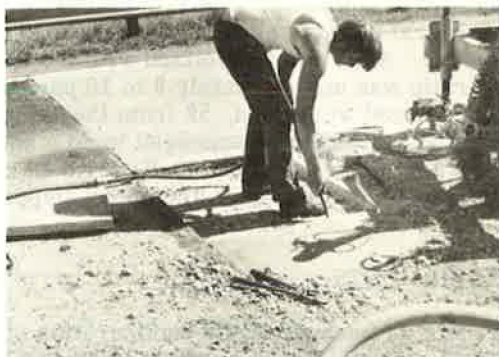
The handwork necessary in preparing the holes consisted of removing the steel mesh with a small hand tool as shown in Figure 11. This resulted in the grid pattern in Figure 12. The handwork also consisted of removing small amounts of concrete at the few joints that had bad concrete below the level cut by the machine. Figure 13 shows a hole from which concrete along the joint had to be removed by hand. In such cases, the crack was filled with epoxy grout up to the level of the remainder of the hole, and the patch was installed in the normal manner. After a hole was prepared for patching, it was sounded to make certain all deteriorated concrete had been removed.

Figure 11. Steel mesh being removed from hole with hand tool.

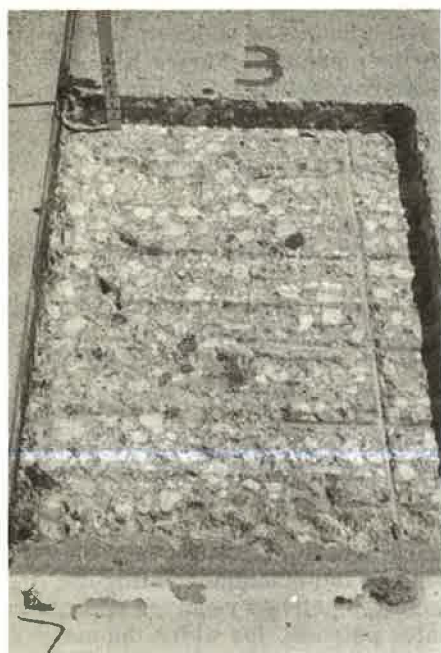
Figure 12. Grid pattern left after removal of steel mesh.

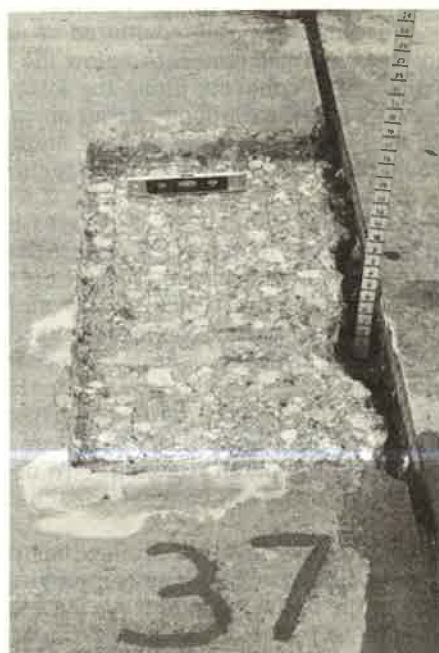
Figure 13. Hole from which deteriorated concrete along joint had to be removed with hand tool.

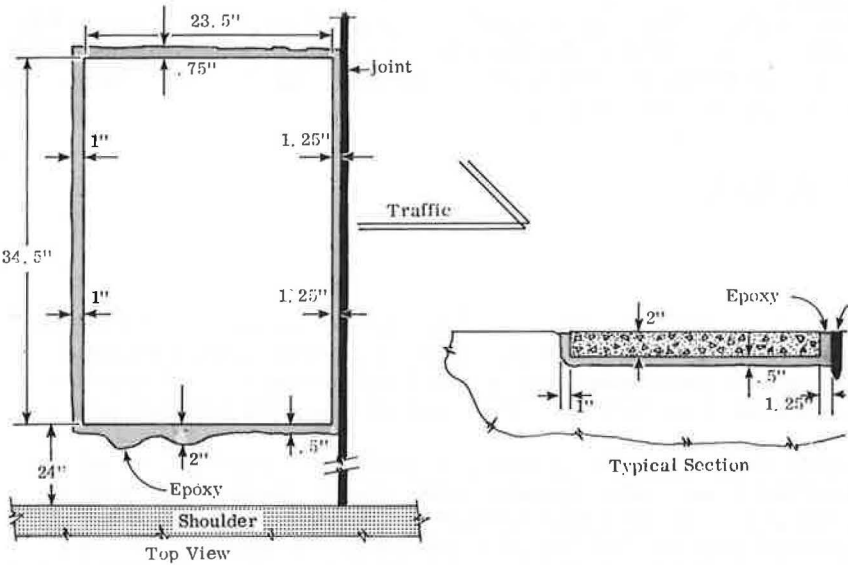
Figure 14. Dimensions of crack around patch.

When the patching operations were under way, a sketch was made of each hole (a) showing all of the dimensions, irregularities, and any other important information and (b) showing the dimensions of the cracks between the slab and surrounding concrete (Figure 14). In addition, a photograph was taken of each hole to show areas next to the joint from which additional bad concrete had been removed and areas that would require backfilling with epoxy grout to bring them up to patching level. A photograph was also taken of the finished patch.

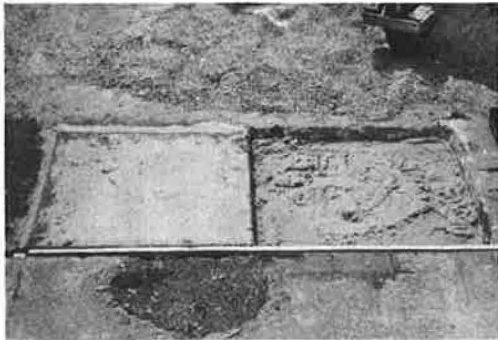
Figure 15. Half finished patch, epoxy grout in right portion of hole.
