# DYNAMIC TESTS OF METAL BEAM GUARDRAIL

E. F. Nordlin, J. R. Stoker, and R. L. Stoughton,  
Division of Construction and Research, California Department of Transportation

The results of four vehicle impact tests into metal beam guardrail using three types of posts and blocks are reported. The then current (1971) California standard plans for metal beam guardrail required 8 by 8-in. (203 by 203-mm) nominal douglas fir posts and blocks. We wanted to determine whether smaller sized wood posts and blocks could be used and whether steel posts and blocks could be used in place of the 8 by 8-in. (203 by 203-mm) blocks to reduce guardrail costs. We also wanted to obtain another permissible post material besides wood. It was concluded that 6 by 8-in. (152 by 203-mm) nominal douglas fir wood posts and blocks were an acceptable substitute and that wide-flange 6-in. by 8.5-lb/ft (152-mm by 12.7-kg/m) steel posts and blocks could be used provided W-section backup plates were used at alternate posts where no beam splice occurred and a positive connection was used at the end-anchor cable in place of cable clips. All four tests conducted used 4,960-lb (2250-kg) passenger vehicles with nominal im

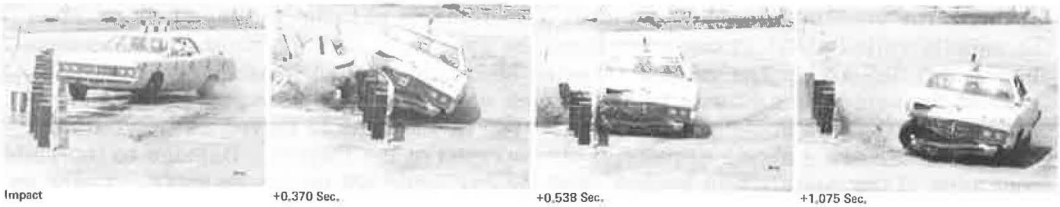
Figure 3. Sequential views of test 272.

There was little rise or roll imparted to the vehicle during impact until it was nearly parallel to the barrier. Then the vehicle rolled about 15 deg away from the barrier, and the right front end rose about 0.9 ft (0.27 m). The vehicle traveled smoothly through impact, had an exit angle of the vehicle's center of gravity (c.g.) of about 6 deg, and an exit heading angle of 0 deg so that the vehicle stayed close to the barrier and almost parallel to it. Figure 3 shows sequential photographs of the impact. The right front portion of the vehicle was so severely damaged that it could not be driven away. There was no intrusion of vehicle parts or barrier components into the passenger compartment. On impact, the dummy, restrained in the driver's position by a lap belt, was thrown sideways and downward toward the right passenger's seat. There were no apparent abrasions incurred by the dummy, and there was no damage to the interior of the vehicle caused by the dummy.

Two guardrail posts near the point of impact were destroyed, and pieces of the posts and their blocks were splintered and broken and thrown behind the barrier. Two other posts and their blocks were split. The metal beam was partially flattened and raised near the area of impact. Maximum displacement of the posts at ground level was 1 ft (0.3 m).

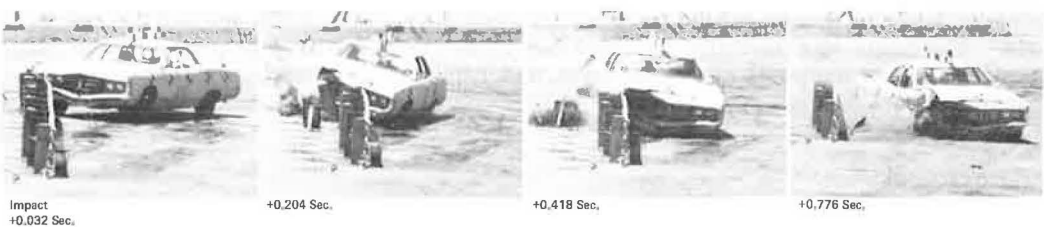
Figure 4. Sequential views of test 273.

Vehicle behavior was similar to that in test 272. There was little rise or roll imparted to the vehicle during impact until it was nearly parallel to the barrier. Then the vehicle rolled about 17 deg away from the guardrail, and the right front end rose about 0.8 ft (0.24 m). The vehicle traveled smoothly through the impact. The exit angle of the vehicle's c.g. was 14 deg, which was the same as the exit heading angle of the vehicle. This angle gradually increased as the vehicle moved away from the guardrail. Figure 4 shows sequential photographs of the impact. Damage to the right front area of the vehicle was severe, and the car could not be driven away. There was no intrusion of vehicle parts or barrier components into the passenger compartment. Dummy behavior was the same as in test 272.

Two guardrail posts near the point of impact were destroyed. A third adjacent post was splintered, and one post near each end of the barrier was split. Three blocks were broken and thrown behind the barrier along with some of the splintered post debris. The beam was partially flattened and raised near the area of impact. Maximum displacement of the posts at ground level was 1.65 ft (0.5 m) perpendicular to the barrier at post 5.

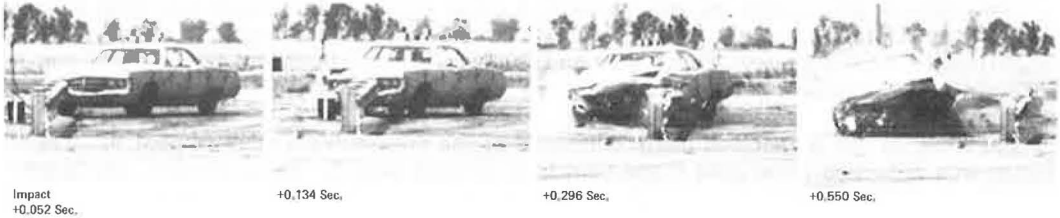
Figure 5. Sequential views of test 274.

The vehicle penetrated the guardrail with little change in direction and spun around 180 deg as it slid to a stop. Vehicle forestructure damage was severe, and the car could not be driven away. There was no intrusion of vehicle parts or guardrail components into the passenger compartment. Figure 5 shows sequential photographs of the impact.

Shearing of the W-section beam occurred at the downstream edge of post 6. The beam was detached from post 6 and bent back around post 5. Downstream, the beam segment was bent where post 7 had been attached and at the upstream edge of post 8. All 13 posts were twisted and displaced; the top of post 1 was displaced 1.5 ft (0.46 m) downstream, and the top of post 13 was displaced 1.25 ft (0.38 m) downstream. Posts 5, 6, and 7 were twisted and bent down near the ground about their minor axes with virtually no displacement of the posts in the ground. Slippage of the cable through five cable clips occurred at the upstream anchorage. These clips had been torqued to 50 ft-lbf (67.8 J) twice, including once on the day before the test. The bolt between the beam and block pulled through the beam at posts 5, 6, 7, and 8. The block at post 6 was buckled flat, and local buckling of block flanges occurred at several posts near impact.

1. The steel posts have about 90 times less torsional rigidity than wood posts, hence they absorbed little of the tensile load developed in the beam. Instead, they twisted and transmitted a large load almost instantly to the cable-end anchors.
2. Because of this large dynamic load (jerk), the cable slipped through the five cable clips at the upstream anchor.
3. Slipping of the cable relaxed the tension in the steel W-section beam and permitted severe pocketing, cold-working, and weakening of the metal beam.

To correct this condition, two changes were made to the barrier design for test 276: (a) A swaged fitting and clevis were used to replace the five cable clips on the cable-end anchorage to provide a positive anchorage and (b) twelve 1-ft-long (0.3-m) backup sections of W-section beam were placed behind the beam at alternate posts where beam splices did not occur. These backup sections reduced the tendency of the rail to hinge or tear along the hard sharp edge of the steel blocks and posts. The results of test 276 proved the effectiveness of these modifications.

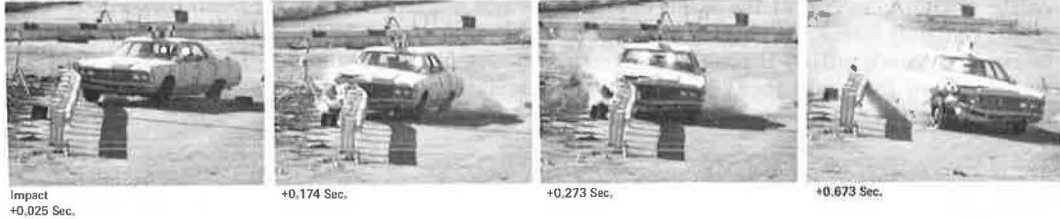
Figure 6. Sequential views of test 276.

Vehicle behavior was very stable during impact; there was virtually no vehicular roll or rise as redirection occurred. The exit angle of the vehicle's c.g. was about 16 deg and was the same as the exit heading angle of the vehicle. This angle decreased as the car skidded clockwise to a stop and came back toward the guardrail. Figure 6

shows sequential photographs of the impact. Vehicle damage was similar to that in tests 272 and 273. During impact, the dummy was thrown to the right and downward into the right passenger's seat, apparently without striking the dashboard. The dummy immediately bounced back into an upright position, struck the back of its head on the left door post, and came to rest against the left door.

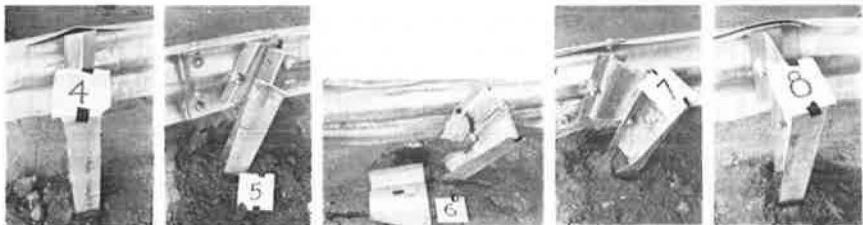
Figure 7. Barrier damage, test 276.

Guardrail damage consisted mainly of moderate twisting and bending of posts 5, 6, and 7 although none of the posts was bent to the ground. Separation of the metal beam from the steel post block occurred only at post 6. Severe buckling of the blocks occurred at posts 5, 6, and 7. A maximum  $\frac{3}{8}$ -in. (9.5-mm) slippage of a beam splice occurred at post 5. Barrier damage is shown in Figure 7.

The guardrails impacted in tests 272, 273, and 276 all met the requirements of containment. There were no indications that they were on the brink of failure. The guardrail impacted in test 274 was penetrated, and this was unacceptable. An analysis of that failure is described later. Figure 7 shows close-up views of posts near the impact area for test 276. The backup plates at posts 4 and 8 clearly resisted excessive bending of the W-section beams at the posts.

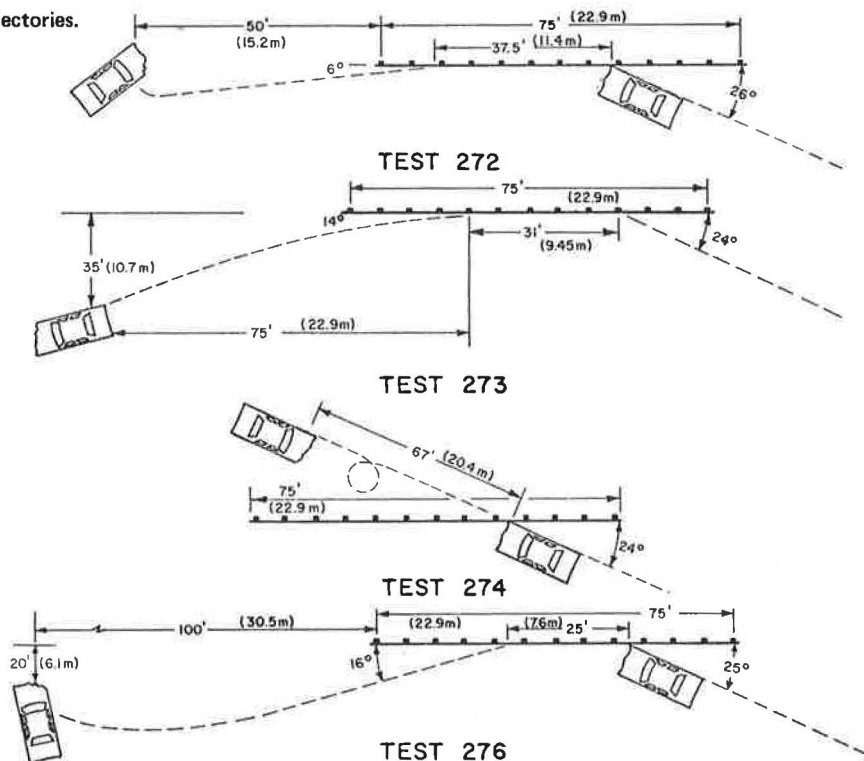
Figure 8. Vehicle trajectories.

Figure 8 shows the paths of the test vehicle after it impacted the test guardrails. There is no easy answer to explain the variance in post-impact trajectories. Various factors having an effect may include guardrail deflection, vehicle crush and damage to the wheel, time when brakes are actuated by remote control, amount of rise and roll, and paving surface conditions.

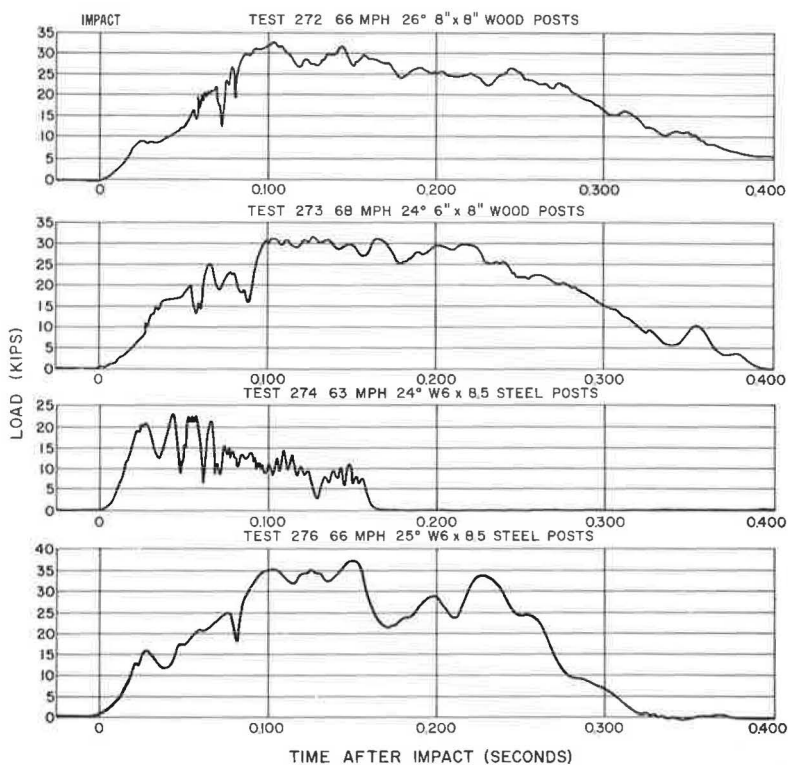
Figure 9. Upstream anchorage.

Figure 9 shows the loads on the anchorage cables during impact and indicates more rapid load initiation times for tests 274 and 276 for which steel posts were used. Figure 9 also shows that the cables are not overdesigned.
