## Evaluation of Concrete Safety Shapes by Crash Tests With Heavy Vehicles

E. O. Wiles, M. E. Bronstad, and C. E. Kimball, Southwest Research Institute, San Antonio

Three crash tests were made to evaluate concrete median barriers at speeds of approximately 70 and 90 km/h (45 and 55 mph) and angles of approximately 7 and 16° with an 18 000-kg (40 000-lb) intercity bus. The 61.0-m (200-ft) long installation was cast in place and reinforced with one number 4 bar placed 150 mm (6 in) below the barrier top. The freestanding barrier was restrained by a 25-mm (1-in) layer of asphalt placed at the installation bottom on the side opposite the impact. The results of the program include the following: The safety shape performed well at the lower angle impacts with no barrier distress or translation. The severe test [an impact speed of 85.1 km/h (52.9 mph) and an impact angle of 16°] showed that the concrete safety shape with minimum reinforcement and foundation restraint can redirect large vehicles at high impact speeds and angles. In the severe test, the rear-end impact during redirection was the principal cause of the extensive barrier damage and displacement.

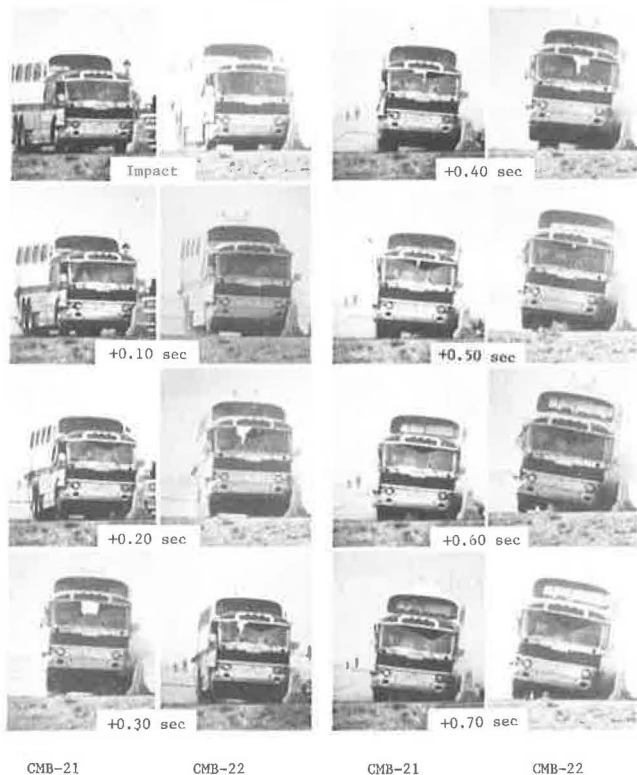
The impact conditions were a speed of 67.1 km/h (41.7 mph) and an angle of 11.5°. As shown in Figure 3, the vehicle impacted the barrier 12.4 m (40.8 ft) from the upstream end of the system and was smoothly redirected with a maximum roll angle of 8° toward the barrier and a total barrier-contact length of 7.9 m (25.9 ft). The maximum 50-ms average vehicle accelerations, which were obtained from high-speed film, were -0.9 g (longitudinal) and -0.7 g (lateral). The barrier damage (Figure 4) consisted of gouging and scraping of the concrete

Figure 3. Sequential photographs of tests CMB-21 and CMB-22.

The minor repairs necessary after test CMB-21 were made before this test. The impact conditions were a speed of 83.0 km/h (51.6 mph) and an angle of 6.6°. As shown in Figure 3, the vehicle impacted the barrier 23.5 m (77.1 ft) from the upstream end of the system and was smoothly redirected with a maximum roll angle

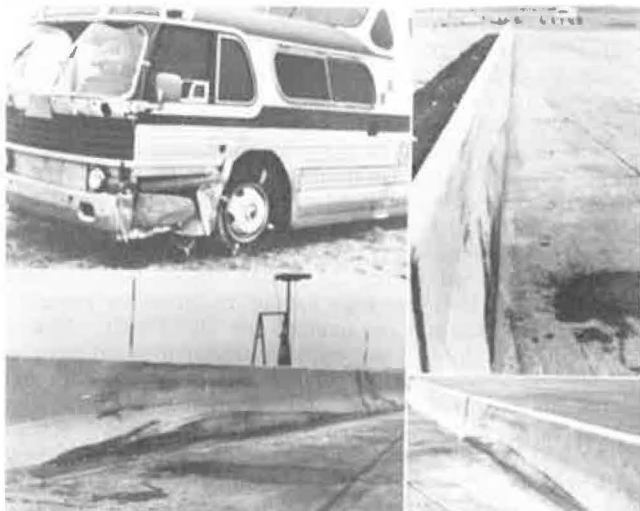
Figure 4. Damage after test CMB-21.

surface by contact with the rim; there was no translation of the barrier. The vehicle, which was drivable after the test, sustained minor front-bumper and sheet-metal damage, which caused some wheel-well intrusion on the left front corner.

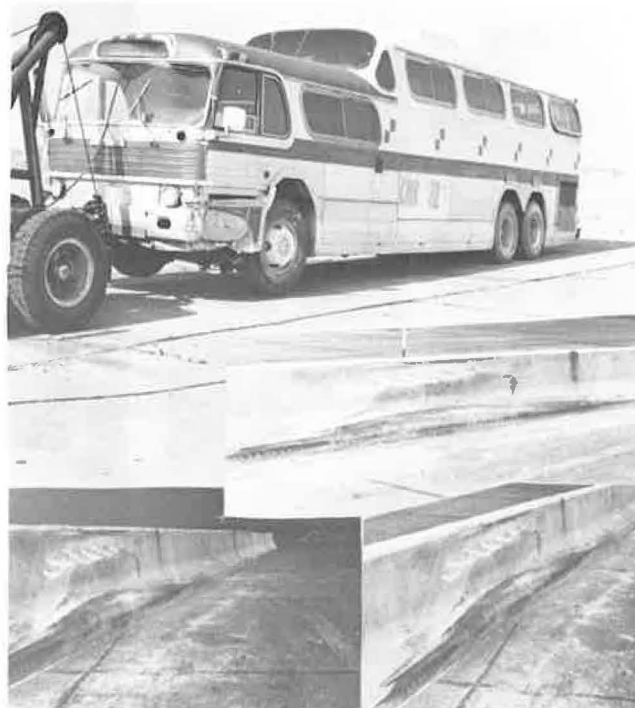
Figure 5. Damage after test CMB-22.

of 9° toward the barrier. The right front tire of the bus was airborne for approximately 0.3 s. The vehicle was redirected with a total barrier-contact length of 8.5 m (28.0 ft). The maximum 50-ms average vehicle accelerations, which were obtained from high-speed film, were -0.9 g (longitudinal) and -0.8 g (lateral). The damages to the barrier and the vehicle were similar to those in test CMB-21 (Figure 5). The vehicle was drivable after the test.

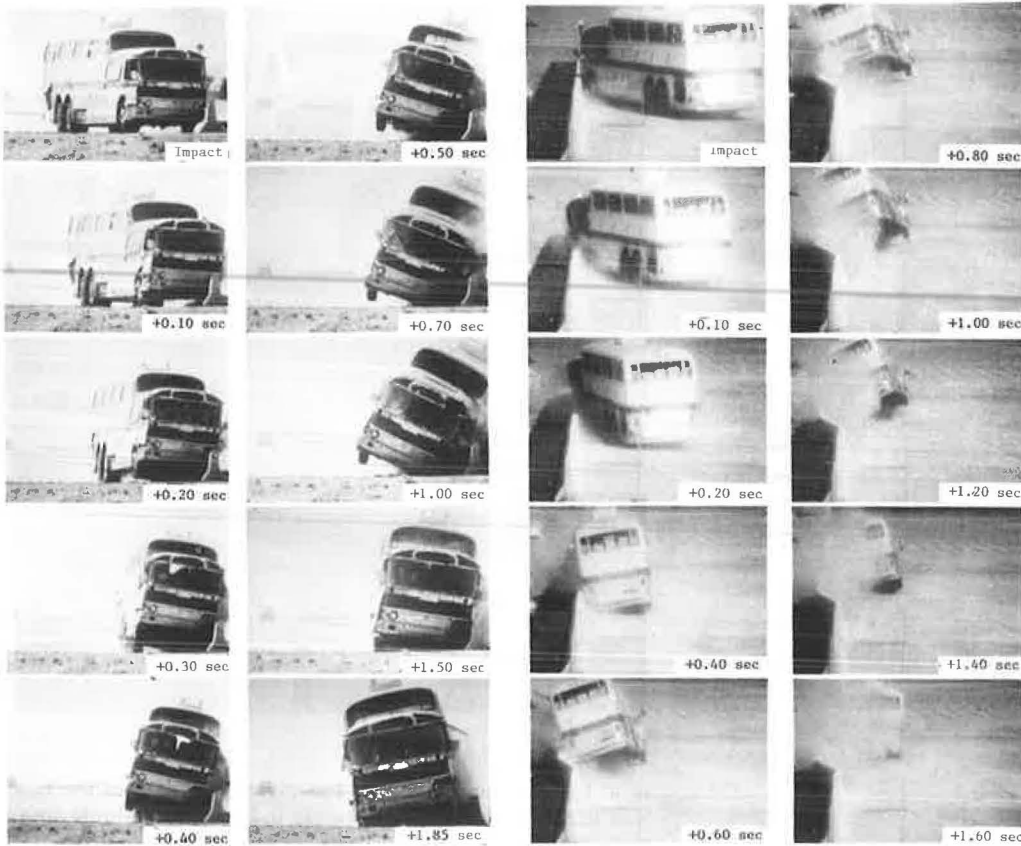
A leak in the oil system and the wheel-well damage were repaired before this test. The impact conditions were a speed of 85.1 km/h (52.9 mph) and an angle of 16°. As shown in Figure 6, the vehicle impacted the barrier 23.5 m (77.0 ft) from the upstream end of the system and was redirected with a maximum roll angle of 24° toward the barrier. The maximum 50-ms average vehicle accelerations, which were obtained from high-speed film, were -0.8 g (longitudinal) and -1.0 g (lateral). There was a local failure of the barrier and subsequent asphalt displacement because of the frontal contact; the resulting displacement was not measurable, but was estimated to be between 0 and 100 mm (0 and 4 in). The significant barrier and foundation failure was caused by the secondary impact. The maximum deflection of the barrier was 0.8 m (2.6 ft). The vehicle damage was extensive: There was major damage to the left front quadrant of the vehicle around the fender and the left side radiator and radiator door. These damages are shown in Figure 7.

Figure 6. Sequential photographs of test CMB-23: front view and rear view.

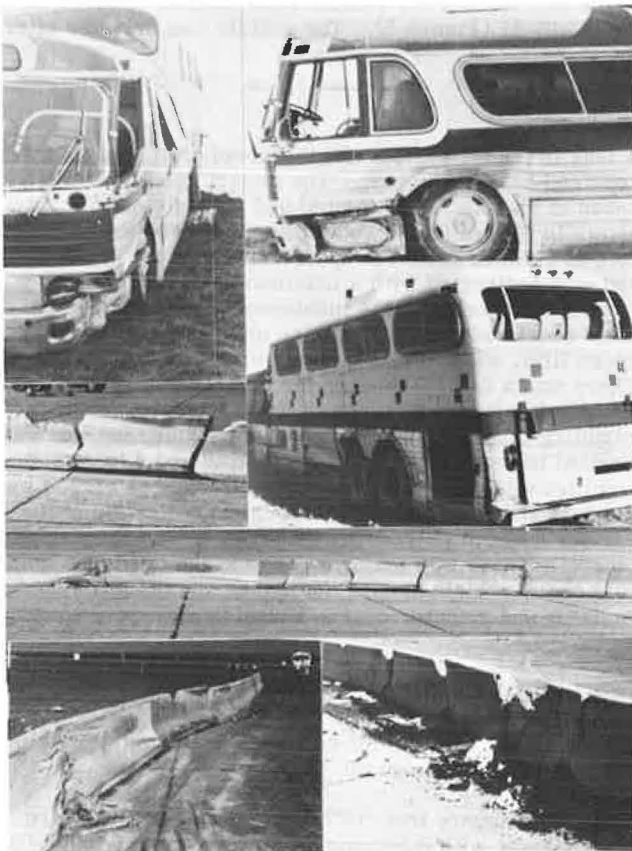
Figure 7. Damage after test CMB-23.

2. In the severe test ( $16^\circ$ ), the local fracture of the concrete occurred during the initial contact with the bus front at a load that was high enough to force the impacting left wheel against the back of the wheel well. However, although this initial contact produced local barrier failure and nominal displacement, the rear-end contact as the bus was redirected was the principal cause of the extensive barrier damage and displacement.
