Ponding an Expansive Clay Cut: Evaluations and Zones of Activity

Malcolm L. Steinberg, Texas Department of Highways and Public Transportation

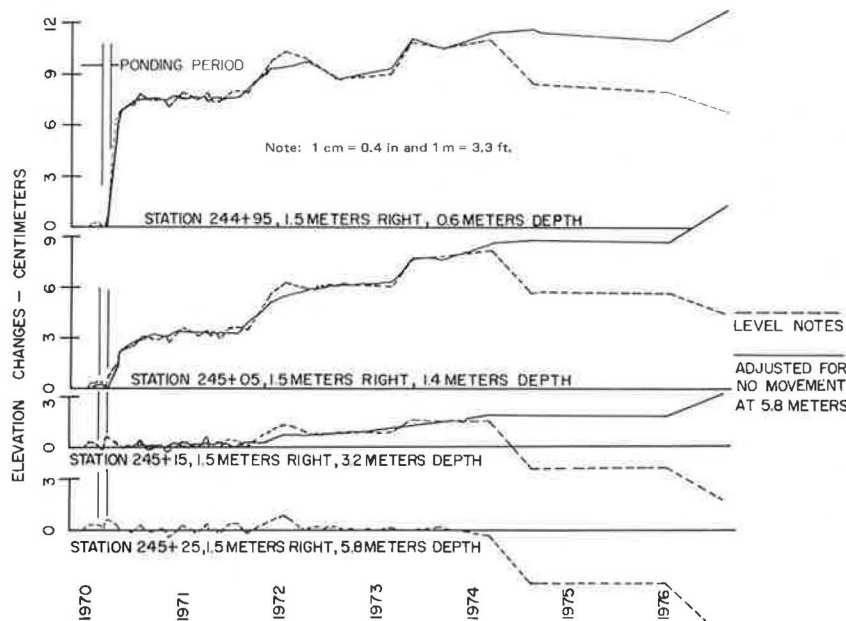
Figure 3. Vertical movement at station 245.

Generally, the ponding caused an upward movement in the elevation rods. This was most pronounced in those set 0.6 and 1.4 m (2 and 4.5 ft) deep, i.e., the shallower rods, and most clearly indicated in the rods set in the ponded median areas. With time, this movement was reflected to a lesser degree in the deeper set rods. No movements greater than 1 cm (0.4 in) were read in the rods set at the 5.8-m (19-ft) depth for more than 4 years. This is typically shown in the group at station 245 (Figure 3).

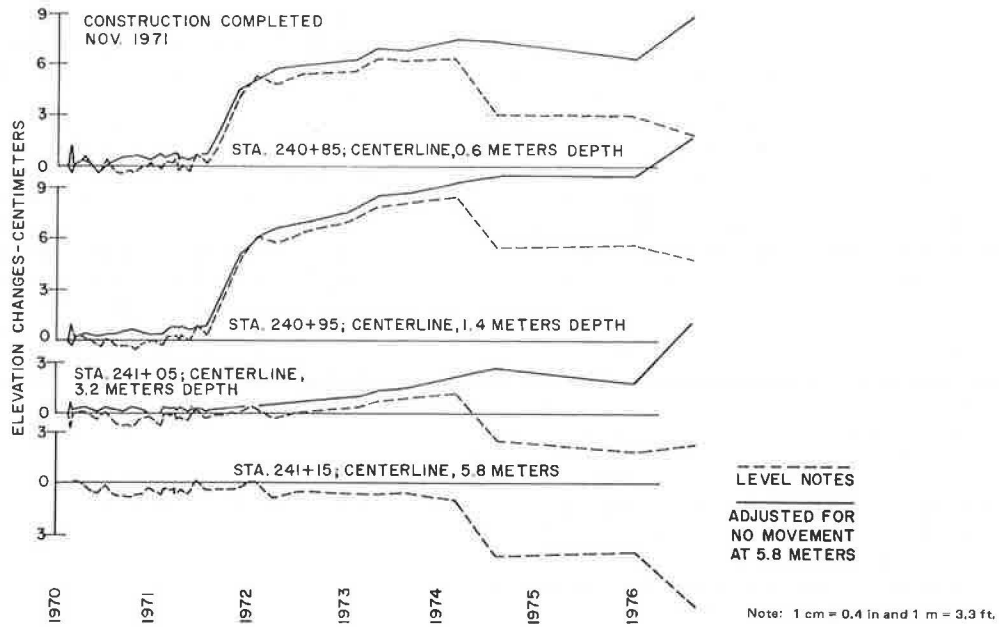
Figure 4. Vertical movement at station 241.

The control rods have also developed upward movements. At station 241, this did not occur until 2 years after the subgrade was shaped and the pavement placed (Figure 4). The movement was greatest in the elevation devices set at the shallowest depths, 0.6 and 1.4 m (2 and 4.5 ft). In the other control group at station 173, no movement was recorded until 1972. There, readings were greater and continue to show more movement from the 1.4 and 3.2-m (4.5 and 10.5-ft) rods than from the shallowest one at 0.6 m (2 ft).

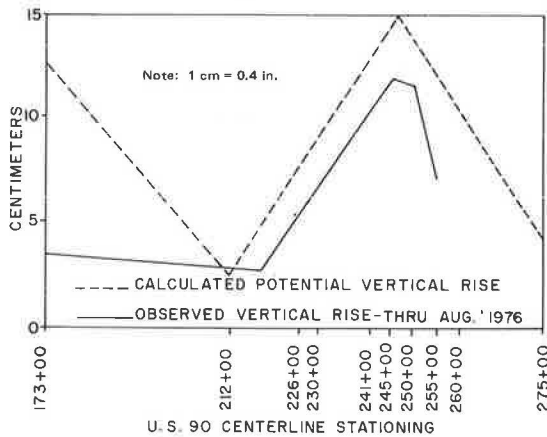
Figure 5. Vertical movements: calculated and observed.

On none of the rods has the actual maximum reading yet reached the calculated PVR. The movements seem to be approaching the calculated values if the adjustment to the 5.8-m (19-ft) rod is used. The rods in the stations 245 to 255 medians are now showing maximum upward movement close to the predicted PVR. The readings at station 173 have not come within that range, nor have the ones 30 m (100 ft) to the left of the centerline (Figure 5).

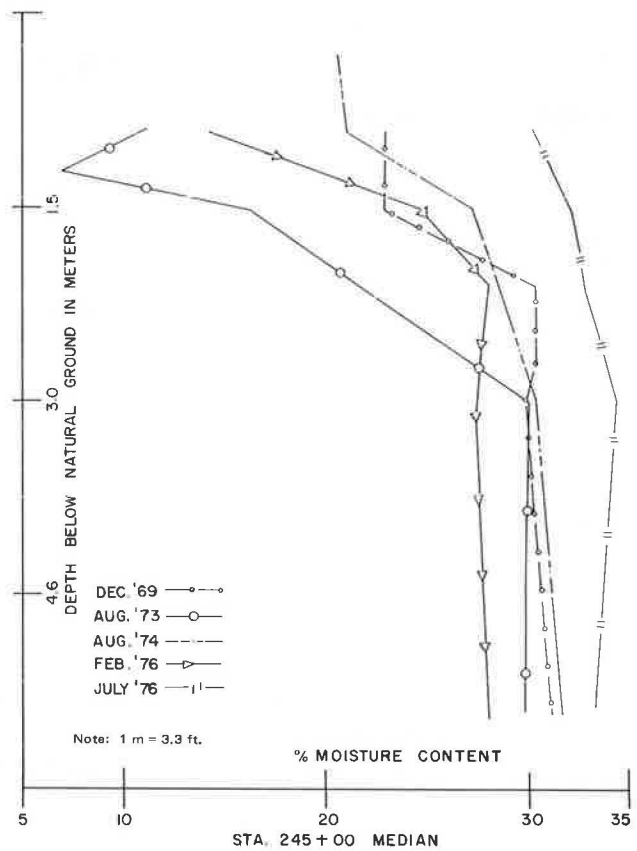
Figure 6. Moisture changes at station 245 (center line).

These readings cover a 9-year period. To avoid variations due to testing modes, they were all taken by the method of laboratory tests of drilled samples. They reflect a zone-of-activity pattern in which there is considerable change in the moistures (usually) down to 3 m (10 ft). They range from a low of close to 5 to a high of almost 35 percent (Figure 6). This was true for both the ponded and the unponded areas and as likely to occur in 1976 as in 1969. Below 3 m (10 ft), the samples showed much less variation. The range at that depth

seemed to be from 24 to 28 percent at one site to 28 to 34 percent at others. Instead of the 30 percent moisture-content variations in the zone of activity, these deeper readings reflect changes of one-third that or less. Moisture changes seem to relate to elevation changes. Both have their maximums in the zone of activity.

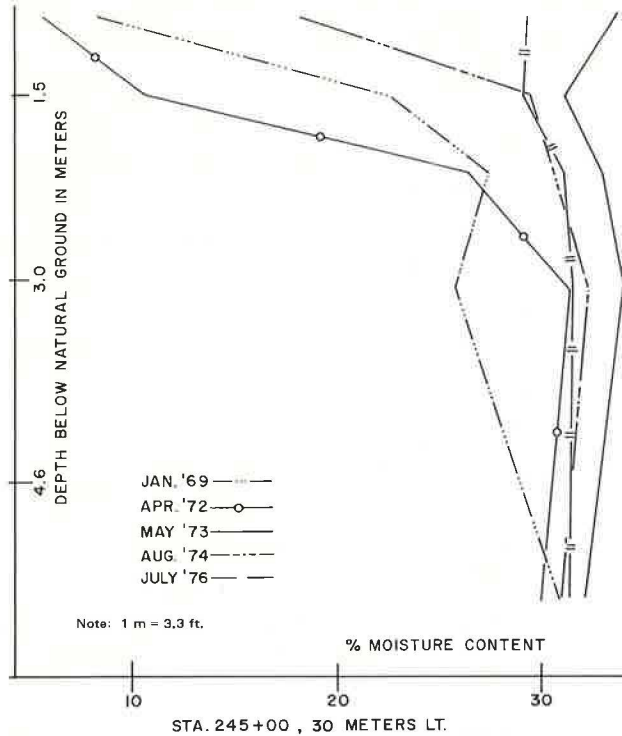
Figure 7. Moisture changes at station 245 (30 m left of centerline).

1969 indicate that they have less moisture variation below 3 m (10 ft) (Figure 7). Whether this diminished range of change is due to differences in the material has not been clarified. The soil profiles do reflect some variations. Other possible reasons are closeness to the slopes of the 6-m (20-ft) deep excavation and the fact that these latter sites were ponded shortly after excavation. However, the pattern is generally the same. Major moisture changes take place near the surface in the zone of activity, and the changes at the lower depths are relatively minimal.

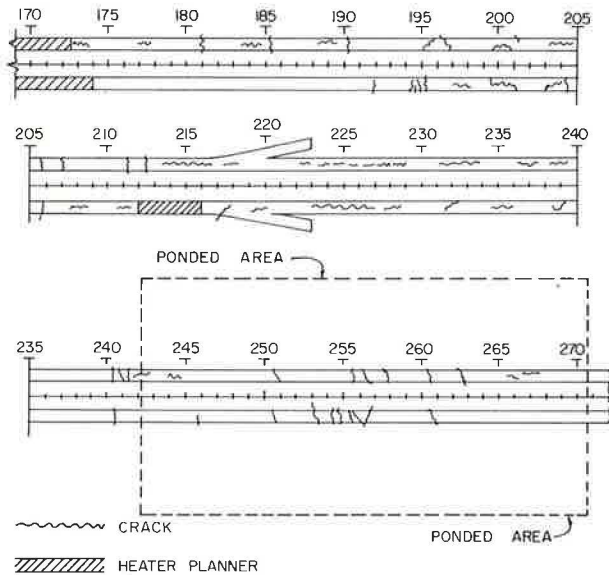
Figure 8. Road inventory.

A road inventory has been made through the test area in the last 2 years. The ponded area has shown less need for major repairs and less major cracking. Heater-planner work areas that indicate the need to reduce a significant swell in the roadway surface have been required only in nonponded areas.

Though cracking has occurred on roadway surfaces over the ponded subgrades, it has not been of a prolonged nature. The cracks that have occurred there are relatively short and usually transverse. The nonponded areas of the test section show more prolonged cracking, both longitudinal and transverse, and require heater-planner repair work. Recent records show the pattern that began to evolve in the first examination (Figure 8).

An attempt to relate some of these observations of roadway conditions to the elevation-rod movements showed that the greatest amount of pavement repair work and apparent distress was between stations 170 and 175, but that these sections had little rod movement compared to those from stations 242 to 255. However, the sections over the ponded areas had also made use of the select material of low plasticity index, which contributed to those pavements relative lack of distress.
