Laboratory Static Load Tests on Five Sunshine Skyway Bridge Girders

Morris W. Self, Department of Civil Engineering, University of Florida, Gainesville

The Sunshine Skyway that crosses the entrance to Tampa Bay south of St. Petersburg, Florida, on a 6.5-km (4-mile) bridge consists of two separate two-lane structures constructed primarily of prestressed concrete girders on reinforced concrete pile bents. The older of the two structures was completed in 1954 and was one of the earliest of its type in the U.S. The girders were post tensioned with steel bars grouted in steel conduits, but spalling and rusting were observed before the bridge was 20 years old. Florida Department of Transportation engineers investigated the structural integrity of the bridge and transported six girders to the University of Florida in Gainesville for laboratory tests. Five of these girders were tested under static loads to determine ultimate flexural capacities, and two were found to be extensively spalled with corroded prestressing bars. These two were the only ones to exhibit a premature fracture of the bars. The tests indicated that no serious loss of strength would be likely to occur before extensive

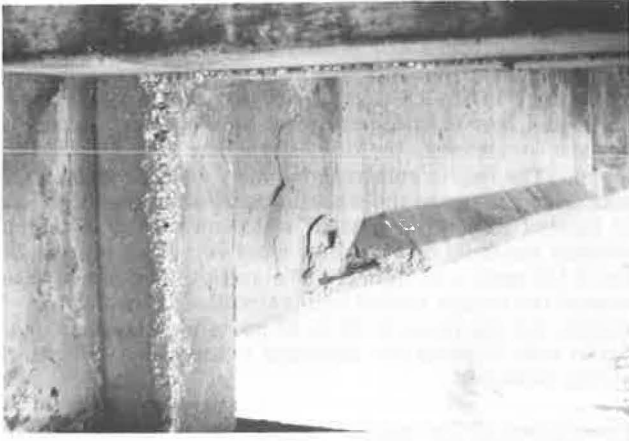
As a result of frequent exposure to chop and northeasterly winds, the eastern sides of the girders show appreciably more cracking, spalling, and corrosion than the western sides. Most of the deterioration occurs near the ends of the spans, where waves strike the pile bents and splash up against the lower girder flanges. The end blocks are reinforced with vertical stirrups and longitudinal tie-bars. The lower tie-bars extend into the tapered region where the girder section changes from rectangular to I-shape. Here the concrete cover is as little as 6 mm (0.25 in).

Saltwater penetrating this thin layer of concrete produces corrosion and expansion of the steel and spalling of the concrete and further exposure to corrosion. Eventually the prestressing conduits become exposed, and corrosion progresses down the length of the conduits and penetrates the prestressing bars. Concrete cover over the conduits varies from about 13 to 32 mm (0.5 to 1.5 in). In many girders several meters of conduit were disintegrated, and in a few girders the prestressing bars had reduced in section to the point where they fractured under the prestress force (these girders have been replaced). Figures 1 and 2 show typical spalling and corrosion of girders.

Figure 1. Typical concrete spalling and steel corrosion in bridge girders.

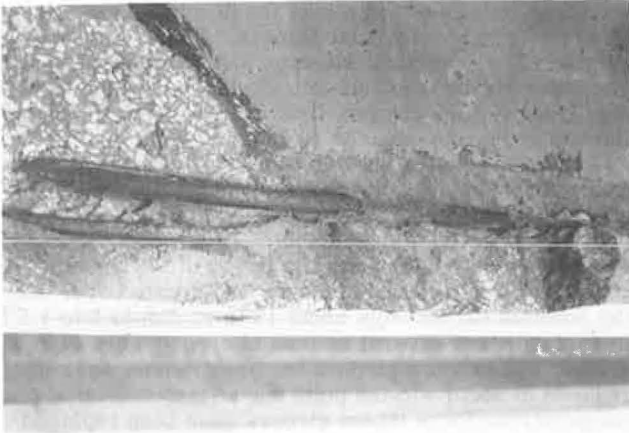
Figure 2. Exposed and corroded prestressing bar in girder lower flange; lower bar is tie bar from end block.

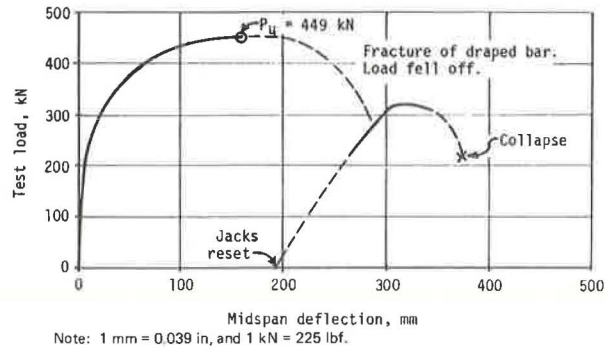
Figure 11. Test of girder 171-S3, one-third point load, showing one lower bar extensively corroded.

This girder exhibited evidence of extreme corrosion of the prestressing conduits and bars at one end of the span. One side of the lower flange was spalled from the end block for a distance of about 2.2 m (7 ft), exposing badly rusted conduit and about a meter of rusted prestressing bar. The rusted surface of the bar was irregular, and the rust penetrated about 3 mm (0.12 in). The girder web was severely cracked at the level of the upper inclined prestressing bar. A single crack through the web followed the bar from the end block to the diaphragm

The test data are plotted in Figure 11. The first crack occurred under a load of 205 kN (46 000 lbf). The lower flange cracked vertically at the load point, and the crack progressed diagonally upward through the web as the test continued. As the load approached 445 kN (100 000 lbf), diagonal tension and flexure cracked the web extensively throughout the end region. At 449 kN (101 000 lbf), we heard the upper bar fracture, and the load quickly fell off to 294 kN (66 000 lbf) with a rapid increase in deflection. Later inspection revealed a brittle fracture of the upper bar at the load point and at a point on the bar where the surface had eroded to a depth of about 2 mm (0.08 in). After releasing the load, re-setting the jacks, and reloading, a second bar failed at about 311 kN (70 000 lbf), and the girder collapsed. The second bar to fail was the one that had been initially exposed by spalling of concrete. The break occurred in the region of exposure near the end block.

A bond failure between the bar and the conduit permitted the bar to slide several millimeters as the beam "opened up" at the load point. This bar also failed by brittle fracture in a region of reduced cross section because of corrosion. The third bar was not corroded or rusted, and it failed ductily with extensive necking.

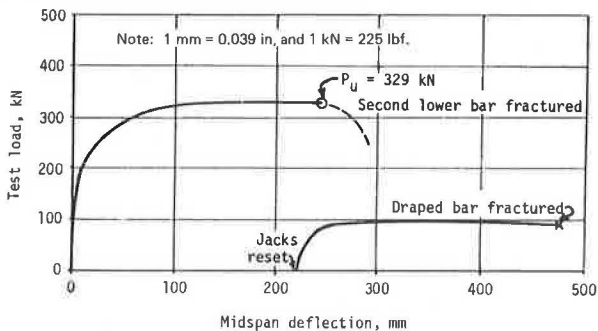
Of the six girders removed from the Skyway bridge, 139-S3 was most extensively corroded. One side of the lower flange was spalled from the end block for a distance of about 3 m (10 ft), exposing badly rusted conduit, rusted prestressing bar, and rusted end block reinforcement. One prestressing bar had completely fractured as a result of extensive rusting. There was a 2-m (6.6-ft) long, barely visible crack running parallel to the lower prestressing bars on the side opposite the spalled side. After the load test, the steel was exposed and revealed extensive rusting of the conduits of both lower bars for an additional meter beyond the point exposed by the pretest spalling.

The test data are plotted in Figure 12. The first crack occurred at a load of 178 kN (40 000 lbf). The lower flange cracked vertically at the load point, and then the crack progressed diagonally upward through the web as the test continued exhibiting the typical diagonal tension crack. At a load of 320 kN (72 000 lbf), the cracks were so large we could see the prestressing bars in the flange and web. At 329 kN (74 000 lbf), the remaining lower prestressing bar fractured and the load

Figure 12. Test of girder 139-S3, one-third point load, showing one lower bar fractured before test.

As was expected, the draped bar, which showed no evidence of corrosion, failed ductily with extensive necking. The lower bar failed by brittle fracture in a region where it was pitted by corrosion.

In girder 139-S3, one of the prestressed bars fractured before the girder was removed from the bridge. As expected, the girder suffered a 33 percent loss of strength as a result of the missing bar. Of the remaining two bars, one was corroded and failed by brittle fracture at near ultimate strength, and the other failed ductily with no evidence of corrosion.

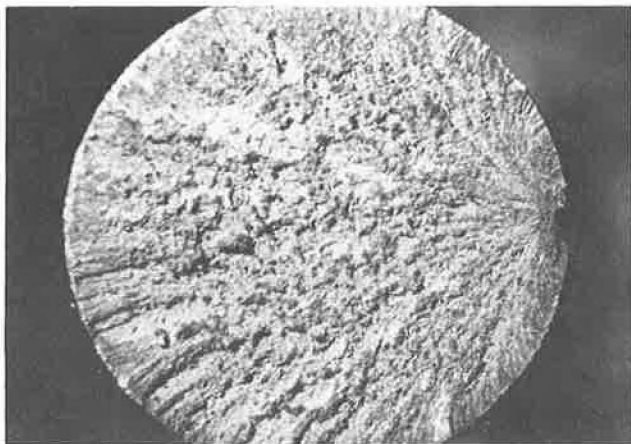
Figure 14. Typical brittle fracture of Macalloy bar.

Girder 171-S3 failed under a test load 8 percent below the theoretical capacity. A prestressed bar began fracturing at a point of corrosive pitting on the bar surface. The failure surface, magnified about five times, is shown in Figure 14, which clearly shows the propagation of the brittle fracture from the surface pit. The bars that were not pitted by corrosion failed in a ductile manner with necking and the associated loss of section area before breaking. Figure 15 shows the typical ductile

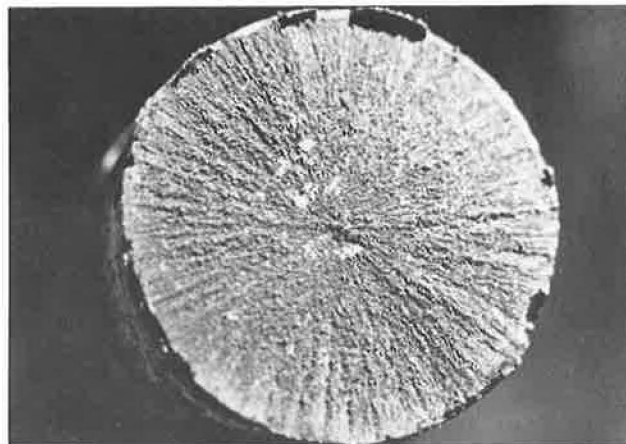
Figure 15. Typical ductile failure of Macalloy bar.

failure surface, when fracture propagates from the center of the section.
