Case Histories of Unsatisfactory and Abnormal Field Performance of Concrete During Construction

Bryant Mather, U.S. Army Engineer Waterways Experiment Station, Vicksburg, Mississippi

Case histories are given relating to concrete produced in connection with the construction of three different projects. One was a major building, the second was an airfield pavement, and the third was a highway bridge deck. The projects are located in three different states on the East Coast of the United States. These case histories have in common that a major part of the problem in each was low strengths of test cylinders. In the first case, defective concrete containing the wrong aggregate and made to the wrong mixture proportions was removed and replaced. In the second case, the problem was traced to the presence in the aggregate of aluminum particles from the bodies of the dump trucks in which it had been transported. In the third case, there were many causes of loss of control of the concrete properties; an instance was found of greater variation of air content in a smaller volume than ever reported previously. In this case, the safety factor in design allowed the concrete to remain in the stru

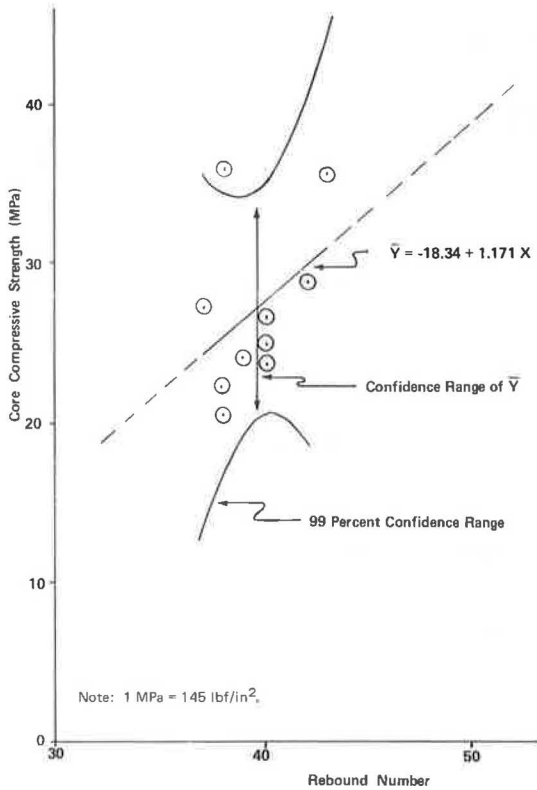
Rebound-hammer tests were conducted on areas adjacent to the locations of the pairs of drilled cores. Calibration curves were made for the rebound-number versus core-strength relation for each class of concrete (Figures 1, 2, and 3).

Figure 1. Core strength versus rebound-number calibration: 28-MPa mixture.

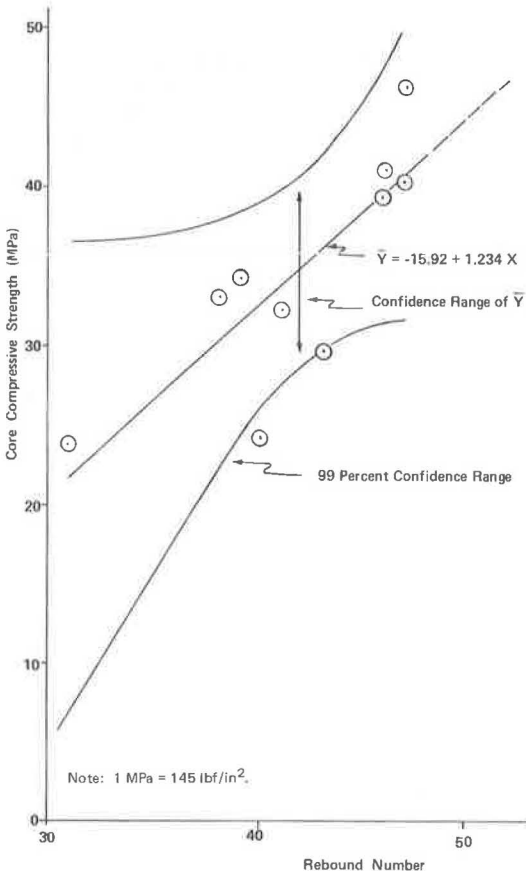
Figure 2. Core strength versus rebound-number calibration: 34.5-MPa mixture.

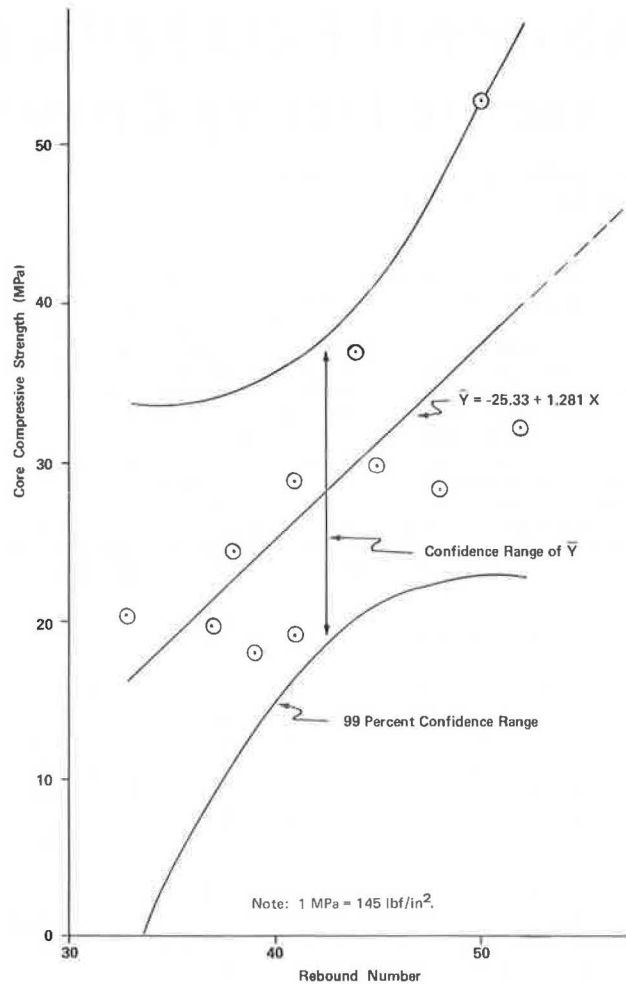
Figure 3. Core strength versus rebound-number calibration: 38-MPa mixture.

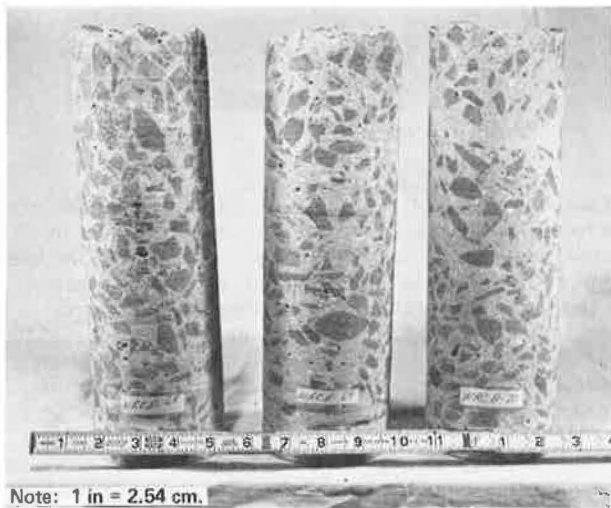
Figure 4 shows cores of concrete containing the approved aggregate. Figure 5 shows cores of concrete

Figure 4. Cores from concrete made with approved aggregate.

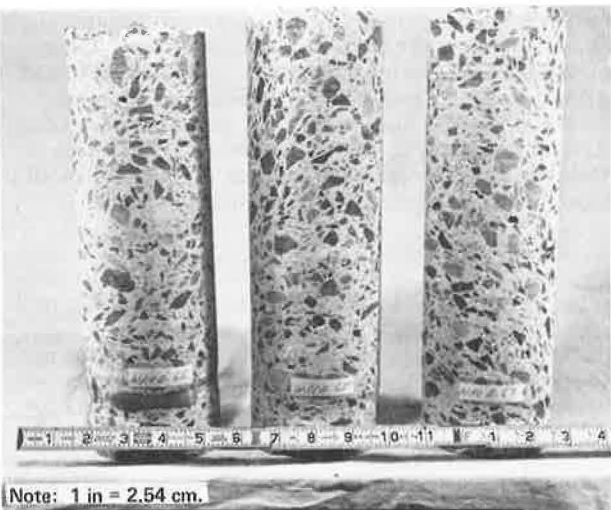
Figure 5. Cores from concrete made with inferior aggregate.

containing inferior aggregate from a different source and of a different grading.

This experience suggests a method for using a non-destructive test—i.e., the rebound hammer—to estimate the range of strength of concrete in a structure. In this case, the contractor was notified as to the known extent of nonacceptable concrete by drilling and testing cores, and he then removed and replaced those portions of the structure.

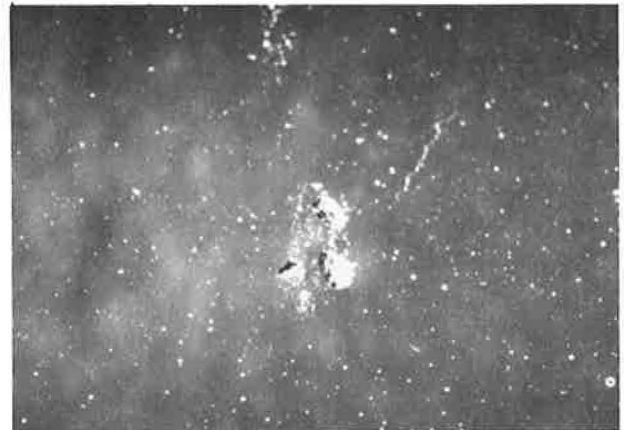
Figure 6. Aluminum particles from aggregate stockpile.

Meanwhile, it was established that grains of metallic aluminum were present among the fines accompanying the coarse aggregate as it was dumped into stockpiles at the job site (Figure 6). It was also confirmed that these particular aluminum particles evolved hydrogen gas when immersed in an alkaline solution (Figure 7) and that there is a direct relation between decreased flexural strength and increased air content of hardened concrete as determined by microscopic examination. So far as is known, this is the first recorded case of generation of hydrogen gas in concrete by aluminum particles present as a contaminant in the aggregate after transportation in aluminum-body trucks.

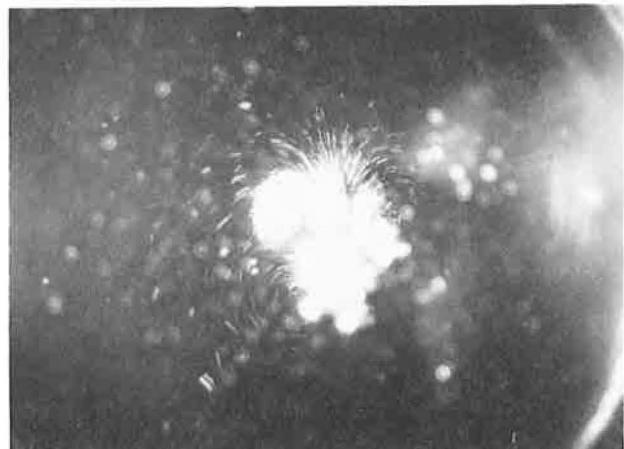
Figure 7. Hydrogen evolution by aluminum particles in alkaline solution.

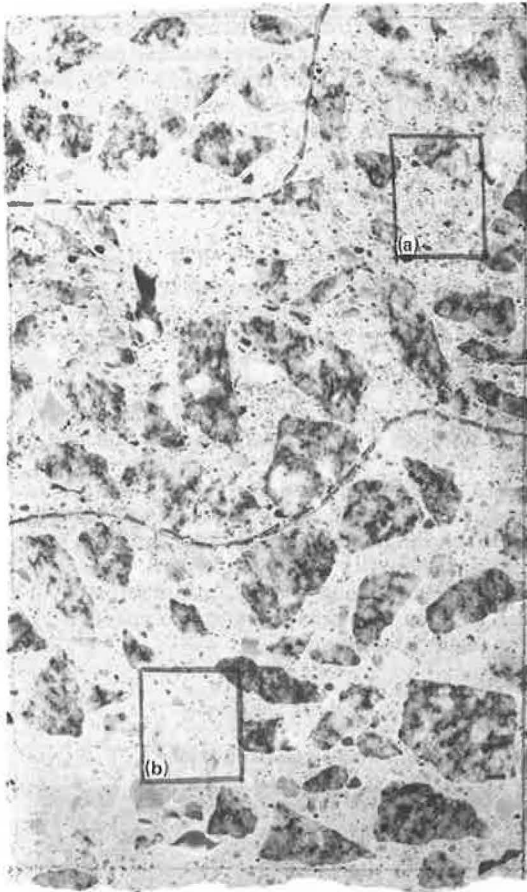
Figure 8. Slice through full thickness of core showing zones of different air content: (a) 12 percent and (b) 3 percent.

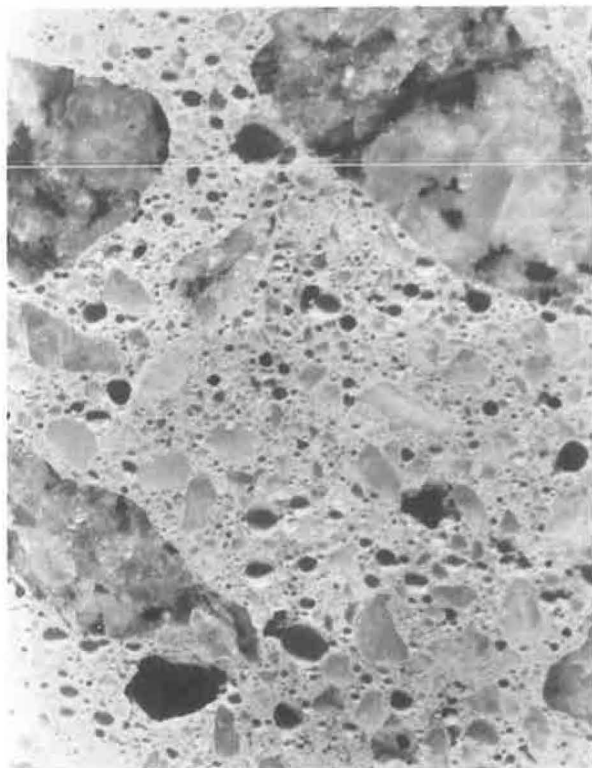
Figure 9. Enlarged view of 12 percent air-content zone (Figure 8a).

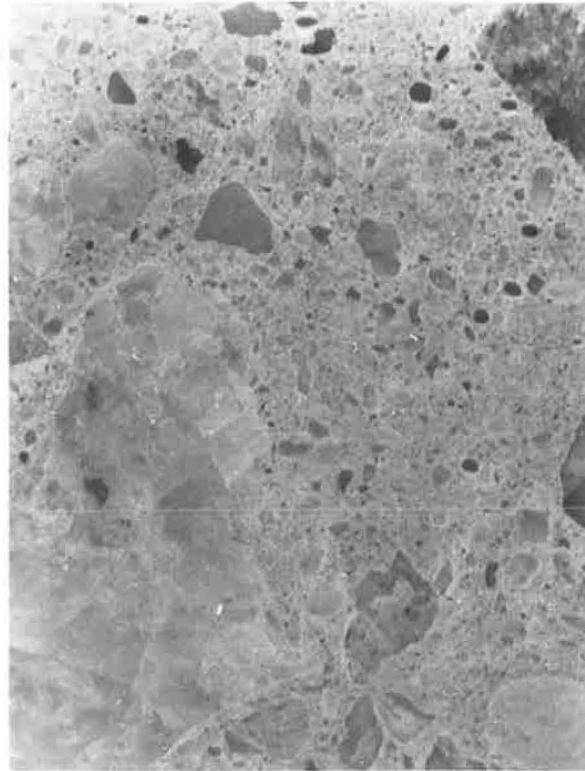
Figure 10. Enlarged view of 3 percent air-content zone (Figure 8b).
