## Assistance of New York State Department of Transportation to Railroad in Solving Soils and Foundation Problems

Harry E. Schultz and Taylor J. McDermott, Delaware and Hudson Railway Company  
Stephen E. Lamb, New York State Department of Transportation

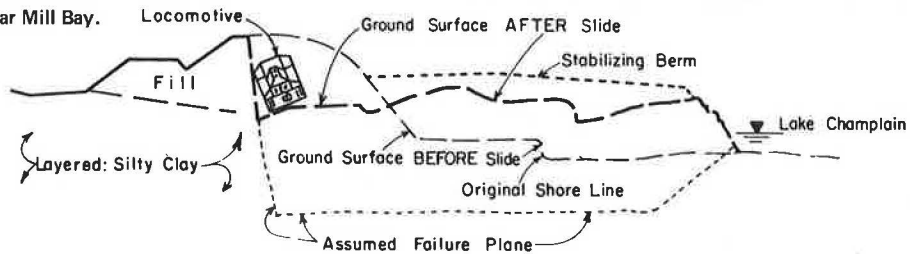
Figure 2. Section of slide: Spar Mill Bay.

crews had repaired some minor track settlement at the site. Additional settlement occurred, and the next day a northbound freight was derailed, scattering numerous cars along the track north of the future failure area. A work train was sent to the site, cleared the tracks, and unfortunately backed onto the unstable embankment-settlement area while waiting for orders. Suddenly, the embankment and locomotives dropped 6.1 m (20 ft) and simultaneously the bottom of Lake Champlain 45.6 m (150 ft) distant rose 3.5 m (12 ft) above the water. The details of this failure are shown in Figures 2 and 3. Figures 4 and 5 show the locomotives and the mud wave that exposed the lake bottom.

Soils engineers in NYSDOT were asked for an appraisal of the failure and recommendations for restoration of the embankment to reestablish main-line service. On inspection, it was found that the area was underlain by a layered silt and clay deposit and that the topography of the adjacent hillsides showed evidence that this was an area of ancient landslides. It was concluded that the initial settlements observed had been caused by minor movements in the underlying clay. Although the embankment had been stable for 30 years, high groundwater conditions may have caused minor plastic movements in the foundation soil and contributed to the settlement that caused the derailment. However, the major movement was caused by the mass of the locomotives and the vibrations of the idling engines. These vibrations apparently caused the liquefaction and complete loss of strength in an underlying silt layer that resulted in the spectacular failure. The recommendations were to construct a stabilizing counterweight berm over the mud wave to the elevation shown in Figure 2. After the berm was completed, the embankment was brought back to grade. This was done in 2 d, and the area has presented no problem during the last 14 years.

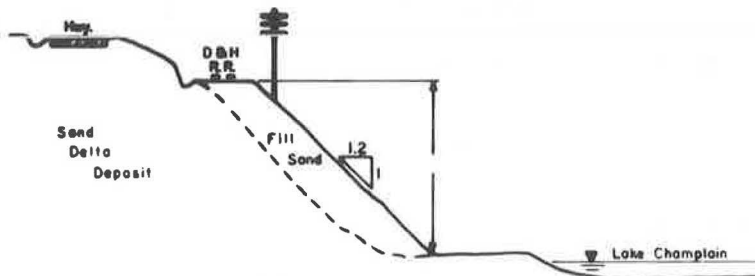
Figure 6. Conditions before failure: Port Kent.

At a location further north at Port Kent, a failure occurred in the spring of 1971. At this location, the roadbed is on a side hill fill 12 m (40 ft) above Lake Champlain, as shown in Figure 6. The embankment was constructed 50 years ago against the face of a delta deposit of sand laid down by postglacial rivers flowing from the Adirondack Mountains. Suddenly, during the spring thaw, a portion of the fill liquefied and slumped

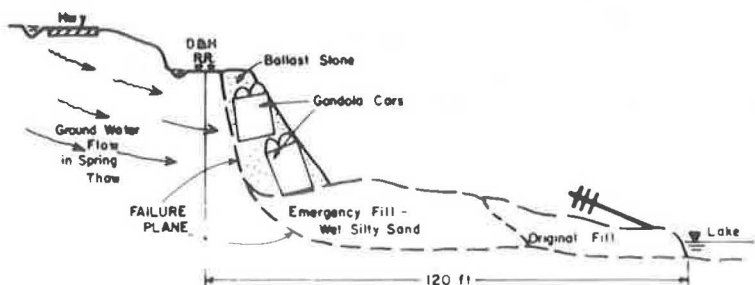
Figure 7. Failure and repair sequence: Port Kent.

into the lake. Railroad maintenance forces placed an emergency fill, but this also became unstable and flowed into the lake.

NYS DOT soils engineers were requested to make recommendations for stabilizing this failure of the main-line embankment. An examination of the site showed that groundwater was emerging from the slide face. This groundwater flow must have increased significantly immediately before the failure; the winter frost had just become completely thawed, and the accumulated surface groundwater could flow downward to the delta deposit where the natural direction of subsurface drainage was toward the lake. The embankment had less permeability than the natural deposit, and the groundwater head and seepage forces caused the fill to become unstable at its steep angle of repose, which resulted in the failure. The solution recommended was the reconstruction of the embankment with a pervious material that would allow drainage and a lightweight material that would reduce the load on the unstable fill. Readily available materials were ballast stone to provide permeability and a number of old gondola-car bodies to decrease the embankment weight. The embankment was constructed to grade with the cars upside down as shown in Figure 7. The main line was reopened to traffic in 2 d, and the embankment has been stable since then.
