## WHAT HAS BEEN LEARNED FROM THE FIRST PRESTRESSED CONC. BRIDGES-REPAIR OF SUCH BRIDGES

Heinz P. Koretzky, Pennsylvania Department of Transportation

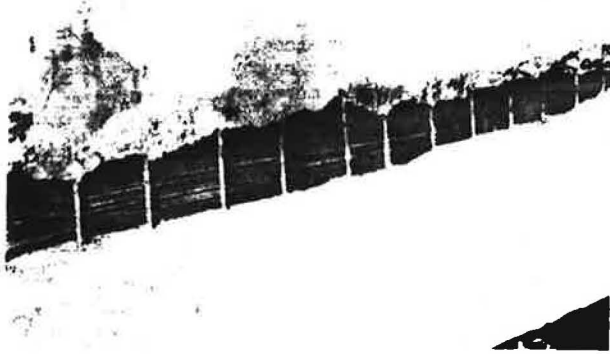
Slide 9. Construction problem in 1st cast girder.

Looking at slide 9, it is obvious what we would do today with such a girder, but at that time, such thoughts were different. I am quoting from the report which indicates that in spite of poor concrete surfaces, honeycombs, exposed reinforcing steel bars, cold joints in bay 4, displacement of vertical web reinforcing steel and displacement of tendon cavities, it was decided that they should proceed with prestressing. The thought at that time was, "if the girder was structurally deficient, the high prestressing forces later to be applied to it would cause the girder to fail." The prestressing was carried out without difficulty, leading to the conclusion that the observed imperfections were of less

significance than originally thought. Therefore, the girder was repaired for appearances sake and incorporated into the bridge.

Early in load testing, the first cast girder, horizontal cracks unexpectedly appeared near the junction of web and bottom flange on one face. The cracking was not considered to be of any particular consequence, but nevertheless was reported by Gustave Magnel. (7)

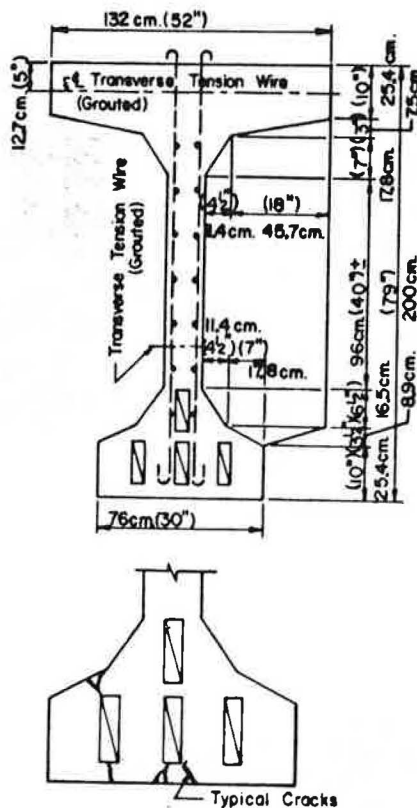
Figure 4. Typical reinforcing in Walnut Lane Bridge girder - also typical cracks shown in large scale detail.

Fig. 4 shows the Walnut Lane Bridge fascia beam cross section. This should be compared with slide 9.

"In November, 1957, a routine inspection made by members of the Maintenance Division of the City's Department of Streets, revealed the existence of longitudinal cracks in the fascia girders of the main span. In addition, there were a number of very localized, fine cracks, hardly visible when observed through binoculars from the floor of the valley some 60 feet below the bridge. There was no pattern to these localized cracks since they occurred erratically throughout the bridge.

The strong discoloration of the concrete in the vicinity of the cracks indicated that they had been present for some time. It also appeared that the cracks had been pointed with grout at some previous time, even though there is apparently no record of this procedure having been carried out. In any event, it was determined that none of the cracks would endanger the structural integrity of the bridge. After the size, type and location of the cracks had been recorded, the City then decided to apply a cement coating to the exposed areas of the girders for the sake of appearances.

Over the next ten years, the cement coating weathered to a point where the cracks again became visible. During a routine inspection made in November of 1967, it was observed that the longitudinal cracks in the South Fascia Girder of the main span seemed to have lengthened and widened. In view of this situation, representatives of the Department decided to inspect all of the girders at close range, and to make and record their observations as accurately as possible."

My office, in cooperation with the office of the Philadelphia District Bridge Engineer, made its own inspection of the bridge, and prepared new repair plans for letting, which relied heavily on the epoxy pressure injection process to seal cracks. The repair/seal work was done by contract during 68/69 and cost about \$140,000. (16)

For the Walnut Lane Bridge, the injection was generally successful. The loose unreinforced concrete shown in Fig. 4 stayed glued together. The tendon ducts were sealed from further corrosion. However, some cracks had to be reinjected and some of the epoxy did not harden completely. The progressively increasing girder cracking was slowed down considerably. I witnessed some of the reinjection of those cracks by the original epoxy injection contractor, which was done free of charge.

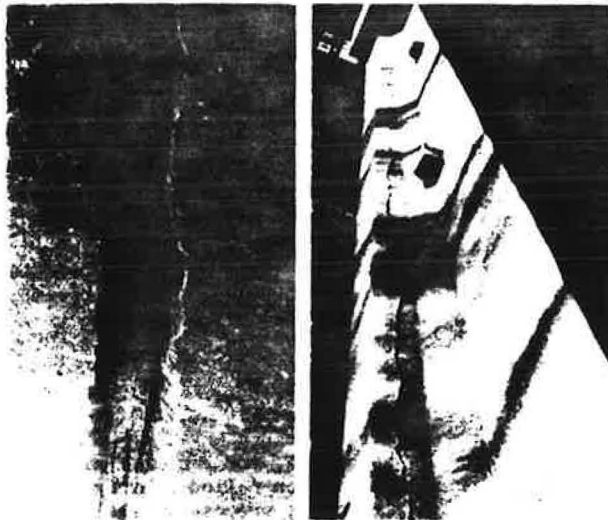
Slide 12. Space between cracks exposing duct space. Slide 13. Crack in the top of bottom flange.

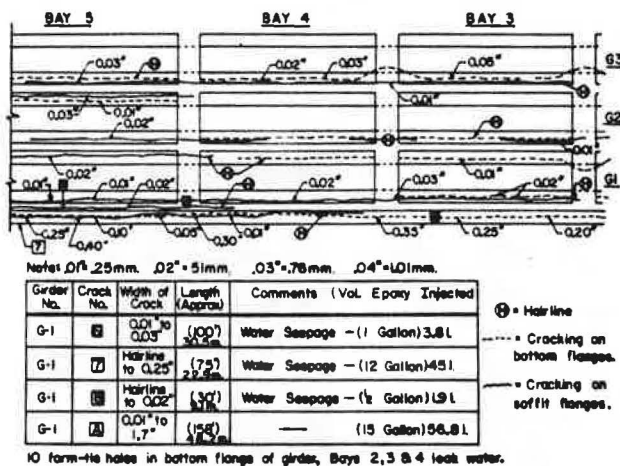
Figure 5. Composite of cracks in a selected area found on Walnut Lane Bridge.

Some of the effects of the built-in latent defects previously discussed in connection with Slide 9 are shown in Fig. 5. This figure shows a composite of the cracks and defects selectively copied from construction plans dated October 4, 1968, and shows cracks observed by the Department, and supplemented by cracks recorded on plans prepared by the repair contractor, and dated January and February 1969. The contractor's plans showed cracks found through close visual inspection and listed observations made during the injection process.

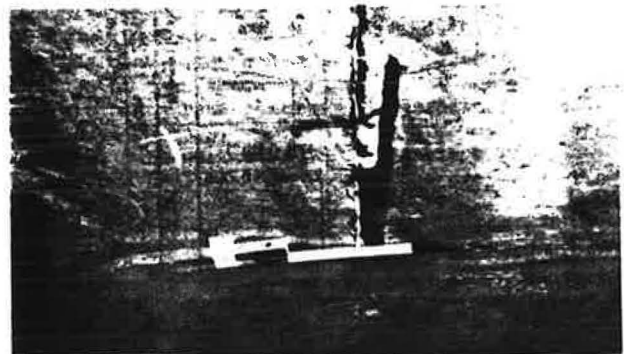
Slide 15. Hershey Bridge with vacuum cured surfaces.

Slide 15 shows the bottom of the Hershey Bridge Beam and clearly shows the imprint left by the vacuum curing process used for this beam and for all beams produced in Pennsylvania from 1951 thru 1955, and for some bridge beams produced by a certain plant to 1959.

The Hershey Bridge Beam (slides 15 to 17) has not been repaired at all and this writer did not note progressive corrosion in the strands exposed by the wide cracks but feels that mortar or epoxy sealing in this instance would be a cosmetic procedure and would not protect the tendons properly unless the beam is pressure-injected with epoxy through-out and the voids are packed with epoxy mortar.

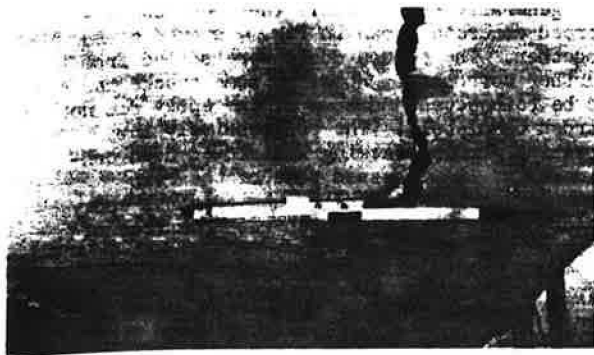
Slide 17. Fascia beam in distress.

Fig. 7 shows the beam cross section as re-structured from existing documents. Slide 17 shows the cause for the surface distress in the fascia beam shown in slide 16, namely the damage caused

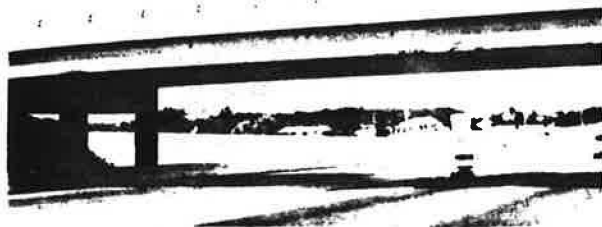
Slide 23. General view of traffic damage to a prestressed concrete adjacent box beam superstructure.

After appropriate stress analysis it was determined that for the box beam bridges cosmetic repairs were all that was required. Cracks were sealed, exposed strands received protective coating and holes were patched.

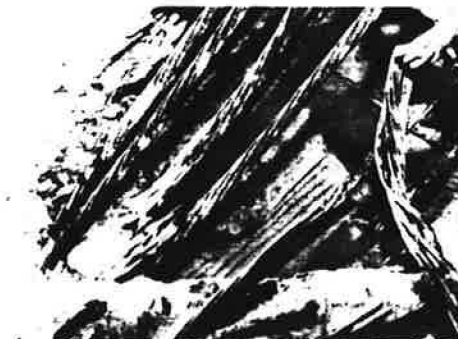
Slide 28. Detailed closeup showing also the cardboard void inside the box beam.

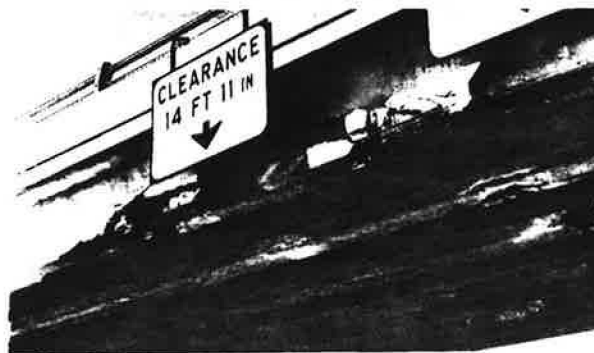
Slide 29. General view of repeated traffic damage to a prestressed I-beam superstructure.

The same procedure was deemed acceptable for the I-beam bridge. Cosmetic repair for the fascia beam was not considered feasible and therefore it was determined to replace the fascia beam in its entirety.

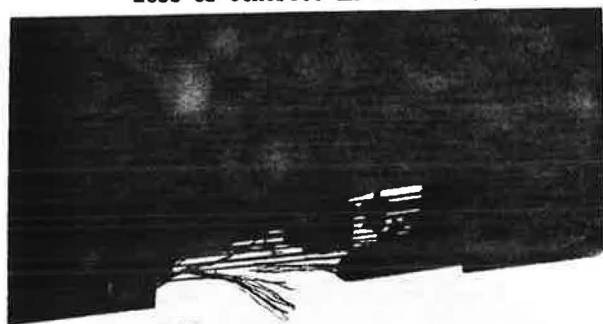
Slide 31. Closeup of the damage, showing ruptured strands, exposed stirrups, and complete loss of concrete in web area.
