## SOME CONSIDERATIONS IN WIDENING AND REHABILITATION OF BRIDGES

M. H. Soto, Chief Bridge Engineer, Gannett Fleming Corddry and Carpenter, Inc.

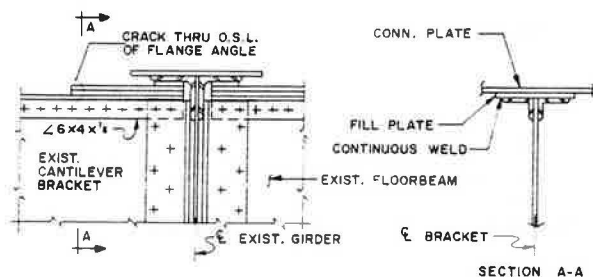
During the initial stages of construction, cracks were discovered in the top flange of the cantilever brackets. The cracks started from the toe of a continuous fillet weld between a fill plate and the flange angle, with the crack propagating through the outstanding leg of the angle. These cracks were, we believe, just beginning to occur. It was considered unlikely that they would have been missed in a recent bridge inspection or by the painters who had also recently painted the structure. (See Figures 10 & 11).

The cause of these cracks became readily apparent when it was discovered that for several of the approach spans, the fill plate between the flange and tie plate had been inadvertently welded for its full length along the sides by an 8-mm (5/16-inch) fillet weld instead of by intermittent welds as was intended. At other locations where the intermittent welds had been used, these had failed and the stress transfer from flange to tie plate was through the rivets as intended.

At the locations where the continuous weld was employed, the welds were probably carrying the total load. This was the tension flange and the stresses were not excessive, but the stress ranges induced in the welds were obviously high enough to initiate fatigue failure. Where failures had occurred, these were repaired with splice angles (Figure 12). At all other locations, the weld was removed and the material ground smooth. The

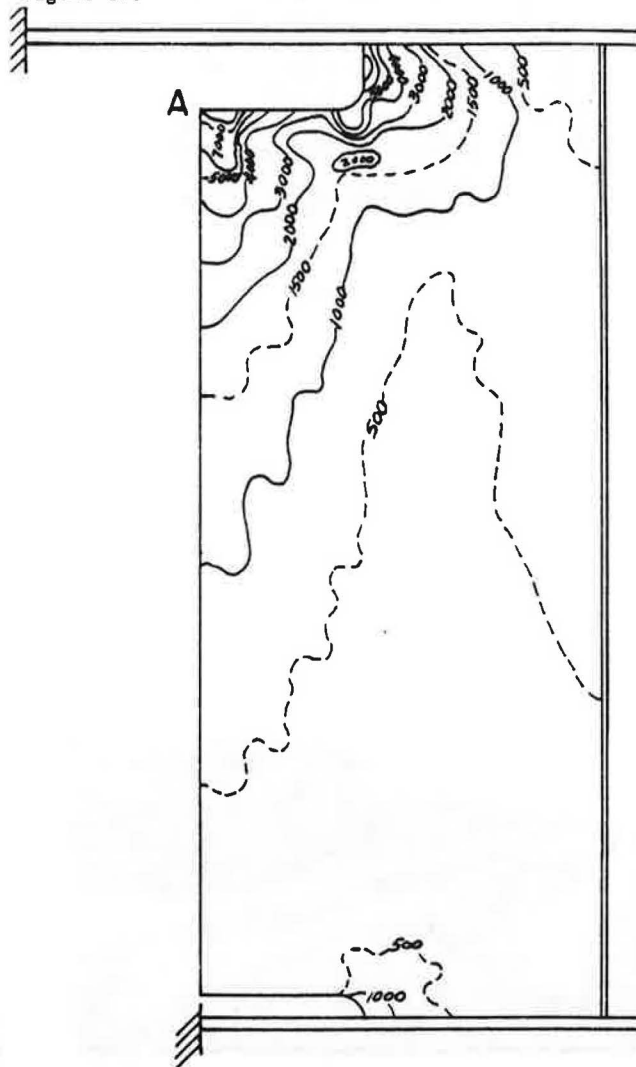
From the voluminous results obtained, maximum principal stresses were determined. The contours for those stresses have been plotted and are shown on Figure 17. Near point A, the level is 57 MPa (8.2 ksi). By extrapolation, it has been determined that for an HS20 vehicle located in the left-hand passing lane, at the near girder to floorbeam connection, the floorbeam web distortion stress level would be 69 MPa (10.0 ksi) which is well below that tolerable for fatigue at 2,000,000 cycles. Similarly, an HS20 vehicle located in the right-hand traffic lane (not the shoulder) would cause a floorbeam web distortion stress at the exterior girder to floorbeam connection of 54 MPa (7.9 ksi) which is well below that considered tolerable for fatigue at "over 2,000,000 cycles".

It was concluded that cyclical web stresses generated in the floorbeam associated with elimination of the connection of the strap plates to the girders are low enough to create no difficulty in fatigue. However, it was requested that the details for the new structure be such that the displacement-induced secondary stresses (5) in the floorbeam web will not exceed the "threshold" 28 MPa (4.0 ksi), a value identified for the Lehigh Canal Bridge.
