RENOVATION OF LIONS' GATE BRIDGE NORTH VIADUCT

Peter R. Taylor, Buckland & Taylor Ltd., Consulting Structural Engineers, Vancouver, Canada

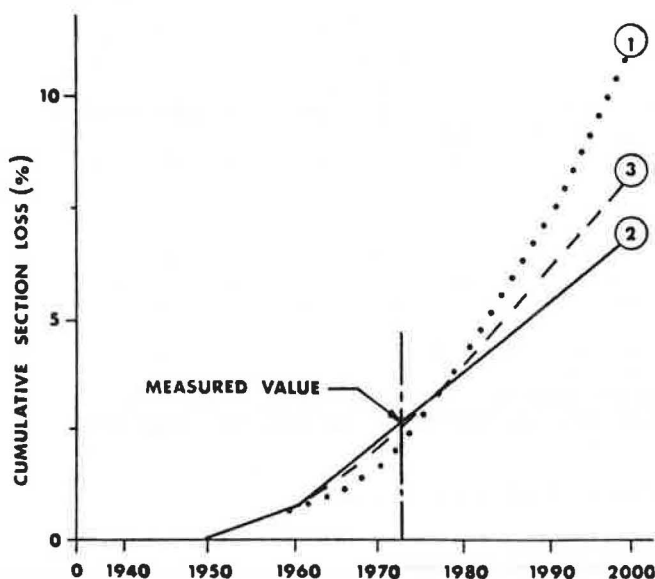
Many approaches were considered for inhibiting the corrosion attack on the viaduct support steel. These ranged from encasing the structure in concrete to the use of sophisticated non corrosive deicing compounds. A study was made of the extent of existing corrosion and then three future section loss curves were projected, see Figure 1. Curve 1 shows a continuation of the existing corrosion rate, Curve 2 shows a reduced rate and Curve 3 an intermediate situation.

Figure 1. Estimated cumulative section losses due to corrosion.

It was concluded that a moderate reduction in the existing corrosion rate would leave adequate structural reserves for four or five more decades of bridge life at present live load levels. It was therefore decided to seal the deck and to take steps to duct the deicing solutions down to ground level away from the support steelwork and to carry out blast cleaning and repainting of this steelwork to bring it to a common level of protective coating. It was considered impractical to attempt to seal all existing corrosion cells in the bridge.
