## RETROFITTING FATIGUE DAMAGED BRIDGES

John W. Fisher, Alan W. Pense, Robert E. Slockbower,  
and Hans Hausammann, Lehigh University

This paper examines continuing laboratory and field studies on ways to retrofit fatigue damaged members. Results of a pilot field study on two bridge structures with known fatigue cracks at the ends of cover plates are reviewed. Fatigue damaged members were retrofitted by peening and gas tungsten arc remelting the weld toe. The initial retrofit is summarized and the results of subsequent inspection after 1½ years is reviewed. Also discussed is the retrofitting of several more bridges by peening weld toes on a more extensive scale. In recent years many highway and bridge structures have experienced fatigue damage from out-of-plane displacements. This has resulted in web cracking at the ends of transverse stiffeners and floor beam connection plates which were not welded to tension flanges. Cracking as a result of out-of-plane movement is reviewed and several examples of cracking in a number of bridges is discussed. Nearly all of these fatigue damaged members have been repaired and retrofitted by drilling holes in the web plate at the ends of the hori

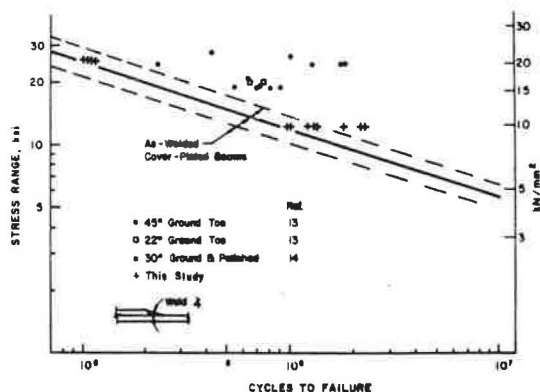
Figure 1. Effect of grinding weld toe on fatigue strength

Grinding the weld toe with a burr to provide a smooth transition and minimize the size of the initial discontinuities was the least reliable method. Some improvement was noted at the lower stress range levels as illustrated in Figure 1, but none at all

at the highest level of stress range. Similar results were obtained in earlier studies on as-welded details which indicated that erratic results could be expected.

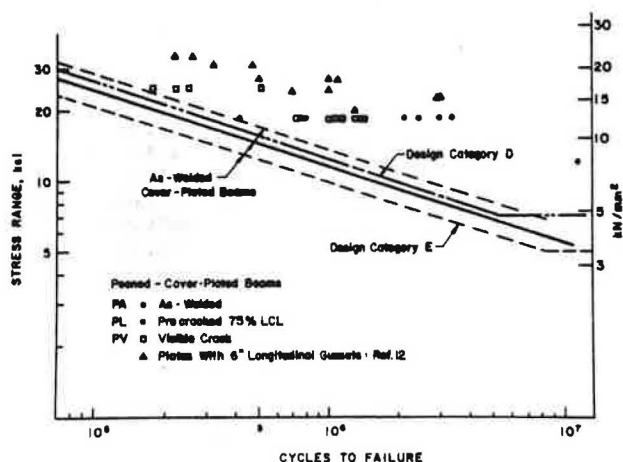
Figure 2. Effect of Peening on Fatigue Strength

The results of all beams with peened details that were tested under a low minimum stress level [13.8 MPa (2 ksi)] or that were peened under their minimum load, are summarized in Figure 2. Those details that were peened in the absence of dead load are not plotted in Figure 2. When the 68.9 MPa (10 ksi) minimum stress was applied to these beams it eliminated most of the beneficial effects of the peening treatment.

The test points designated as PA were as-welded beams treated prior to any fatigue testing. The test points designated as PL were for beams that were first precycled to 75% of the lower confidence limit of as-welded-untreated beams. After precycling these beams were then treated. They had fatigue cracks of various sizes. Two series of precracked beams (PL and PV) and one series of as-welded beams (PA) were tested to determine the effectiveness of peening. Cracks as large as 19 mm (0.75 in.) length and between 1.3 and 3.8 mm (0.05 and 0.15 in.) deep were observed prior to peening. After peening the precycled cracks were no longer visible. Inspection of the fracture surfaces indicate that movement occurred between the crack surfaces to a depth of 3.8 mm (0.15 in.). The precracked details usually failed from continued crack growth from the original crack, but at a slower rate. In a few cases failure was observed from the weld root. It is readily apparent that substantial increases in life were achieved for as-welded and precracked beams after peening, when peening was applied in the presence of

dead load. The fatigue strength was increased by at least one design category(6)

Also shown in Figure 2 are test results on small plate specimens with 152 mm (6 in.) longitudinal gussets welded to their surface. These tests were reported by Gurney and were made on as-welded specimens(5). The studies on welded attachments reported in NCHRP Report 147 have demonstrated that the attachment length has a significant effect upon fatigue strength. Hence, these 152 mm (6 in.) longitudinal gusset plates were expected to exhibit slightly more life than those provided by cover-plated beams. This was confirmed by the test data. All of the peened plate specimens fell near the upper limit provided by peened cover-plated beams. This suggests that other details can be expected to exhibit a similar increase in fatigue strength when subjected to peening at the weld toe.

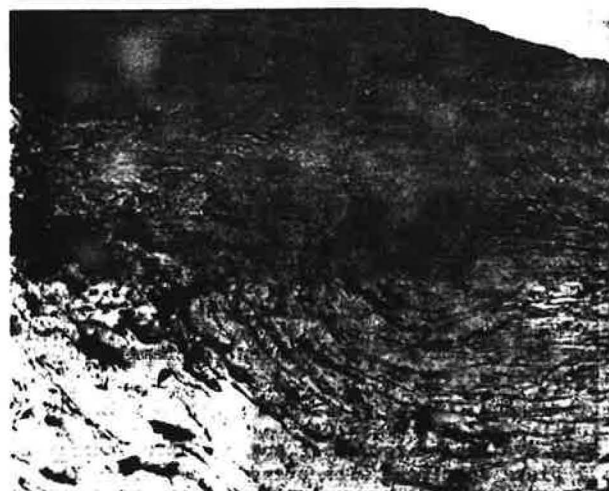
Figure 3. Lap-type defect in a peened weld toe

Transverse sections through several peened weld toes, revealed numerous lap-type defects which were the result of extensive surface deformation. An example of this deformation is shown in Figure 3. The depth of these laps was in the order of 0.05 mm (0.002 in.) to 0.25 mm (0.010 in.) which was approximately the same depth as the original slag intrusions. These defects are believed to be typical of the whole weld toe since they were found on all transverse sections.

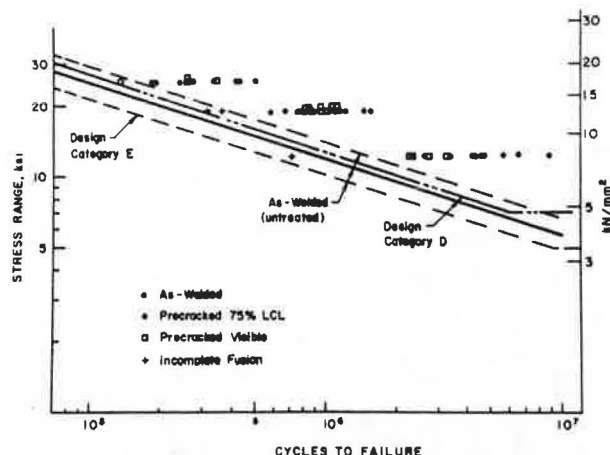
The results of all three test series are summarized in Figure 4. The test points plotted as as-welded beams were treated prior to applying cyclic loading. The test points identified as precracked to 75% LCL were all precycled to 75% of the lower confidence limit for untreated details. At that time the "fatigue-damaged" detail was treated with the gas tungsten arc remelt. In some cases no

visible crack existed. Those points indicated as visible precracked all had clearly visible cracks prior to treatment. Except for those failures in precracked beams that occurred because of failure to incorporate the complete crack into the gas tungsten arc remelt (see Figure 4), approximately the same increases in life were achieved by all specimens. None of the test series exhibited an influence of minimum stress. Stress range was observed to account for nearly all of the variation in fatigue strength.

Figure 4. Effect of gas tungsten arc remelt on fatigue strength

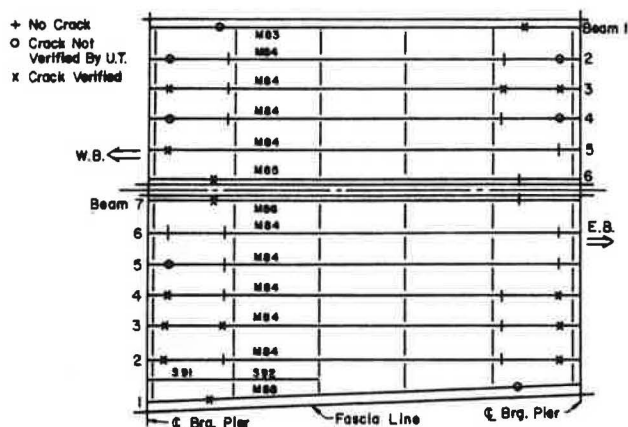
Figure 6. Plan of inspected details in span 10 Yellow Mill Pond Bridge

Figure 6 shows the approximate location of the details which were inspected in span 10 and summarizes the findings. Nine details in span 11 were also visually inspected. Indications of cracking were found at seven details. Very large cracks were observed at the east end of Beam 5 of the eastbound bridge and Beam 4 of the westbound bridge - span 11.

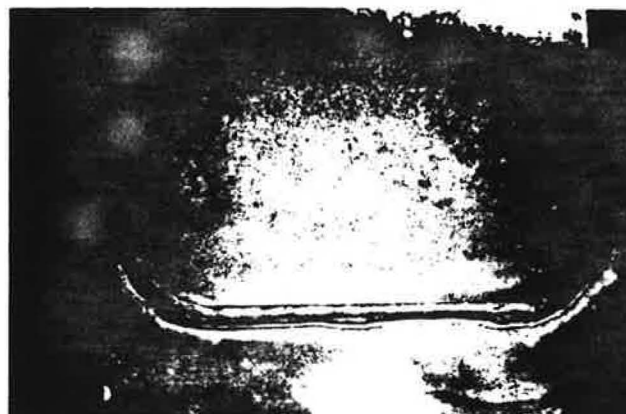
Figure 7. Peened weld toe on Yellow Mill Pond Road

Peening of the weld toe introduces compressive residual stresses. The weld toe was mechanically air-hammer peened until it was plastically deformed.

Peening was performed with a small pneumatic air hammer operated at 0.17 N/mm<sup>2</sup> (25 psi) air pressure. The end of the peening tool was radiused with a 19 mm (3/4 in.) radius about one axis and a 3 mm (1/8 in.) radius about the other axis. All sharp edges were ground smooth. Several minutes were required to peen the weld toe. Peening was continued until the weld toe became smooth. A peened weld toe at Yellow Mill Pond is shown in Figure 7. The depth of indentation due to peening was approximately 0.8 mm (0.03 in.).

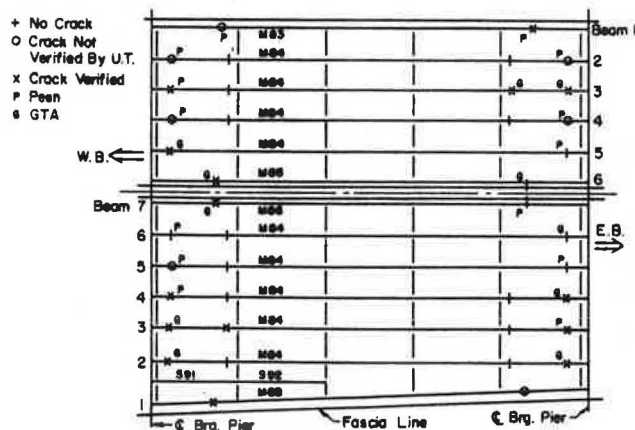
Figure 9. Repair methods on span 10, Yellow Mill Pond Bridge

Twenty-five of the cover plate details in span 10 were repaired after being inspected. Fourteen were peened and eleven were gas tungsten arc remelted. Figure 9 summarizes the type of repair which was made at each cover plate weld toe.

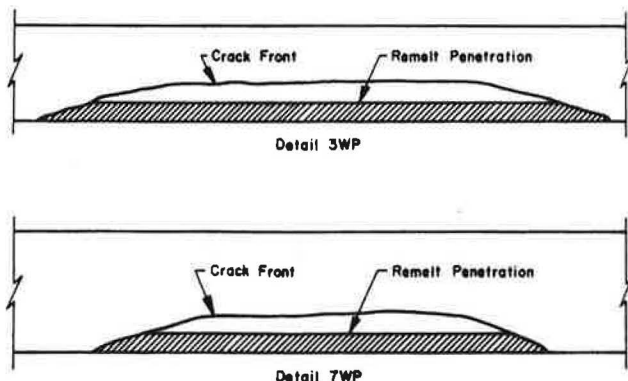
Figure 10. Crack shape for Beams 3 and 7 (1976)

The shape of the large embedded cracks at the west primary detail of Beam 3 (eastbound bridge) and at the west detail of Beam 7 (eastbound bridge) are shown in Figure 10. The stress intensity model for these embedded cracks is shown in Figure 11. This approximate model combines the solution for an eccentric crack (8) with the stress gradient correction factor,  $F_G$ , defined in Ref. 9. Utilizing this model and the crack growth rate  $da/dN = 3.8 \times 10^{-9} \Delta K^3$  ( $\Delta K$  in units of  $\text{MPa}/\sqrt{\text{mm}}$ ,  $da/dN$  in units of  $\text{mm}/\text{cycle}$ ), the number of cycles necessary for the crack to propagate through the retrofit weld toward the weld toe was estimated. It was assumed that when the embedded crack penetrated the exterior flange face it would quickly become an elliptical surface crack with the major semidiameter axis being defined by the crack shape ratio prior to retrofitting.

For this study the retrofit weld penetration was assumed to be 4.8 mm (3/16 in.). The estimated number of cycles necessary to propagate the embedded cracks through the retrofit weld at a stress range of 13.1 MPa (1.9 ksi) for Beams 3 and 7 were 7.0 and 6.7 million cycles, respectively. The elliptical surface cracks for both beams were approximately 13.5 mm (0.53 in.) deep at the beginning of the final stage of crack growth. An additional 1.0 and 2.7 million cycles would be necessary for the cracks to grow through the flange thickness for Beams 3 and 7, respectively.

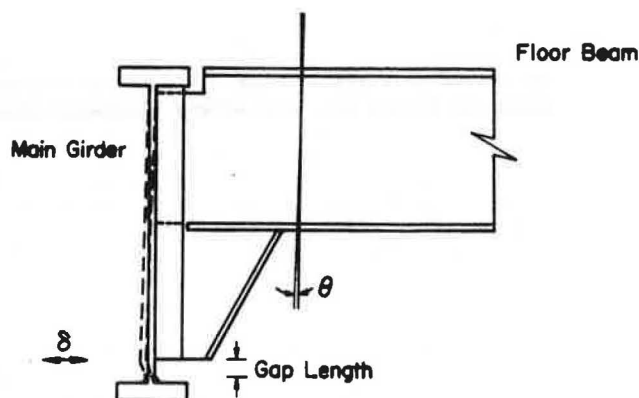
Web cracking has been observed in welded girders at the ends of transverse stiffeners and floor beam connection plates(10). These cracks are caused by out-of-plane movement at the web. Out-of-plane movement as shown schematically in Figure 12 is introduced from the end rotation and displacement of floor beams which frame into the web of the main longitudinal built-up girders and by horizontal deflections of bracing members connected with stiffeners. It can also be introduced by bending during handling and shipping. Out-of-plane movement causes large bending stresses in the short gap at the end of the stiffeners.

Figure 12. Schematic of deformation at end of floor beam connection plate

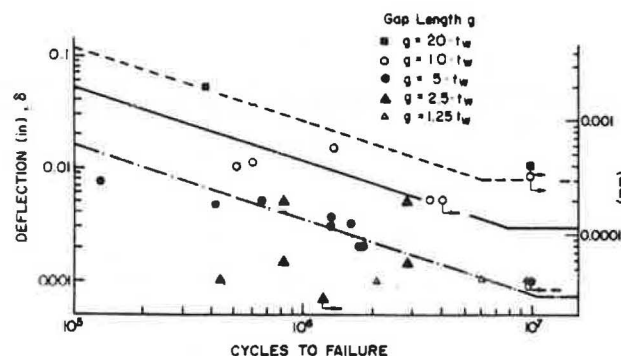
The tests have shown that the specimens crack either immediately at the end of the transverse stiffener or at the end of the stiffener weld. No cracking occurred at the longitudinal weld between the web and the flange. In Figure 13 the preliminary results for several gaps under different deflections are shown.

Figure 13. Experimental relationship between web gap length and out-of-plane displacement

The experimental data suggest that increasing the gap by a factor of two results in an order of magnitude increase in the cyclic life. If the stress range at the gap were only proportional to the deflection, i.e.
