## REPAIR OF POPLAR STREET COMPLEX BRIDGES IN EAST ST. LOUIS

Wei Hsiung, Illinois Department of Transportation

The web cracks found in the Poplar Street Complex Bridges were located at the top of the web-to-bottom flange fillet weld near the end floor beams. The buckled web was observed at the end of the girders behind the bearing stiffener. This report summarizes the results of the study which intends to determine the proper causes of the distress. It is believed that the main cause of the web crack was due to the out-of-plane movement of the web; and that the cause of the web buckling was from the eccentric reaction induced by the seized bearing pin. The repair method was developed mainly to stiffen the section and to carry the secondary stress induced from the out-of-plane movement of the web and to resist the distortion of the girder due to differential deflection of the main girders. Suggested details for future design are also included.

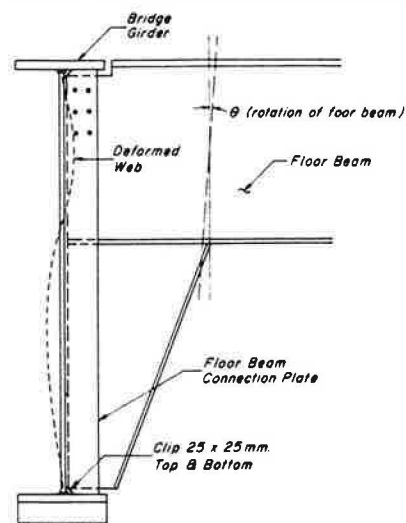
These cracks were found near the end of the girders. As shown in Figure 5, the end floor beam is rigidly connected to a connecting plate on the inside face of the girder web. The connecting plate located 18 cm. (7 inches) from the centerline of the end bearing stiffeners was welded to the top flange and the web of the girder, but had a tight fit at the bottom flange of the girder. Since the end floor beam is rigidly connected to the connecting plate, the rigid connection transmits the rotation of the floor beam to the supporting girder. The rotation tends to pull the top half of the main girder inwards and push the bottom half outwards. The girder flanges at this location are restrained from movement by the concrete slab at the top and by the bearing assembly at the bottom. This restraint induces a moment at the junction of the girder web and the girder flange. The moment at bottom of the girder web produces tension stress on the inside face of the girder web and compression stress on the outside face of the girder web. The unconnected but tight fitted lower end of the connecting plate cannot resist this tensile stress and this additional force is transmitted into the web. The stress produced by this force on the web approaches the yield strength of the material every time when the end floor beam is subject to the designed live load. The fatigue resistance of the web at the end of the welded connection plate is classified as category C in AASHTO Specifications. It is apparent that the high cyclic tensile stress in the web will initiate the fatigue crack.

Figure 5. End floor beam connection.

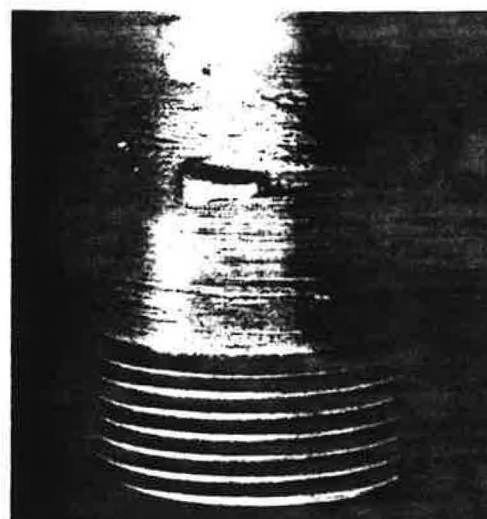
Laboratory test were carried out by the Research Team of the Illinois State Department of Transportation in order to determine the cause of the bearing seizure. A pilot test was made on a one-third size model. Loads were applied in increments up to a maximum load which produced a unit bearing pressure of 228 Mpa (33 Ksi) on the contact surface of the bearing pin. Examination of the pin after testing had revealed evidence of galling on both the pin and the saddle as shown in Figs. 21 and 22. The galling had produced a build-up of hard, solid material which could lock the pin to the saddle.

Figure 21. Galling on the surface of the bearing pin (1/3 size model).

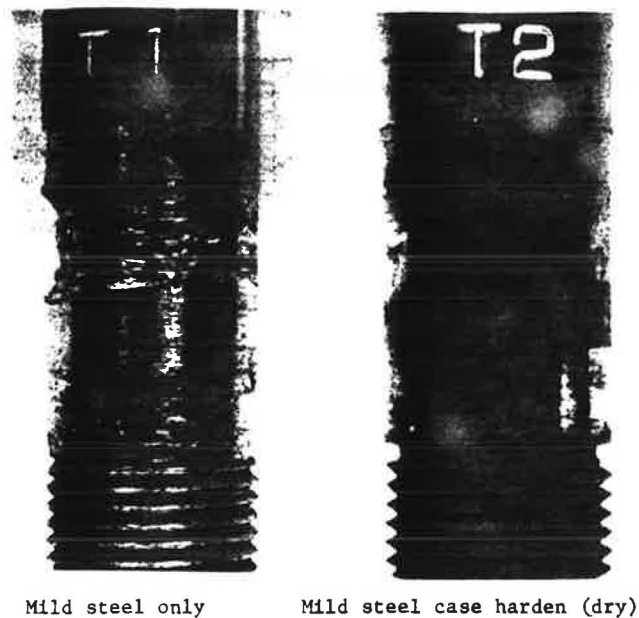
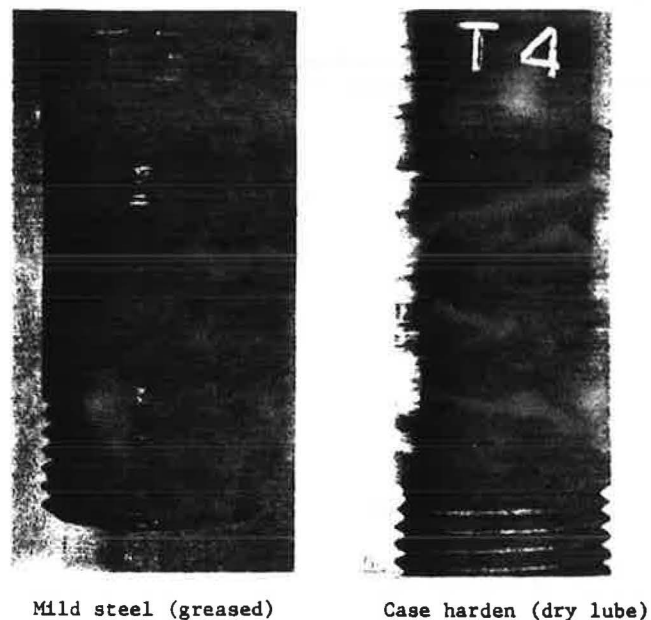
A mild steel pin without surface treatment was tested first. Galling appeared on the surface of the pin as shown in Fig. 23, specimen T-1. A second specimen was of the same mild steel pin but was case hardened. The amount of wear experienced was not significant as can be seen in Fig. 23, specimen T-2. A third specimen was of a mild steel pin with no surface treatment but lubricated with a heavy duty grease. Galling to some extent was evident as shown in Fig. 23, specimen T-3. The last specimen was a case hardened pin with a dry film lubricant. The result of this test showed little benefit in the use of dry lubricant. See Fig. 23, specimen T-4.

Figure 23. Specimens after cyclic test.

A conclusion can be drawn from these tests that use of the pin with a case hardened surface and lubricated with a heavy duty grease would be highly beneficial as a means of improving the behavior and life expectancy of a pin supported bearing.
