# Some Examples of Detection and Repair of Fatigue Damage in Railway Bridge Members

R. A. P. Sweeney, CN Rail, Montreal

Examples of details that have caused fatigue damage in recently designed railway structures are given. Procedures for arresting crack growth and some repair details are described. Emphasis is placed on damage caused by secondary and out-of-plane effects often not considered by designers.

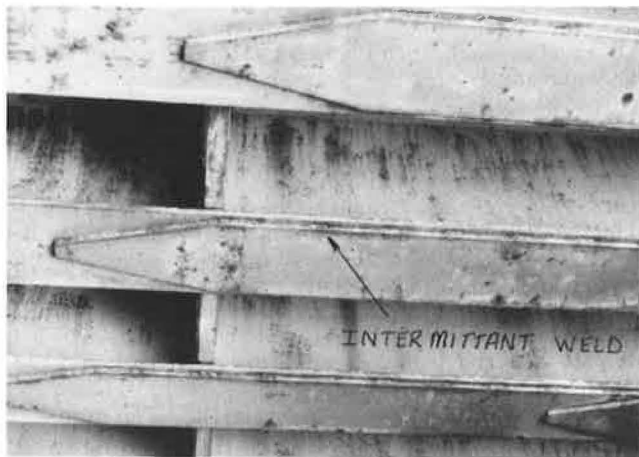
1. As an extreme example and to make a point, consider the multibeam structure shown in Figure 1. The cover plates are attached by intermittent welds. Each small length of weld is designed to replace a cer-

tain number of rivets. The current codes classify this as an E-detail because of the lack of adequate test data. Nevertheless, in this case, it is probable that higher strength exists because the intermittent welds are continuing so that the connected plates are about equally strained and because the welds are well made. This last point is crucial in evaluating details. Despite the fact that the structure has been in service since 1961, because of its redundancy, the actual average root-mean-square stress range is far below the limits of category E. Unfortunately, defective details take time to become evident and, because of redundancy, may never show up.

Figure 1. Multibeam structure that has cover plates attached by intermittent welds.

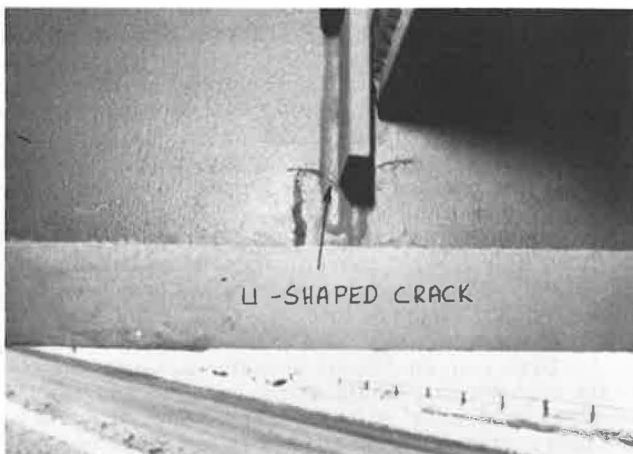
2. On our railway, the first group of problems to develop on welded structures were cracks at the bottoms of stiffeners on skewed structures. Figure 2 shows a typical example—a diaphragm or brace frame attached to a stiffener in which the stiffeners are not extended to the bottom flange. This was in blind obedience to the dictum of an early worker in welded construction that one should not weld to the tension flange. Because of the stresses introduced by the differential deflections of the connected girders and by small out-of-plane movements, cracks appeared in less than 5 years on heavily traveled lines. This type of crack begins at the bottom of the stiffener and then forms a "U" shape around it. If the original stiffener-web weld is of good quality, the crack turns out into the web and slows considerably. A temporary cure is to drill a round hole containing the crack tip. However, if the web-stiffener weld has a series of surface toe discontinuities (undercut or lack of penetration), the crack can run up the web, which causes the girder to split in half. Fortunately, our railway has not experienced such a failure. Figure 3 shows a crack following a weld upward. A circular hole was drilled to prevent any further propagation.

Figure 2. Crack at bottom of stiffeners on skewed structure.

If the structure cracked because it was restrained from movement and movement is essential to its function, as in the skewed-girder case, then a repair of the existing detail will be of no value. In fact, the next crack may be not in the same place but at a more serious location. A quick calculation of the stresses in a squared brace frame between skewed girders shows that these stresses will be very high and cannot be taken by the web alone (Figure 18). In addition to the obvious differences in vertical deflection of skewed girders, one should consider conceptually that the torsion in a girder will occur in the part most capable of rotating. The flange is generally much stiffer than the web, particularly in the space between the stiffener and the bottom flange, and any girder rotation (out-of-plane movement) will be forced to occur in this small space (Figure 4). Needless to say, the stresses will be enormous. To solve the problem, either the stiffeners must be run down to the bottom flange, or they must be cut back far enough to relieve the stresses, or the source of rota-

tion must be removed. If the stiffeners are connected to the bottom flange in an area that has a high positive moment, this may entail a reduction in capacity. In some cases of composite deck slabs, a repair is not worth doing. The cracked detail will suffice for the one-shot accidental load.

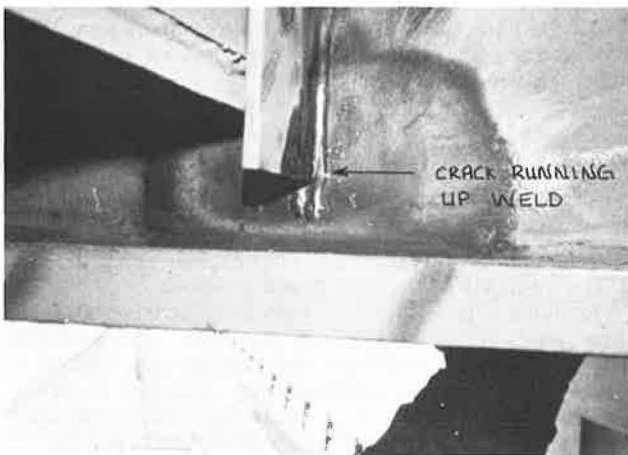
Figure 3. Crack following weld upward.

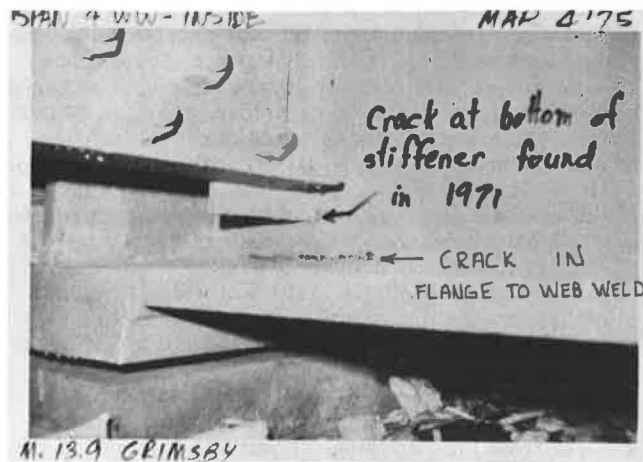
3. After cracks have occurred as described above, the next point of rigidity is that between the web and flange. If there is any motion out of the plane of the girder, it is only a matter of time before there will be cracks in the web-to-flange weld below the stiffener (Figure 4). Stopping these cracks is very important. Figure 5 summarizes the problems with this type of cracking.

Figure 4. Crack in web-to-flange weld below stiffener.

Repairing cracks that occur between the flange and the web is extremely important. The general procedure for any crack is to

1. Use a chisel to vee out the crack,
2. Fill the resulting groove by using 7018 electrodes, and
3. Grind flush.

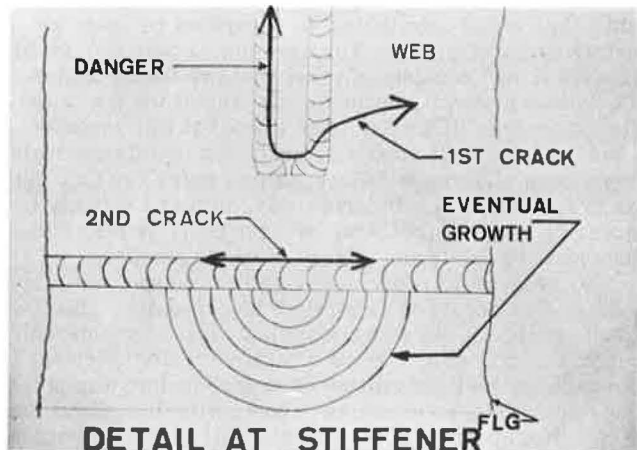
Figure 5. Summary of web-stiffener-flange cracking.

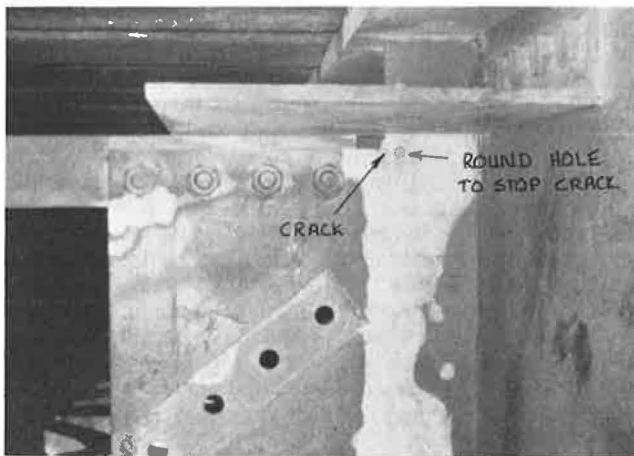
5. Another detail that has given unexpected trouble is the connection of brace frame angles to stiffeners (see Figure 6) that have the gusset groove welded to the

stiffener. As shown in Figure 7, the critical detail has a zero radius (category E). The stress that causes crack growth is the lateral force from trains. Because the hunting (side-to-side snaking) of empty cars causes frequent maximum lateral impacts, it took less than 5

Figure 6. Connection of brace frame angle to stiffener that has gusset groove welded to stiffener.

years for these cracks to develop. The time from the discovery of the first crack until the development of more than 400 on the same structure was less than 1 year. The danger is that, when the crack reaches the stiffener-to-web weld, if there are a few microdiscontinuities in that weld, the crack can run down the weld and split the web in half.

The detail of the gusset groove welded to the stiffener developed problems in less than 5 years; thus, problems with these details can be expected to reoccur in the same time frame if they are repaired. Therefore, it was decided to replace the butt-welded detail with a bolted de-

tail for the brace frames (Figure 19). Before doing this, all cracks were repaired by welding (Figure 20) and the top and bottom 7.6 cm (3 in) of the stiffener, where the gusset was removed, were ground smooth to remove any incipient cracks.

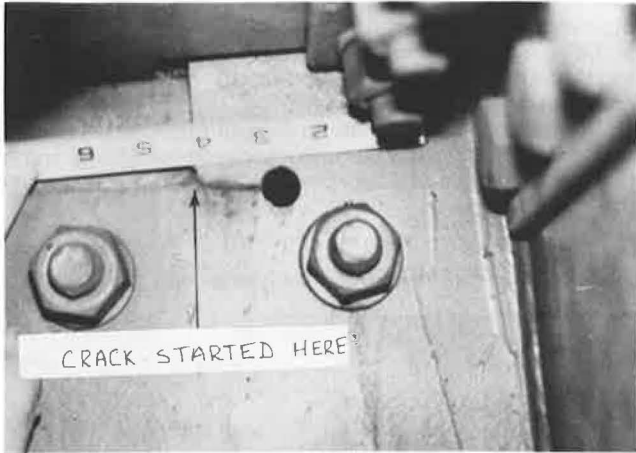
Figure 7. Critical detail from Figure 6.

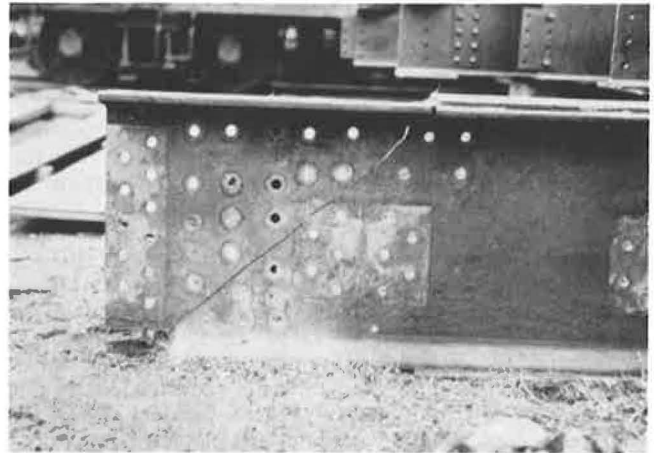
11. At stringer or floor beam connections, inadequate copes can approach an E-detail. Under normal traffic, these will not behave as pin connections but as nearly fixed. The resulting tension can cause a crack to propagate (see Figure 12). The beam is resting upside down.

Figure 12. Crack caused by inadequate cope.

In the case of copes, those that have small cracks or none at all are ground to a smooth radius, which eliminates the problem. Others are handled in a variety of ways, taking care to use details that are adequate for the negative bending that designers do not calculate, but that actually occurs. The detail shown in Figure 21a is poor because there is a relatively highly stressed E-detail. A better solution is to use an oversized connection and not stiffen the joint in a prying sense (Figure 21b). This reduces the stress considerably at the notch.

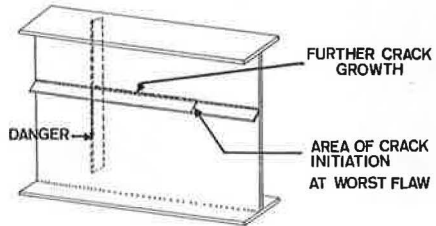
6. Longitudinal stiffeners are usually supplied in varying lengths and butt welded. Because they are usually in a compression area, not much concern has been given to inspection of them in the past. At least one railway and several highway departments have suffered failures from defects in these welds. Thus far, failures in this type of detail have initiated in overall tension areas. Although it is true that critical cracks occur only in tension areas, most welds are tension areas because of the residual stresses induced by the welding process. A crack can run along a weld until it reaches a tension area or until there is no material left. A crack (see Figure 8) can grow slowly in the butt weld, propagate along the longitudinal-stiffener-to-web weld, and then run down a vertical-stiffener-to-web weld and split the girder in half (4).

Figure 8. Crack growth from butt weld.

In the case of longitudinal stiffeners, if the crack is caught before it propagates, it is usually left alone.

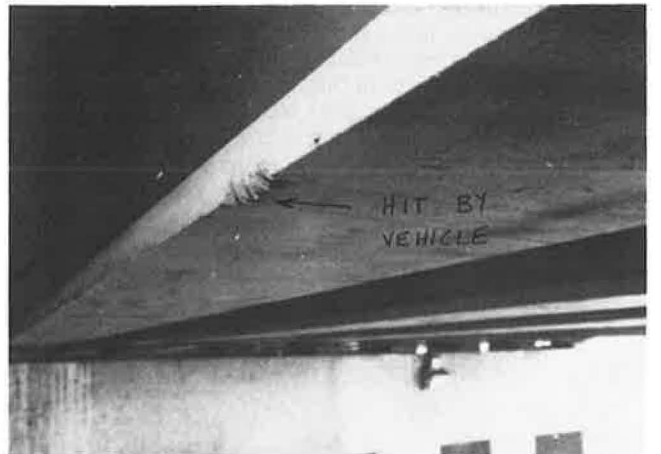
12. Welds and notches that do not meet the design codes are a source of almost certain future cracking, as are notches caused by impacts from trucks (see Figure 13), loose shipments (see Figure 14), or even ships. The rapid rate of dynamic loading caused by a shipment collision usually causes immediate brittle fracture. An example of the damage that a loose shipment can cause is shown in Figure 15; the bridge truss collapsed when one of the tension members was severed by a load of culvert pipe.

Figure 13. Notch caused by impact from truck.

Whenever a sharp notch is noticed in a member (Figure 22), if it is in a highly stressed area and if it is not on an almost abandoned branch line, it should be ground out at the first opportunity. The same should be done for tack welds, which seriously increase stress.

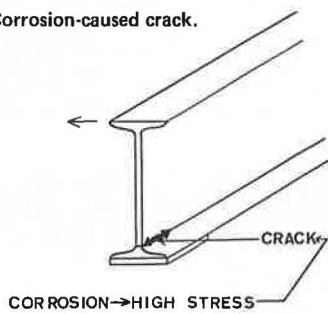
9. Figure 10 illustrates a rather unexpected fatigue failure that occurred as a result of corrosion. The I-beam stringers shown were subjected to a considerable amount of oil, grit, and such because trains often sat for quite some time waiting clearance and also engaged in frequent stops and starts during switching operations. The bottom portion of the web above the bearing corroded sufficiently so that the out-of-plane bending stresses reached a critical level. Lateral forces caused a crack to run along the fillet between the flange and web. Within a very short time, the bottom flange, which suddenly had to act as a beam, tore through. If bearing stiffeners had been placed as required by the code, the small lateral movements could not have occurred and the web could literally have rusted to nil before failure. The time to failure of these stocky web sections was about 15 years.

Figure 10. Corrosion-caused crack.

The corroded web was repaired by welding the flange to the web and adding a bearing stiffener. Those in which the flange had cracked through were replaced.

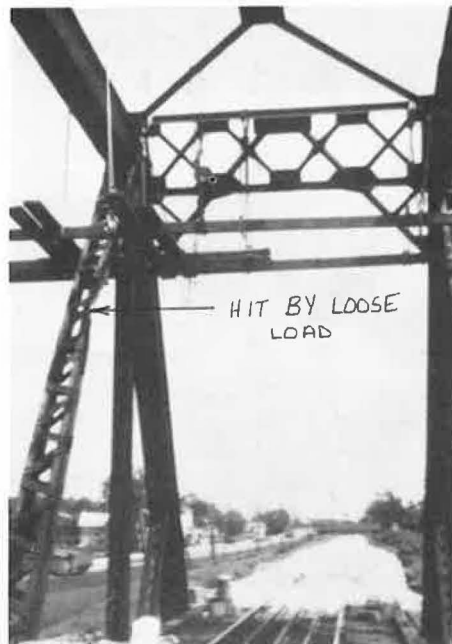
Figure 14. Notch caused by impact from loose shipment.

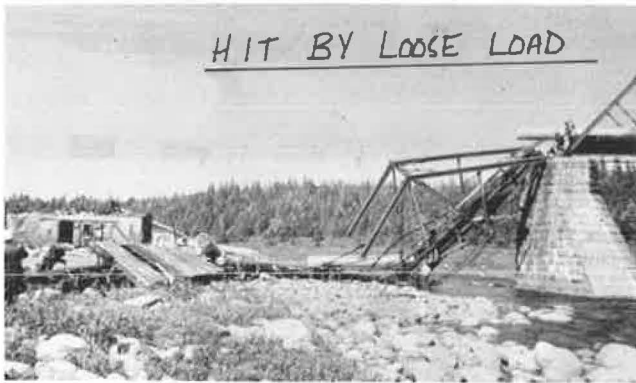
Figure 15. Truss collapse caused by impact from loose load.

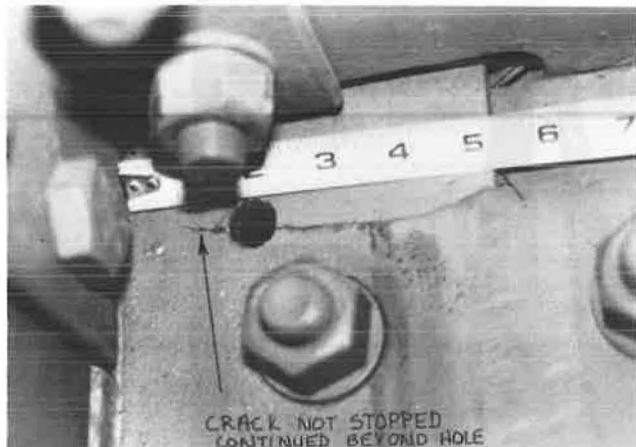
The classic way to stop a crack is to drill a round hole (6). This converts a running crack that must be considerably worse than an E-detail to a B-detail if the hole is carefully reamed or at least to a D-detail (unless the workmanship is really sloppy). On our railway, a 1.27- to 22.7-cm (0.50- to 0.875-in) diameter hole is specified, depending on how easy it is to get at the crack tip. It is imperative that the hole contain the crack tip. If there is any doubt, it is better to lead the crack. Figure 16 shows a hole that did not contain the tip. The crack propagated from the hole edge where it was not visible when the hole was drilled to that shown in less than 4 weeks.

Figure 16. Hole that did not contain crack tip.

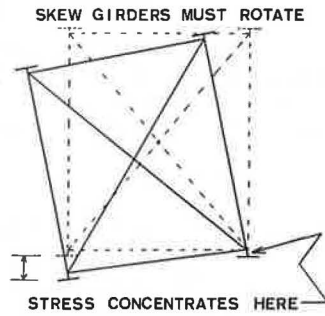
Figure 18. Stresses in squared brace frame between skewed girders.

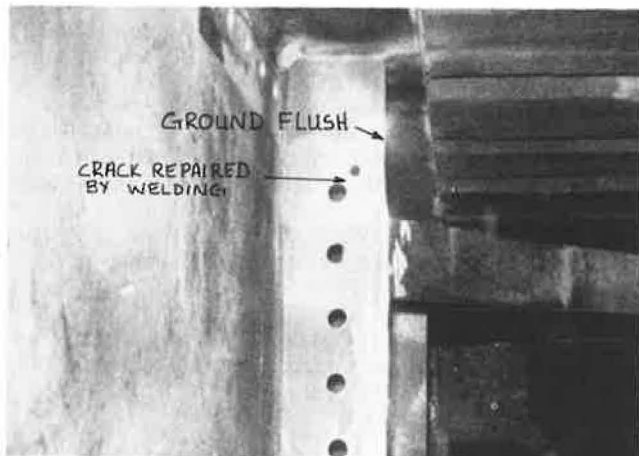
Figure 20. Illustration of procedure shown in Figure 19.

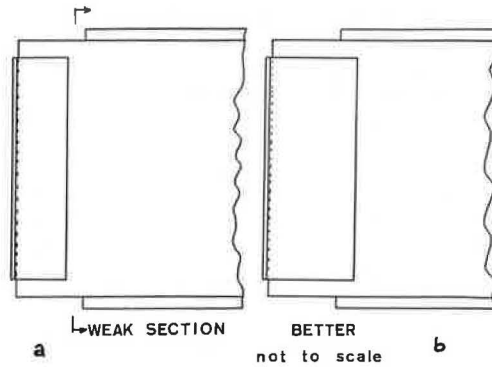
Figure 21. Procedure for repair of cope that has small cracks.

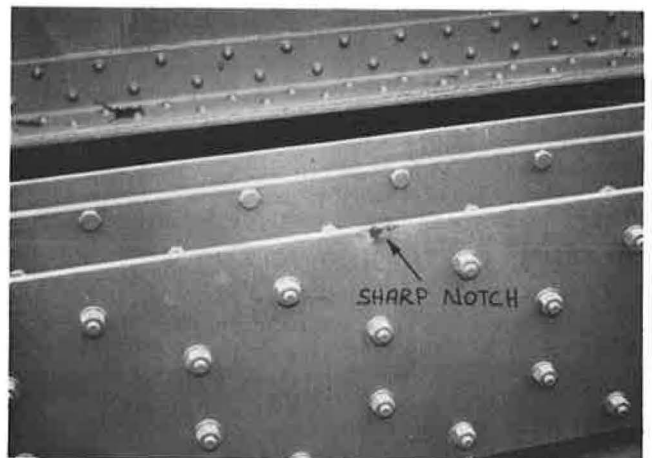
Figure 22. Sharp notch in member.

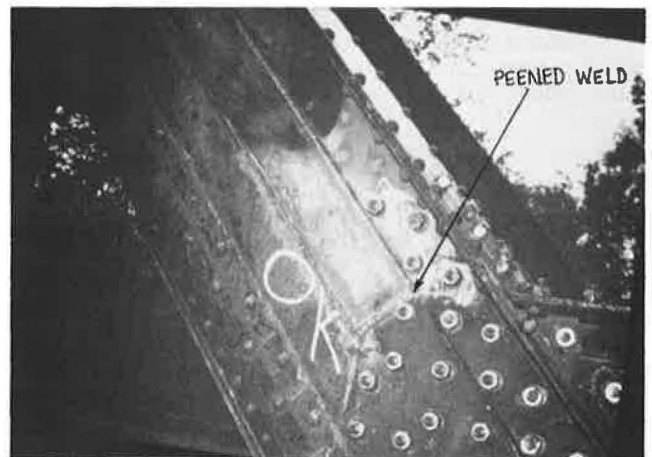
Figure 23. Truss repaired by welding and peening.

Several years ago, some strengthening was done to a truss (Figure 23). The welding was quite poor, and several cracks were detected on the surface. Some of the rough spots were removed and rewelded, and the entire weld was peened with a ball peen hammer. Sufficient peening was done to flatten any surface cracks and perhaps introduce a certain amount of residual surface compression. In theory, this should prevent surface crack growth. The structure has been in service since 1972 on a lightly traveled branch line in northern Vermont; it is too early to tell whether the desired effect was achieved. However, hand peening is extremely time consuming and unreliable if more than a short length of weld is involved.
