Repair of Cracked Structural Concrete by Epoxy Injection and Rebar Insertion

F. Wayne Stratton, Roger B. Alexander, and William J. Nolting, Kansas Department of Transportation

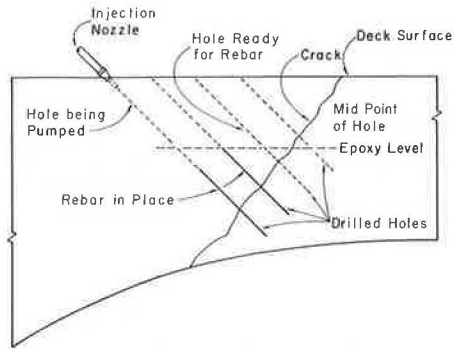
Figure 1. Level of epoxy when rebar should be inserted in hole.

As soon as the four holes were complete, epoxy pumping was begun. We pumped 11.3 L (3 gal) of high-modulus low-viscosity epoxy into this repair. All pumping was accomplished by using the drilled holes as access to the crack. Rebars were inserted into the drilled holes and spanned the crack 0.46 m (18 in) on either side (see Figure 1). Pumping continued until leaking occurred beyond the sealed zone.

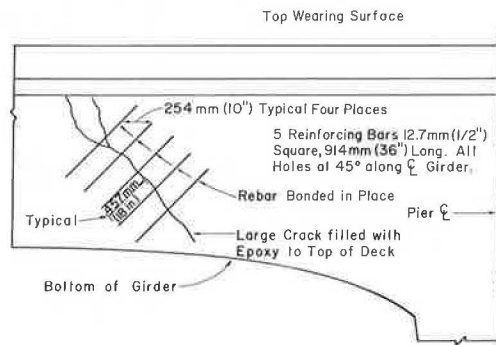
Figure 2. Typical repair sketch and description.

In all, 11 major cracks were repaired. The repairs involved installation of 15 rebar sections, 9 of which were placed across the two largest cracks. We pumped 31.2 L (8.25 gal) of bonding epoxy and used 9.5 L (2.5 gal) of sealant epoxy. The total time for the repair was 192 working h (this included traffic control time but excluded research engineer time). Figure 2 shows a typical repair sketch.
