Crash Test Evaluation of Temporary Traffic Barriers

Maurice E. Bronstad and C. E. Kimball, Southwest Research Institute, San Antonio

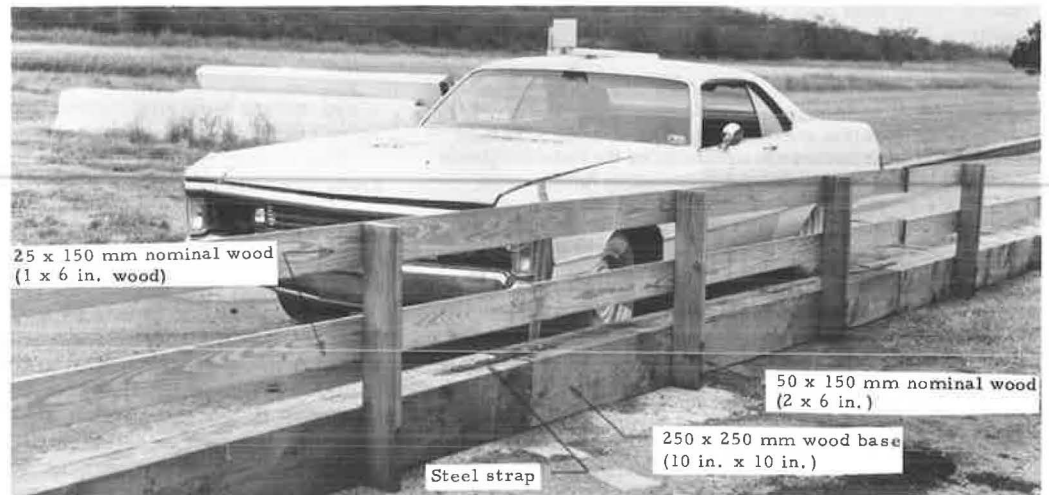
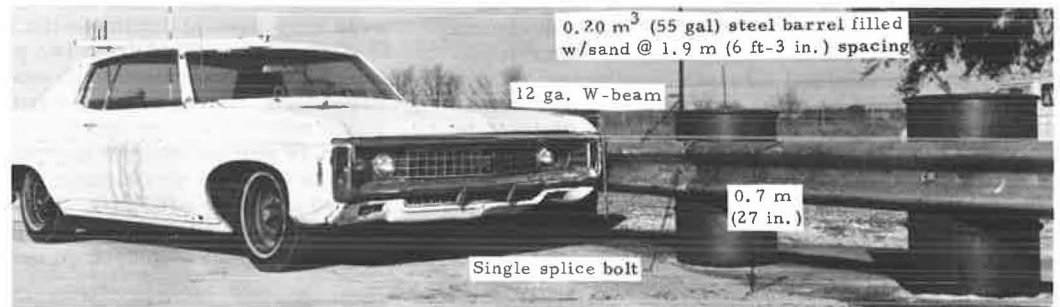
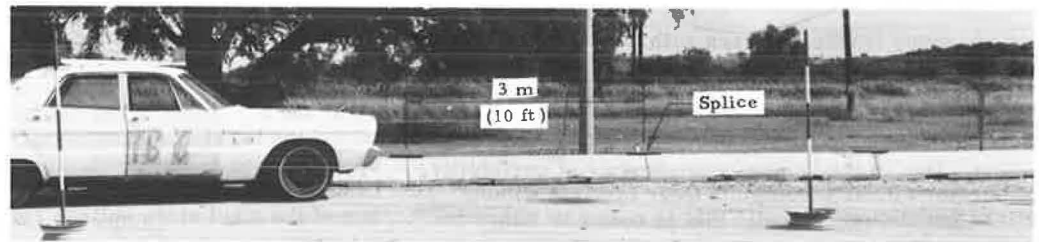
Figure 1. Temporary barrier test installations.

Three currently used temporary barriers were selected by the Federal Highway Administration (FHWA) for evaluation by crash test. The three barriers, as described in Figure 1, are (a) 250 x 250-mm (10 x 10 in) timber barrier, (b) W-beam-barrel barrier, and (c) type X curb.

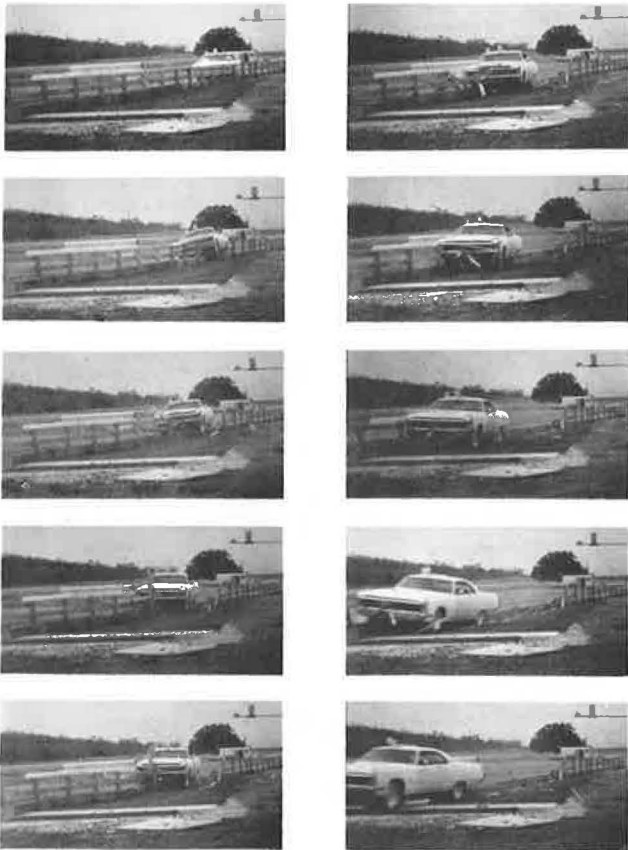
Figure 2. Test TB-1 sequential photographs.

Impact conditions for the vehicle were 61 km/h (38.0 mph) and a 7° angle. The vehicle's left front tire contacted the barrier approximately 13.1 m (43 ft) from the upstream end and immediately climbed up and over the base, as shown in Figure 2. After straddling the barrier, one of the steel strap splices released, allowing the barrier section to pivot and imparting redirection to the vehicle. The vehicle came to rest 1.2 m (4 ft) from the downstream end of the barrier, as shown in Figure 3. The vehicle sustained only minor damage; damage to the upper barrier rails downstream of the impact was total. The 250 x 250-mm (10 x 10-in) base sections were widely displaced, as shown in Figure 3.

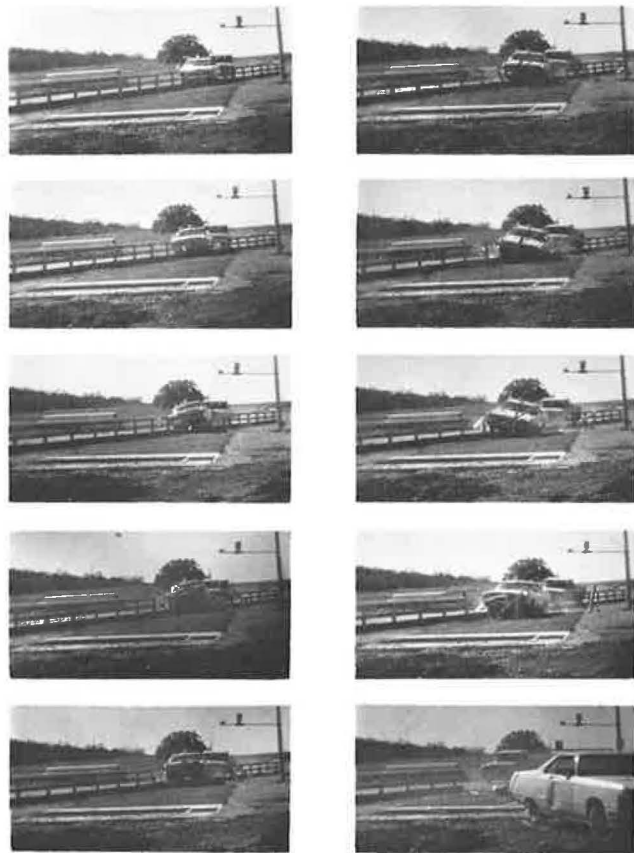
Figure 4. Test TB-2 sequential photographs.

Vehicle impact conditions were 55.3 km/h (34.6 mph) and a 15° angle. The vehicle's left-front tire contacted the barrier 14.6 m (48 ft) from the upstream end. As shown in Figure 4, the vehicle vaulted over the base and with little redirection continued over and through the barrier. Two of the base sections were displaced, as shown in Figure 5. The vehicle came to rest with the rear end 6.1 m (20 ft) behind the barrier.

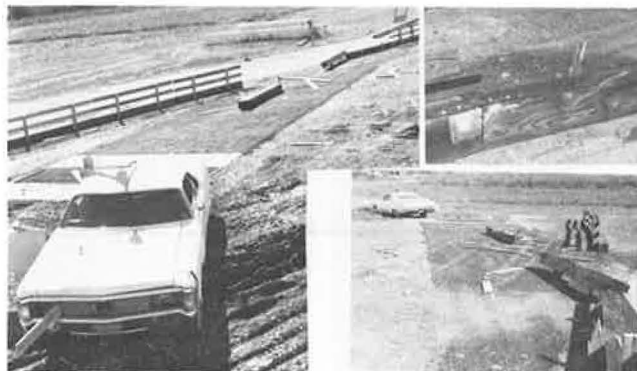
Figure 5. Test TB-2 vehicle and barrier damage.

Vehicle damage resulted from spearing of the grill by one of the upper rail members. There was consider-

able damage to the vehicle front suspension, transmission, and rear-end (differential) assembly.

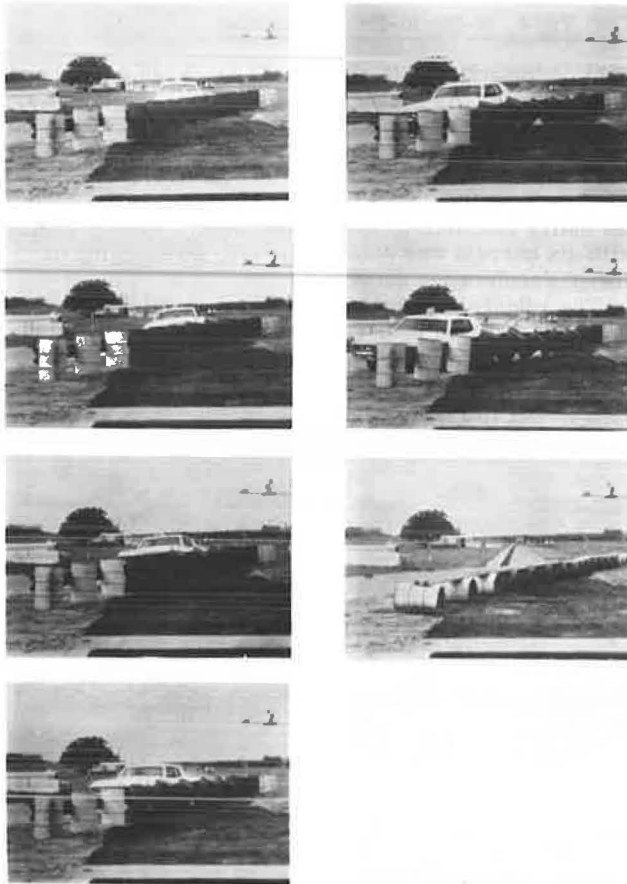
Figure 6. Test TB-3 sequential photographs.

Vehicle impact conditions were 57 km/h (35.5 mph) and a 14.3° impact angle. As shown in Figure 6, the barrels

in the impact area immediately tipped away from the vehicle as it was smoothly redirected. Barrels adjacent to the impact area subsequently began to tip, and similar to a domino effect, the barrels rotated over on their sides, as shown in Figures 6 and 7. Although there was wheel contact with three barrels, no abrupt decelerations were observed.

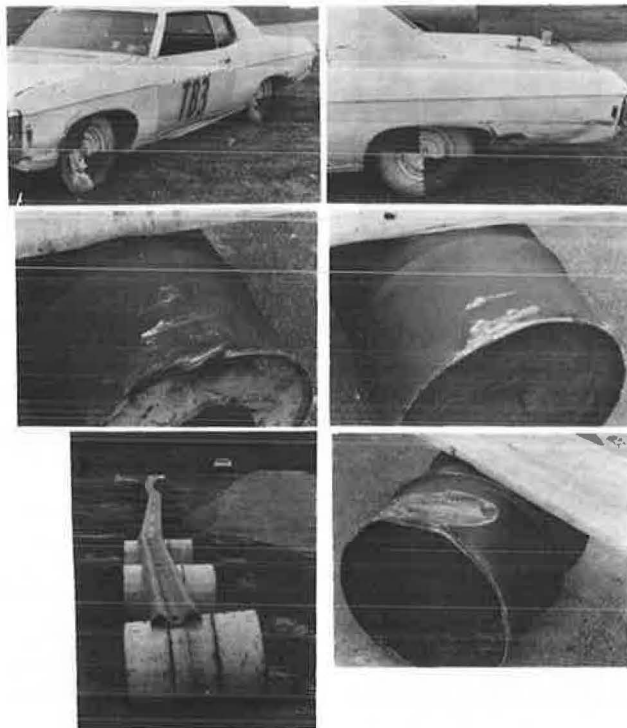
Figure 7. Test TB-3 vehicle and barrier damage.

The vehicle sustained minor sheet metal damage; otherwise it was undamaged. Although the entire installation was displaced, as shown in Figure 7, it was easily

restored to an upright position for test TB-4.

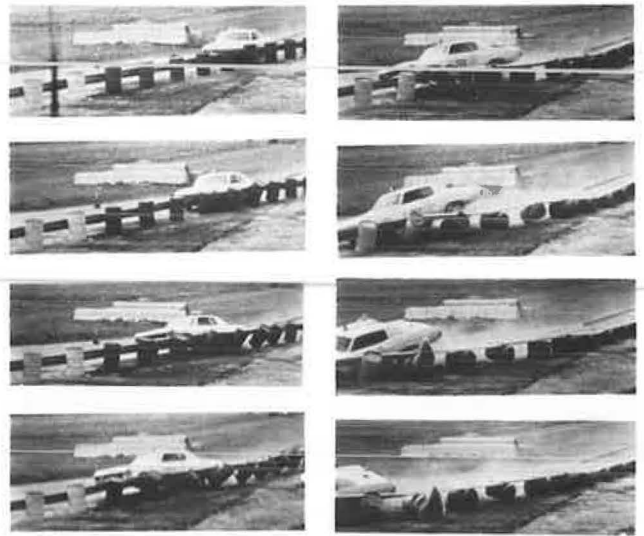
Figure 8. Test TB-4 sequential photographs.

Vehicle impact conditions were 73 km/h (45.4 mph) and a 14.6° angle. As shown in Figure 8, the vehicle impacted the installation 15.2 m (50 ft) from the upstream end, and barrels in the impact area immediately tipped away from the redirected vehicle. As in test TB-3, the barrels out of the impact area rotated sequentially until the entire installation was pushed over. Vehicle contact with six barrels was noted; however, no snagging or abrupt deceleration occurred.

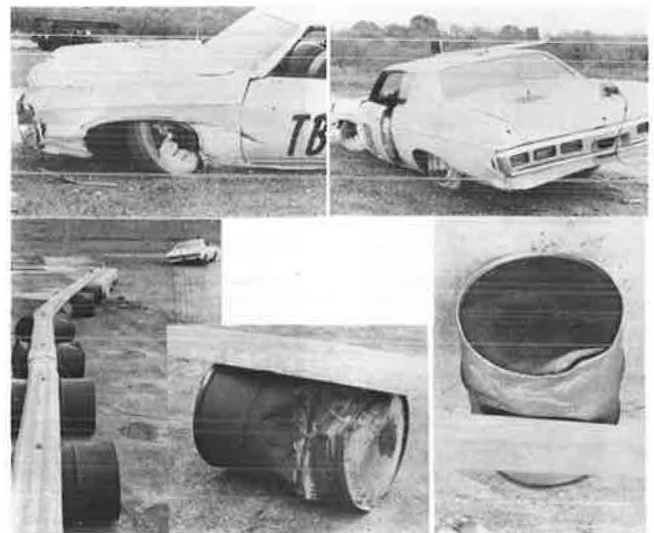
Figure 9. Test TB-4 vehicle and barrier damage.

The vehicle sustained minor sheet metal damage to left-front and rear fenders, as shown in Figure 9. In ad-

dition, the lower ball joint at left-front wheel was separated and both left tires were punctured during impact. Damage to the installation was limited to three barrels, which were replaced prior to the next test.

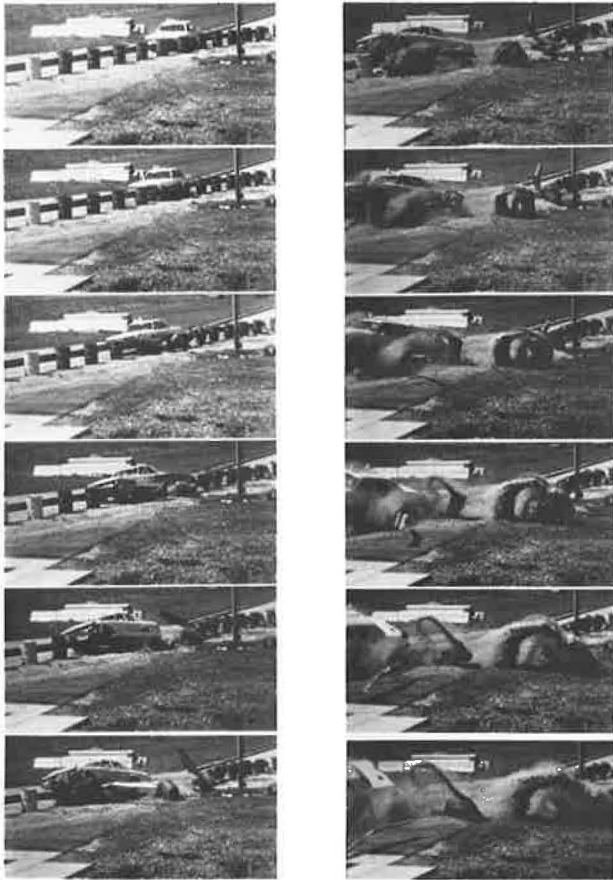
Figure 10. Test TB-5 sequential photographs.

Vehicle impact conditions were 92.7 km/h (57.6 mph) and a 15.8° impact angle. As seen in the sequential photograph of Figure 10, the vehicle pocketed slightly, and then, from an orientation approximately parallel to the barrier, vaulted over the barrier. As the W-beam splice connection failed, the vehicle climbed over the barrels in front. Although the vehicle was airborne and unstable, it did not roll over and came to rest as shown in Figure 11.

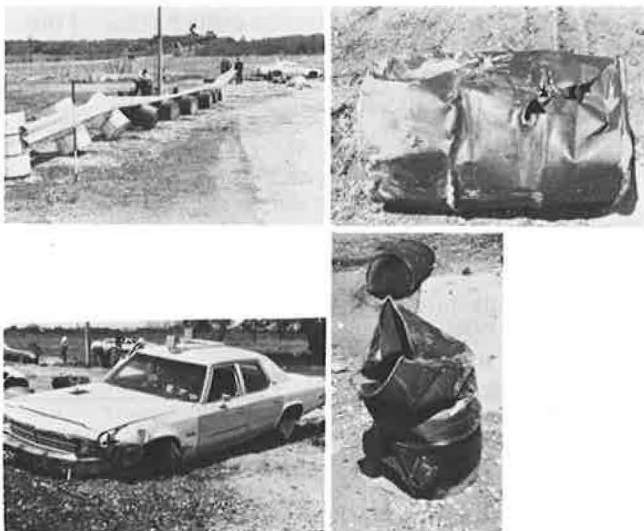
Figure 11. Test TB-5 vehicle and barrier damage.

Considerable sheet metal and suspension damage was sustained by the vehicle's left-front quadrant. In addition, the rear transmission mount and differential housing attachments failed. Barrier damage was extensive, as shown in Figure 11.

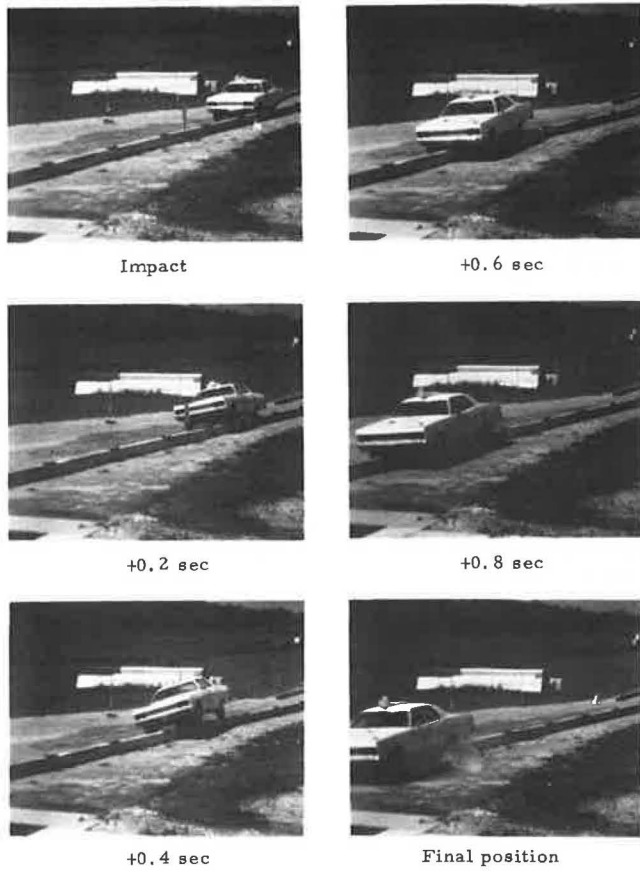
Figure 12. Test TB-6 sequential photographs.

Vehicle impact conditions were 56 km/h (35 mph) and an 8.1° angle. Initial impact was 9.8 m (32 ft) from the upstream end. As shown in Figure 12, the left wheels immediately climbed up the sloped curb face. The vehicle pitched (nose up) initially, and then as it straddled the barrier, the front underside snagged on one of the 25-mm

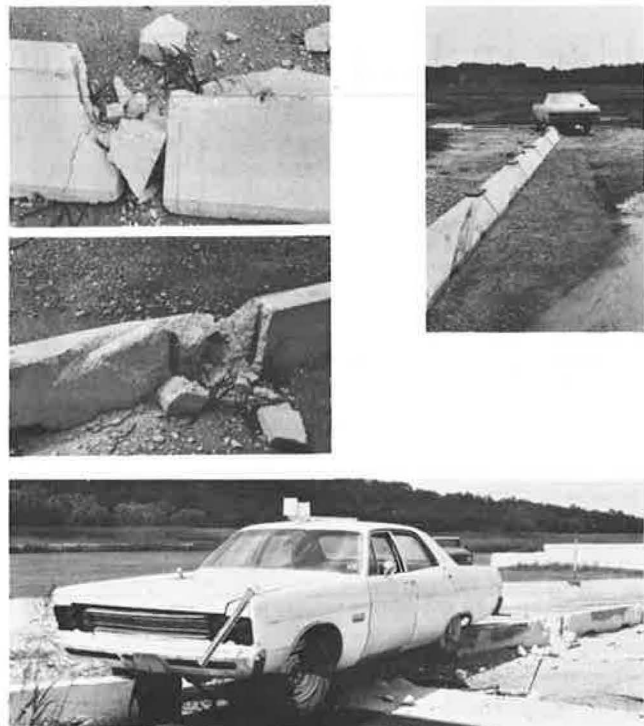
Figure 13. Test TB-6 vehicle and barrier damage.

(1-in) thick splice plates. Significant deceleration forces were then applied to the vehicle by this splice plate and the one immediately downstream. These forces were sufficient to prevent the vehicle from proceeding over the barrier; however, considerable damage to the vehicle's underside and three barrier sections was observed. Final position of the vehicle and the barrier damage are shown in Figure 13.

of 8° it does not appear to be capable of redirecting a 2040-kg vehicle impacting at 56 km/h (35 mph). The fact that the test vehicle did not completely go over the test barrier is attributed to the deceleration force imparted to the vehicle by the splice plate snagging previously cited. This snagging is undesirable in that it causes severe damage to both vehicle and barrier segments. In addition it cannot be considered as a repeatable means of decelerating a vehicle due to the intermittent spacing of the splices.
