Attempts to Reduce Reflection Cracking of Bituminous Concrete Overlays on Portland Cement Concrete Pavements

K. H. McGhee, Virginia Highway and Transportation Research Council, Charlottesville

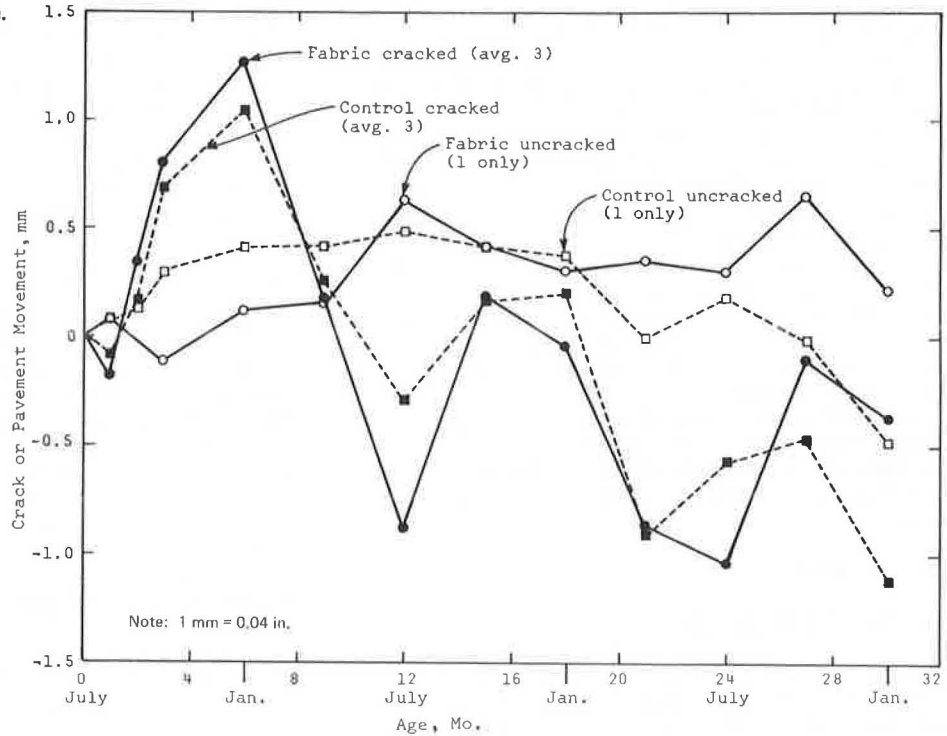
Readings of both the test and calibration points were taken at monthly intervals for 30 months subsequent to the overlay. During the first 3 months, reflection cracks developed between the gauge points at three locations in each section. At one location in each section, a reflection crack developed outside the limits of the gauge points. At the end of the 30-month period, only one joint in each section had not reflected through the overlay. The results of these studies are shown in Figure 1; a positive number on the ordinate of this figure indicates joint opening and a negative number indicates joint closure. It is apparent that the fabric-reinforced test section and the control section behaved in a similar manner; there is no evidence from these tests that the stress-relieving layer provided any advantage in preventing reflection cracking. Once the cracks had formed, their behavior was generally as would be expected for the first year and seasonal movements were clearly evident. However, there is no ready explanation for the strange behavior of the measurements after the first year. Ob-

viously, the indication that the cracks (which were clearly visible) took on negative widths is ridiculous. It is evident that, for unknown reasons, the distances between the gauge points became somewhat less than the nominal 250 mm originally established. This anomaly may be related to the humping effect noted at many transverse reflection cracks in Virginia. In such cases, a gradual upheaval or accumulation of AC at the reflection cracks results in noticeable roughness.

Figure 1. Movement of cracks with age.

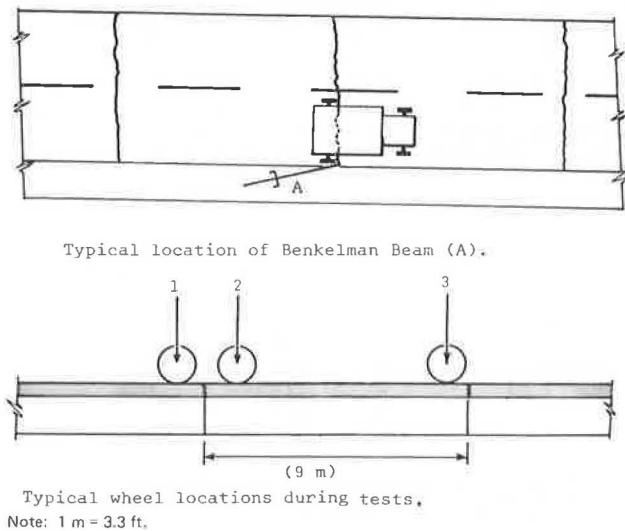
In April 1972, deflection tests were conducted at the joints on both the fabric-reinforced and the control sections. The procedure for these tests is indicated in Figure 2. A Benkelman beam (A in Figure 2) is placed on the shoulder of the road with its point near the edge of a reflection-cracked joint or of a joint that has not reflected through. A dump truck loaded to 80 kN (18 000 lbf) on its rear axle is positioned on the opposite side of the joint. At this point (point 1, Figure 2), an initial beam reading is taken. The truck is then driven slowly across the joint, and beam readings are taken as points 2 and 3 are traversed. The edge-deflection reading for point 2 (D_2) indicates the deflection when the wheel load is directly at the joint. The comparison between the reading for point 1 (D_1) and D_2 indicates the load-transfer efficiency, and the reading for point 3 is used to ensure that the Benkelman beam, still located at point 2, is no longer within the area of influence of the wheel load.

Figure 2. Schematic of deflection-testing procedure.

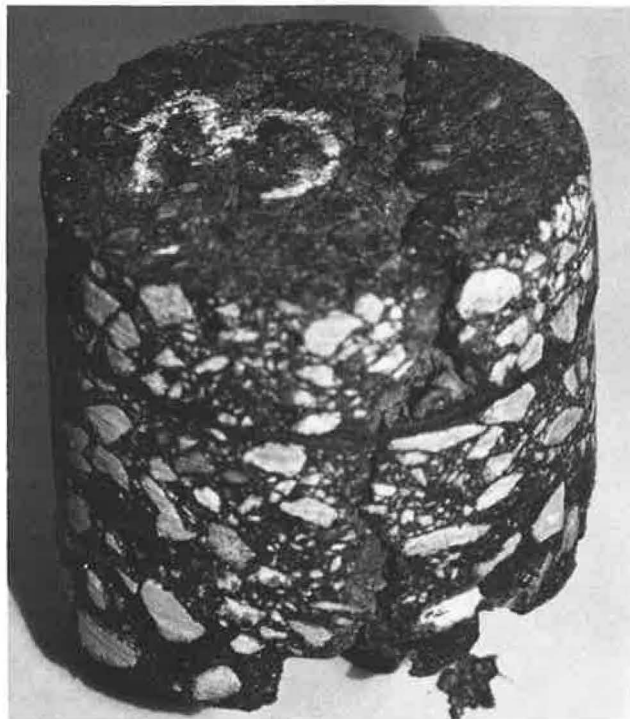
Figure 3. Core through new overlay (top), polypropylene fabric, and old overlay.

During the September 1974 crack survey, five 100-mm (4-in) diameter cores were removed from the US-460 pavement. Each core was taken at a reflection crack in the fabric-treated section and was located so as to intercept the crack approximately as a core diameter. These five cores were returned to the laboratory for study. The results of these studies are indicated in Figure 3, where it can be seen that the core through both AC layers is held together by the polypropylene fabric. The reflection crack is plainly visible both above and below the fabric. Attempts to separate the AC from the fabric showed that all were firmly bonded together so that some effort was required to remove either AC layer. When the AC had been removed, the fabric showed no evidence of damage but had a slight wrinkle that corresponded to the location of the reflection crack.

The observation that there were no tears or other signs of elongation of the fabric was taken as further evidence that the reflection cracking had been caused primarily by vertical joint movements.

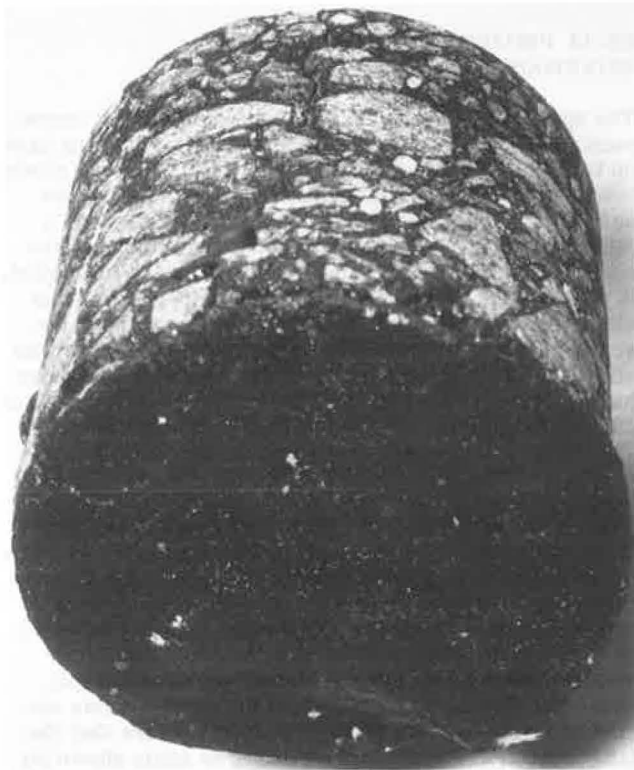
Figure 4. Core through bituminous layers and polypropylene fabric: I-95 project.

Cores removed from site 2 during July 1974 showed results similar to those described above for the US-460 project. For both the polypropylene- and the nylon-fabric-treated cracks, the cores showed that the cracks were directly above cracks in the PCC base and that the fabric was still intact and showed no signs of distress (see Figures 4 and 5).

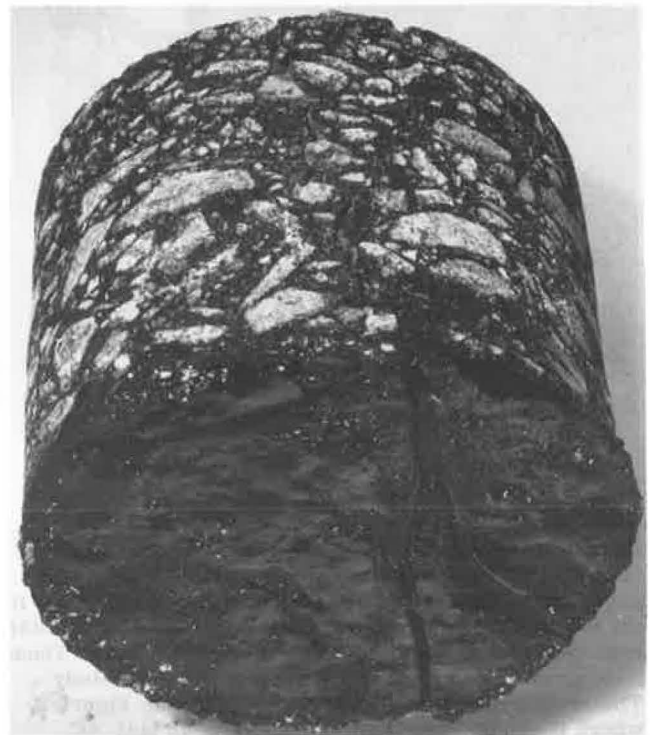
Figure 5. Core through bituminous layers and nylon fabric: I-95 project.
