# Membrane Technique for Control of Expansive Clays

Douglas Forstie, Harold Walsh, and George Way, Materials Services, Arizona Department of Transportation

Much northeastern Arizona highway is built on expansive clay. Changes in the moisture content of these clay subgrades cause volume changes that in turn cause excessive pavement deterioration and thus affect safety. During initial construction, a variety of experimental sections were built to test such stabilization methods as moisture and compaction control, chemical admixtures, electro-osmosis, overexcavation, ditch widening, underdrains, and membranes, alone or combined. Some methods were relatively successful when compared to the rapid deterioration of the untreated highways. These findings led to choosing impermeable rubber membranes to control moisture in the clay subgrades. The first trial of the technique at full contract scale was an 18-km (11-mile) overlay on I-40 completed in 1975. After the slopes were flattened for safety, the roadway prism under the asphalt concrete overlay and down the shoulder slopes was covered with the asphalt-rubber membrane. The control section was an adjacent overlay of the same design but

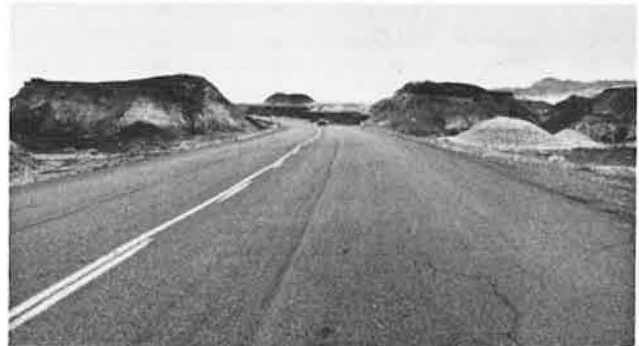
overlay included pavement distortion, cracking, and excessive maintenance. The picture in Figure 4 shows the typical condition of a highway before overlay. Visual observations of the projects were sufficient to indicate the nature and extent of the distress, but the following measurements indicated the severity of the problem:

Figure 4. Highway condition before overlay.
