Final Geotechnical Investigations on the Vail Pass Project

Robert K. Barrett, District 3, Colorado Department of Highways, Grand Junction

An overview of final geotechnical investigations on the 22.5-km (14-mile) Vail Pass I-70 alignment is presented. The geotechnical studies involved personnel of the Division of Highways, Colorado Department of Highways, and consultants from four engineering firms. The Interstate corridor traversed several areas where geologic conditions posed extreme difficulties. Unique and innovative designs were required to provide a stable, attractive, and environmentally compatible highway. Examples of the geologic problems encountered and the techniques used to surmount them are described. Approximately 30 person years of geotechnical expertise and 10 drill-crew years were required on the project. The geotechnical studies are estimated to have cost \$2 million.

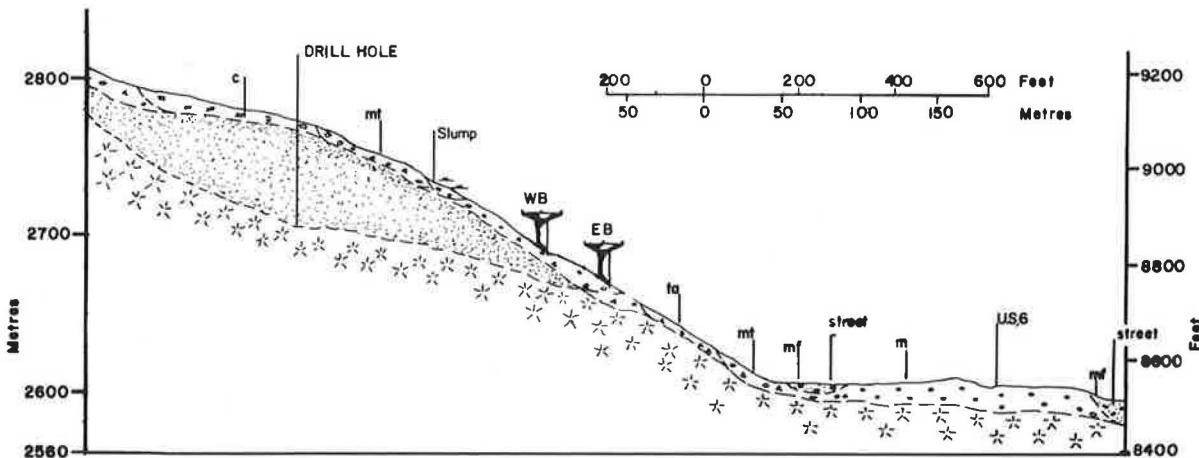
Figure 3. Geologic section: station 335.

The consultant's preliminary studies concluded that the hillside in the vicinity of stations 310-340 probably contained deep deposits of unconsolidated materials. Concern was expressed about the extensive side-hill cuts proposed for that area (see Figure 3).

In 1972, drilling was initiated in the area. The soils initially selected for drilling consisted of granite boulders as large as 0.9 m (3 ft) in diameter in a matrix of sand, gravel, and cobbles. Since these materials could not be penetrated by the standard rotary drilling equipment owned by the Colorado Department of Highways, they were drilled by a private firm using a percussion drill.

solidated glacial deposits were perched on the mountain-side above the proposed extensive cuts. These deposits consisted primarily of sand overlaid by gravel and boulders and contained organic horizons at various depths. The deepest deposit exceeded 43 m (140 ft), and the water table was near the surface. Had cuts been attempted in this area, extensive failures—probably involving more than 900 000 m³ (1 000 000 yd³)—would have resulted.

Based on the drilling information, it was recommended to the designers that no cuts be made in this area. Two alternatives remained: a standard fill slope or a side-hill viaduct. Partly because of extensive condominium development and high land values, it was determined that a viaduct was the better choice.

During foundation investigations for the structure, it was discovered that the cross-slope safety factor was only 2.0 in the existing hillside in the vicinity of one of the piers. Precedents established on Interstate projects required a 3.0 safety factor on structure foundations. After considerable review, highway department management and personnel of the Federal Highway Administration agreed to accept a factor of 2.0 in this area.

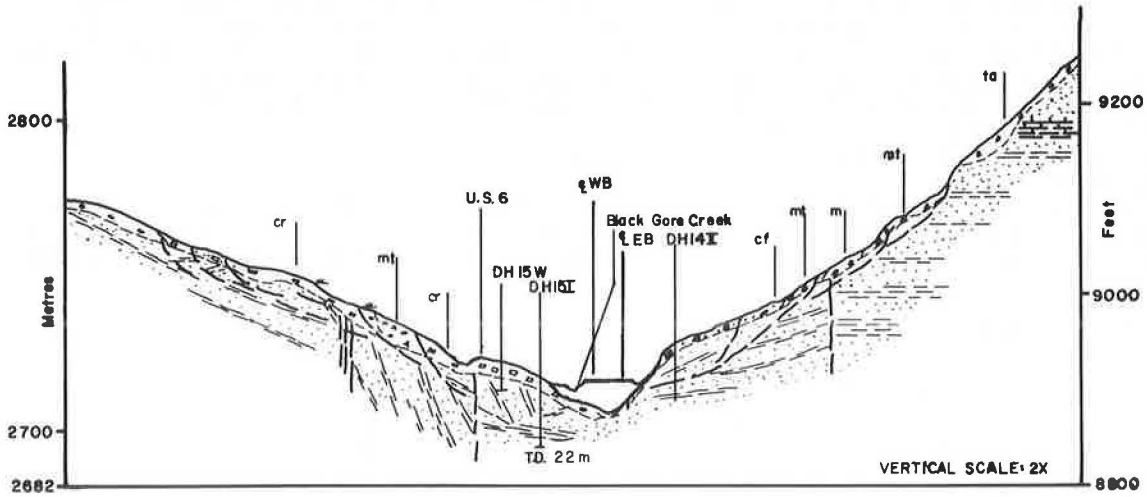
Figure 4. Geologic section: station 425.

In the area of station 425, geologic mapping and subsequent instrumentation by a geologic consulting firm defined an area in which two active landslides were

moving from opposite sides of the valley and constricting Black Gore Creek. After intensive studies and analyses, it was decided that an extensive earth buttress would successfully stop movement in the slides. This buttress would fill the channel and floodplain of Black Gore Creek and cause the slides to push against each other (see Figure 4).

One major consideration in this decision centered around the fate of Black Gore Creek itself. Economically, it would have been desirable to place the creek in a large pipe under the embankment; that alternative, however, was deemed aesthetically unacceptable by practitioners of several disciplines.

Keeping the stream flowing on the surface posed major design problems. An impoundment was required upstream from the earth buttress and a run-down, or waterfall, was required on the downstream end. Because of the marginal stability of the area, design and construction procedures were quite complex. The technique chosen for the run-down included stepped gabion walls with deep foundations to act as cutoff walls and post-grouting to reduce permeability through the rock baskets.

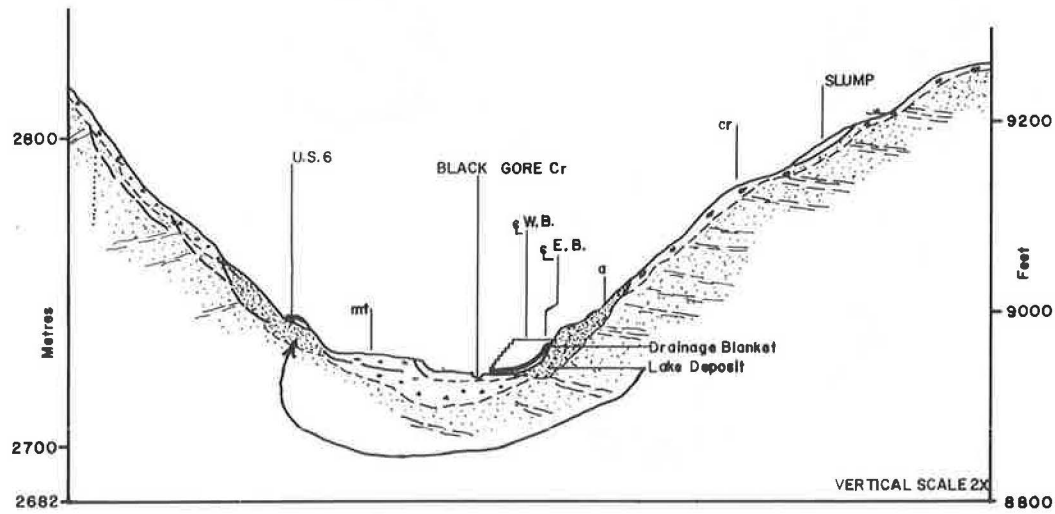
Figure 5. Geologic section: station 450.

In the area of stations 438-450, subsurface investigations revealed the presence of a lake deposit consisting of silt and fine sand perched on the hillside where a balanced cut-and-fill alignment was planned. The lake

sands were saturated, and cuts into these deposits would certainly be unstable. Predrainage was not a practical alternative. Neither was a standard all-fill template, since moving the alignment out to an all-fill section would have required extensive rechannelization of Black Gore Creek. A channel change was not recommended because of the presence of unstable, unconsolidated lake deposits on the opposite hillside. It was also aesthetically unacceptable.

The remaining choices were a high wall or a side-hill viaduct. Because of foundation conditions and cost factors, a reinforced earth wall was selected. Before

construction of the wall, organic soils in the floodplain of Black Gore Creek were excavated and a drainage blanket was placed over most of the wall foundation area and on the slope behind the wall. Extensive under-drain systems were installed to further ensure continued adequate drainage (see Figure 5).

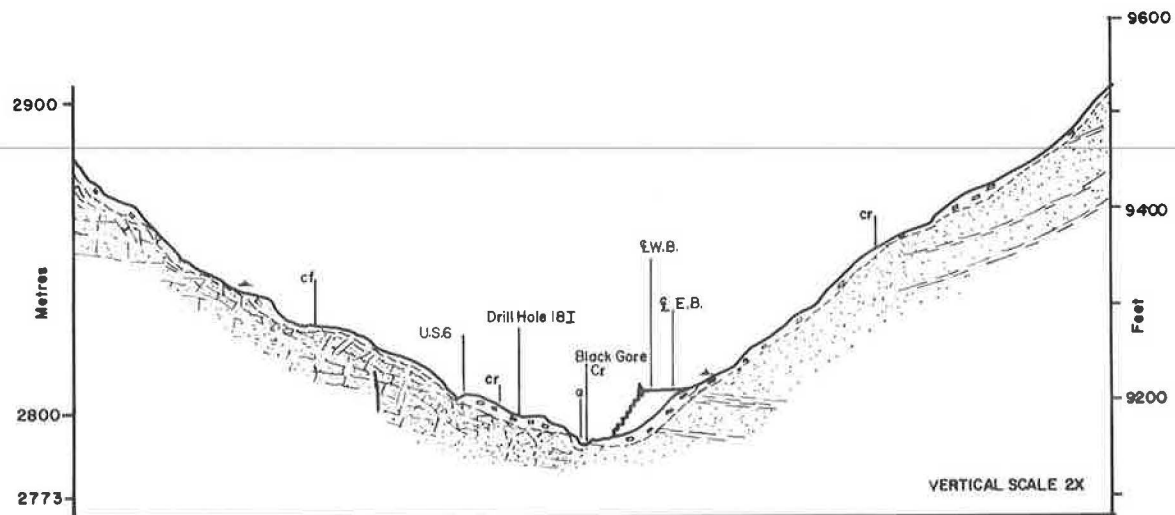
Figure 6. Geologic section: station 499.

Instrumentation installed during the intermediate study identified an active landslide on the north side of Black Gore Creek in the area of station 499, a discovery that

resulted in the final alignment being placed totally south of the creek and requiring one high retaining wall. This retaining wall was the first precast tieback wall to be constructed on a highway project. There was a substantial amount of instrumentation on this wall, including load cells, inclinometers, and strain gauges. The wall system proved effective and efficient. Figure 6 shows the final cross section.

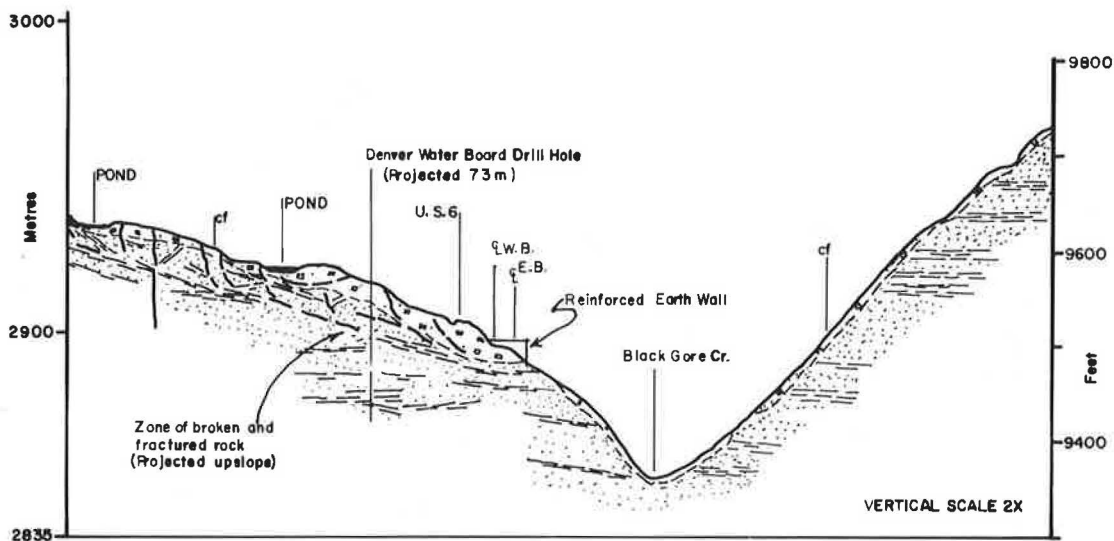
Figure 7. Geologic section: station 550.

The most difficult and challenging problem for geotechnicians at Vail Pass was in the area known as the Miller Creek slide. This slide is over 1 km (0.62 mile) long, almost 1 km wide, and about 46 m (150 ft) deep. The slide consists of up to 21 m (70 ft) of surficial silty soils overlying some 24 m (80 ft) of failed bedrock. Water levels were erratic, varying from surface ponds in some areas to dry in other areas.

During the earliest drilling, the lowest failure plane was thought to be at the soil-rock interface. Two core samples from 6 m (20 ft) below this contact indicated intact sandstone and siltstone dipping by about 4°. This matched the geology in the surrounding area. It was found, however, that this did not match a deep core hole drilled previously by the Denver Board of Water Commissioners in conjunction with a proposed water-diversion tunnel. A third hole was drilled to 46 m (150 ft), and several obvious shear zones were found. Additional drilling revealed areas of completely disrupted bedrock. Competent, intact bedrock occurred below this zone. The bedrock failure plane corresponded with the 4° bedrock dip in the lower reaches of the slide.

During the course of the drilling, a buried soil profile was uncovered in the toe area of the slide. Carbon-14 dating showed that a sample of organic material from the soil layer was 1000 years old, plus or minus 70 years, which indicated that the movement was relatively recent.

The topography of the Miller Creek slide area, shown in Figure 7, included a deep canyon at the toe of the slide into which the slide would spill during active periods. Severe grade restrictions, both up and down station from the slide area, dictated that the alignment must cross the toe of the slide. In other critical areas, it was usually possible to vary vertical

The remaining alternative was a high, vertical, reinforced earth wall, the toe of which would be placed on the edge of the steep canyon wall and the base of which would have to be placed on intact bedrock. In place, this design raised existing safety factors insignificantly, but excavation of the toe of the slide to permit construction showed a mathematically significant reduction in the safety factor on the critical circle.

After a tentative decision was made to try the wall concept, a detailed geotechnical investigation was done. It was decided that, if the water table could be lowered about 11-17 m (35-55 ft) below the ground line as far as 91 m (300 ft) horizontally behind the excavation, it would be possible to construct the wall. Based on readings from several water-level-monitoring sites, it was also decided that the wall would have to be constructed during the winter months, the period of lowest groundwater levels and least groundwater recharge.

The horizontal drilling proved successful and interesting. Some intact blocks of rock were as large as 24 m (80 ft) across and, almost invariably, great bursts of water would flood from the drill holes when the bit broke through into a shear zone. One such flow was measured at 757 L/min (200 gal/min). Most flows dropped off substantially in 30 min to 2 h.

Water levels were reduced by almost exactly 11 m (35 ft). Because of the low cost and the success of the drainage program, it was decided that it would be worthwhile to drill another series of holes at a lower elevation in conjunction with the construction project. When the second series of drain holes was completed more than two years later, the toe area had, in the interim, dried substantially. The second series lowered water levels to about 15 m (50 ft) below the ground surface.

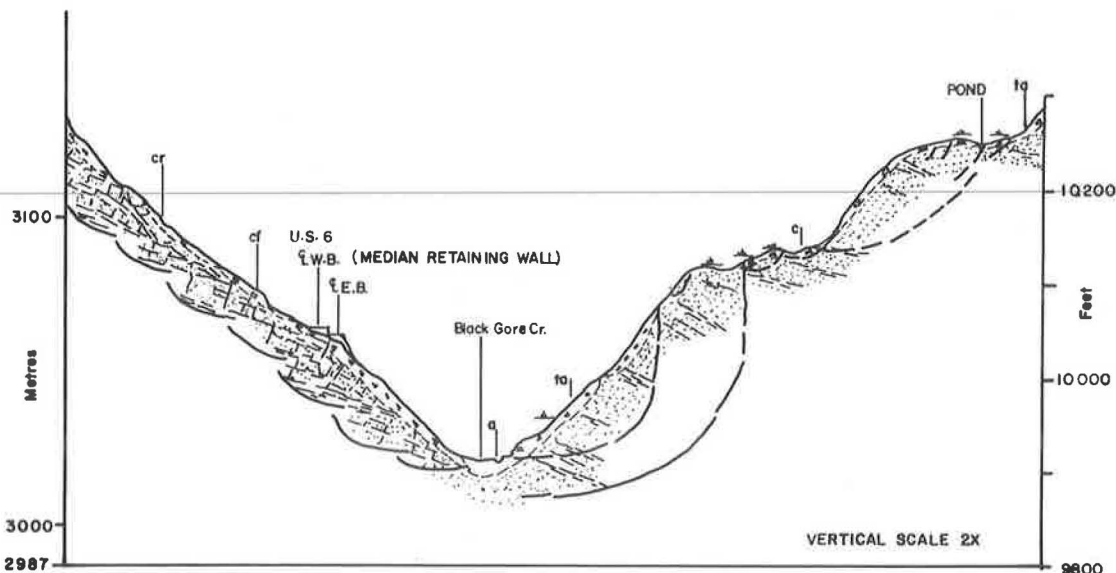
Figure 8. Geologic section: station 640.

Bedrock failures were observed throughout the upper reaches of Black Gore Creek. One failure series was continuous from station 615 to station 750±. The alignment location was first split, the eastbound on the

south valley wall and the westbound using the existing US-6 platform. This concept was abandoned when it was discovered that a bridge from the west valley wall would have to be located on marginally stable failed bedrock.

The remaining choice was to place both directions of travel on or near the existing US-6 alignment. The roadway template was minimized by using a median wall, which allowed a better fit on the steep hillside. Several attempts were made at defining critical failure circles and strength parameters through this area. None were felt to be entirely reliable, and the final design was accepted by geotechnical personnel on the basis that it caused the least disturbance—that is, the least reduction in safety factor on mathematical models. It was the consensus of opinion that the final alignment had a reasonable and acceptable probability of success (see Figure 8).
