# Embankment Stabilization by Use of Horizontal Drains

Stephen E. Lamb

An embankment 24 m (about 80 ft) high that traverses a narrow valley on I-81 about 56 km (35 miles) south of Syracuse, New York, began to fail several years after construction. In the spring of 1973, the pavement dropped several centimeters to bring the cumulative patch to 46 cm (about 18 in). Complete failure of the embankment was anticipated for the spring of 1974 because past movements had been largest during the spring and recent monitoring had indicated an increase in the rate of movement. A design for a stabilization project to counteract the effects of the hydrostatic pressure that was believed to be causing the failure was prepared that consisted of a berm and shear key at the toe of the embankment. Implementation of this design, however, could not be completed before spring. Therefore, it was decided to stabilize the embankment by decreasing the excess hydrostatic pressure by installing a system of horizontal drains, a project that could be completed before spring and at a cost saving of \$1 000 000. The project was completed in early spring of 1974, and the embankment has been stable since then. This

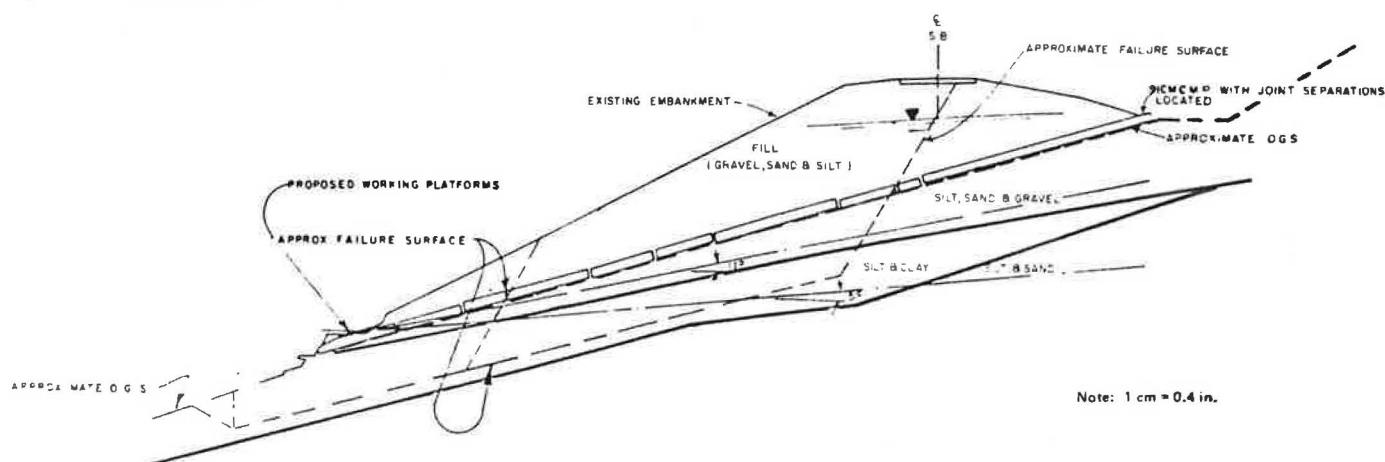
The cross section shown in Figure 3 indicates the soil profile and observed static water table. The obser-

vation wells indicated a variable artesian pressure below the silt and clay layer, and measurements in these wells indicated significant lateral movement in the lower part of the silt and clay strata.

An analysis of the data obtained by the end of July 1973 suggested that a progressive wedge-type shear failure was occurring through the silt and clay. The most significant factor contributing to the failure was that, since construction, the static water table had risen 21 m (approximately 70 ft) in the embankment.

Figure 3. Cross section: typical soil profile.

from an educated guess rather than a theoretical analysis. Basically, the drains were to be installed in a fan-shaped pattern from the toe of the embankment at two different inclinations. The upper level was to be installed above and parallel to the silt and clay strata to achieve the maximum possible drawdown in the embankment material and to prevent recharge during peak runoff. The lower level was placed so as to provide drainage for the lower permeable strata (see Figures 3 and 4).

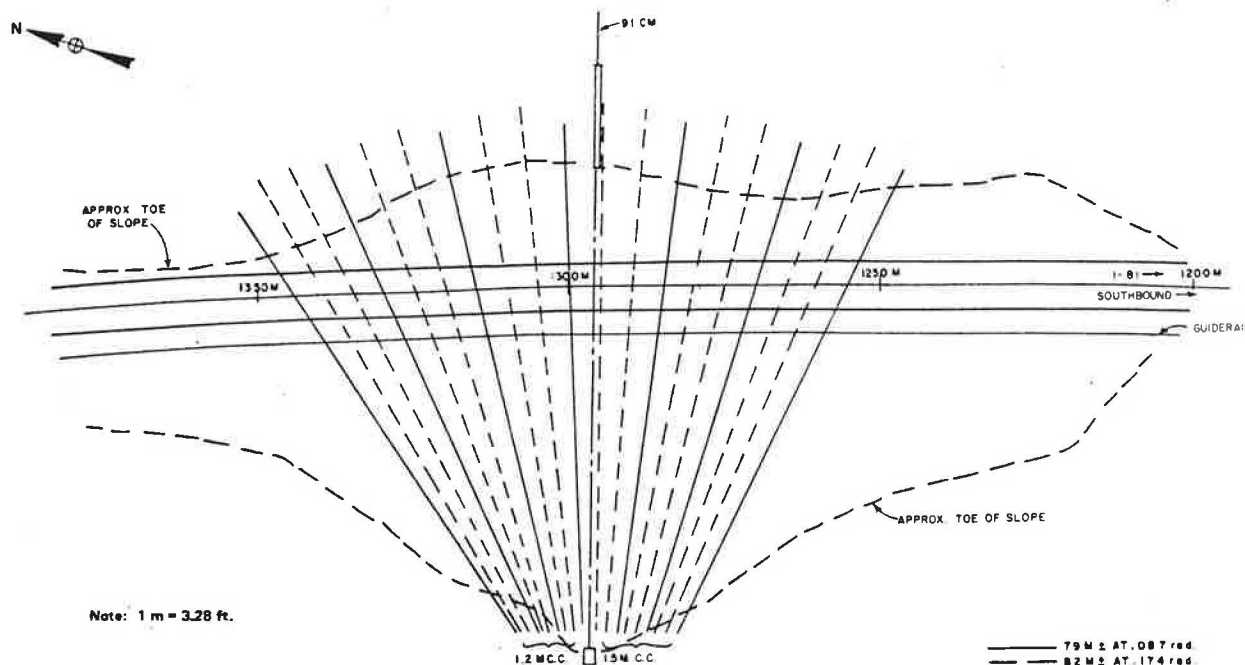
Figure 4. Drain layout: plan view.

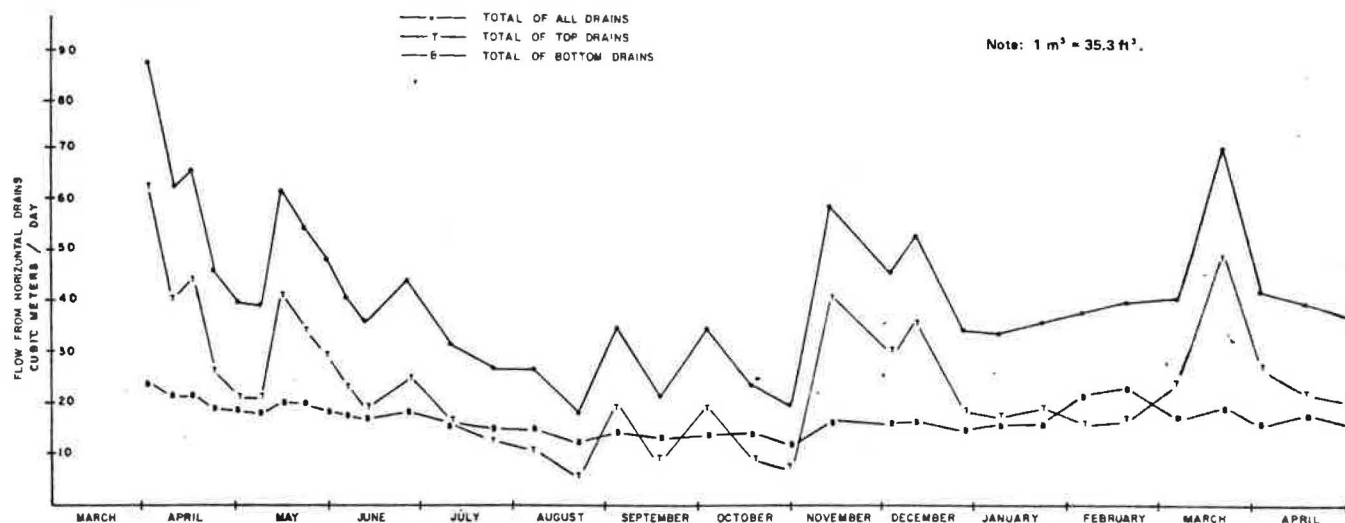
The total flow rate and the flow rates from each level of drains are shown in Figure 6. Records from a nearby weather station indicate that the upper level of drains

Figure 6. Flow data.

may be sensitive to rainfall. The flow data obtained after April 1975 indicate that the total flow is generally increasing. However, these readings were obtained during traditionally wet seasons. The data shown suggest that more information is desirable for a long-term performance evaluation of the drains.

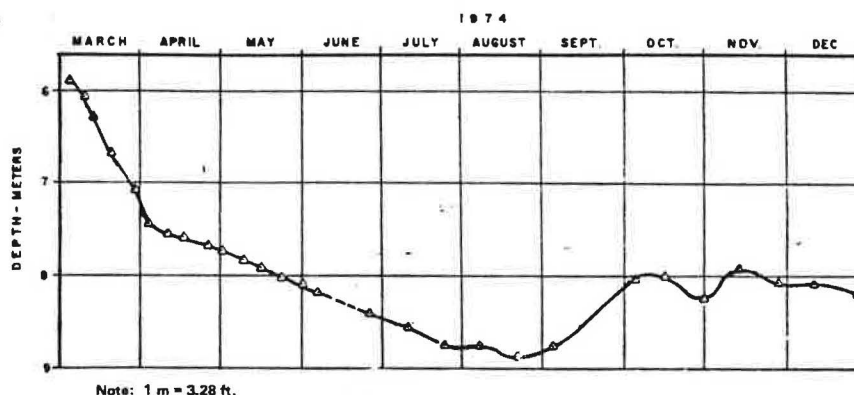
Figure 7. Typical drawdown curve: observation well DAF-14.

The typical drawdown curve shown in Figure 7 indicates that the static water table above the silt and clay strata was generally lowered 3 m during 1974. This drop, coupled with a 1.5-m (5-ft) reduction of the water table in both the silt and clay and the underlying silt and sand was sufficient to provide stability. The data to date indicate that the drop in the water table will be long term.
