Evaluation of the Durability of Metal Drainage Pipe

RICHARD W. KINCHEN

Preliminary results are presented of a 10-year field study undertaken in Louisiana to determine the ability of aluminum and galvanized-steel culverts to resist corrosion in moderate, acidic, and low-electrical-resistivity environments. In 1973, 10 types of aluminum and galvanized-steel culverts were installed, generally as side drains, at 10 test locations. One pair of each type of culvert was installed at each site. Every two years, investigators are removing one designated culvert of each of the pairs and subjectively rating the condition of the metal and protective coating. Field samples of the culverts are evaluated in the laboratory, and the test culverts are installed again after each inspection.

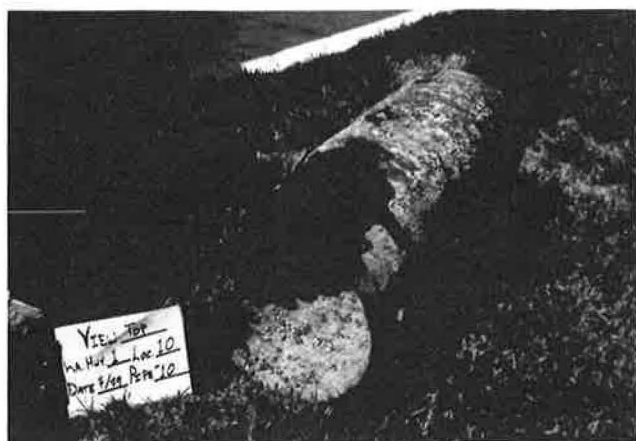
resistivity. An increase in the rate of corrosion can also be noted in Table 2 as the character of the environment changes from moderate to acidic and then to low electrical resistivity. Figure 2 shows the advanced level of corrosion in the galvanized-steel test culvert after six years in the low-resistivity (brackish-water) environment. Figure 3, a photograph taken after six years, shows that corrosion of this type of culvert is progressing at a slow but steady pace in an acidic environment. The soil-side corrosion shown in Figure 3 indicates that the nature of the soil as well as the nature of the effluent should be considered in specifying and designing metal culvert for durability. In Figure 4, the galvanized-steel test culvert is shown to be resisting corrosion quite well after six years in a moderate environment.

Figure 2. Condition of galvanized-steel culvert in low-electrical-resistivity environment (site 10) after six years.

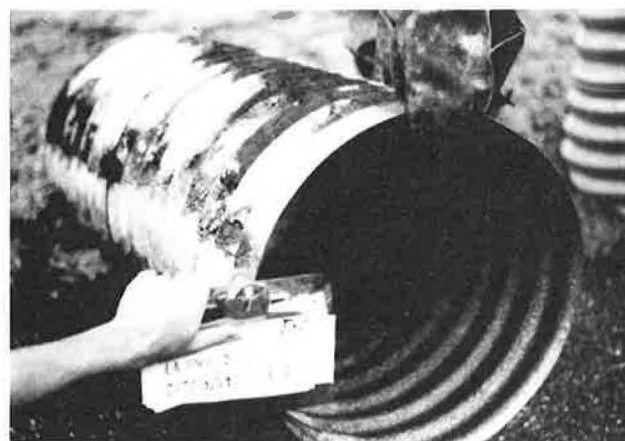
Figure 3. Condition of galvanized-steel culvert in acidic environment (site 4) after six years.

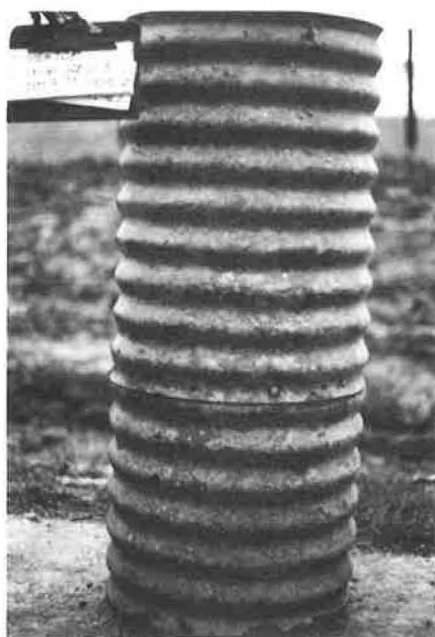
Figure 4. Condition of galvanized-steel culvert in moderate environment (site 5) after six years.

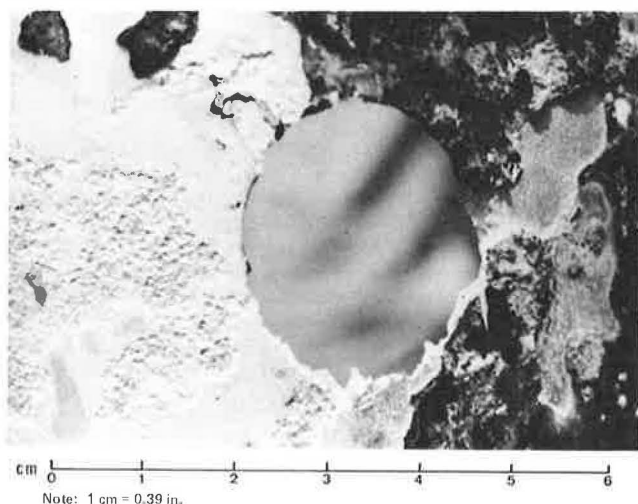
Figure 6. Pitting and thickness loss in aluminum-alloy plate arch after six years in low-resistivity environment (site 10).

Panel ratings for the aluminum-alloy-plate-arch test culvert are also given in Table 2. These ratings have generally been on the borderline between good and fair except at sites 6, 7, 9, and 10 (the four brackish-water sites), where the panel has through the years noted severe pitting and thickness loss and perforation of two of the test plates.

The plate arch is not clad with another aluminum alloy as were the round aluminum-alloy pipes mentioned above. However, the aluminum-alloy plate and pipes did experience similar signs of deterioration--pitting and thickness loss. These signs are shown in Figure 6, a close-up field photograph of the plate arch at site 10.
