The Rural Mailbox: A Little-Known Roadside Hazard

HAYES E. ROSS, JR., KENNETH C. WALKER, AND W. J. LINDSAY

The results of seven full-scale crash tests conducted at the Texas Transportation Institute to evaluate the impact behavior of rural mailbox installations are reported. Three of the seven tests—two of single-box installations and one of a four-box installation—involved commonly used wood-post supports. Two tests of single-box installations involved promising new support concepts that use standard steel pipe with a breakaway mechanism. The final two tests involved a steel-pipe, multiple-box support in the shape of an inverted U. The results showed that installations with multiple boxes mounted on boards pose a serious hazard to motorists because the board can easily penetrate the windshield. The inverted-U design eliminated the penetration problem, but the change in vehicle momentum on impact exceeded the recommended limit. The results also showed that, for a single-box installation, a pipe post performs better than a wood post. Careful attention must be given to the box-to-post attachment to prevent separation during impact and thus minimize the potential for windshield pene

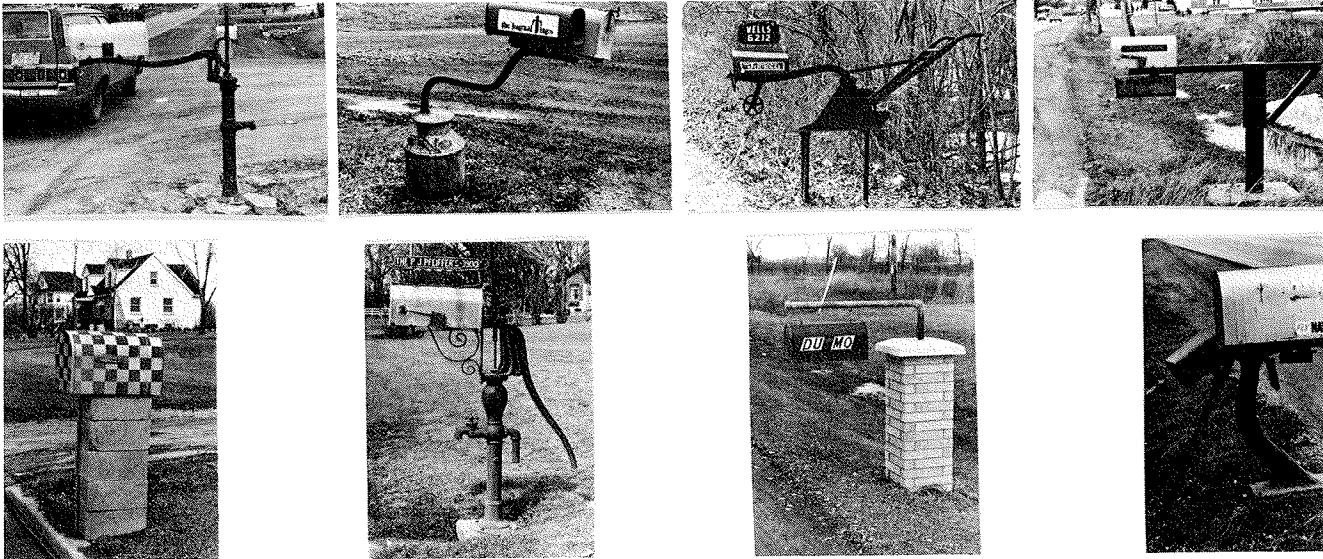
Figure 1. Single-box installations.

Figure 1 shows some of the "ingenious" devices used to support mailboxes. These include steel tractor wheels, old-time stoves, water pumps, plow-shares, milk cans filled with concrete, massive I-beams, and pipes. Such supports may be artistic to some, but most are serious roadside hazards.

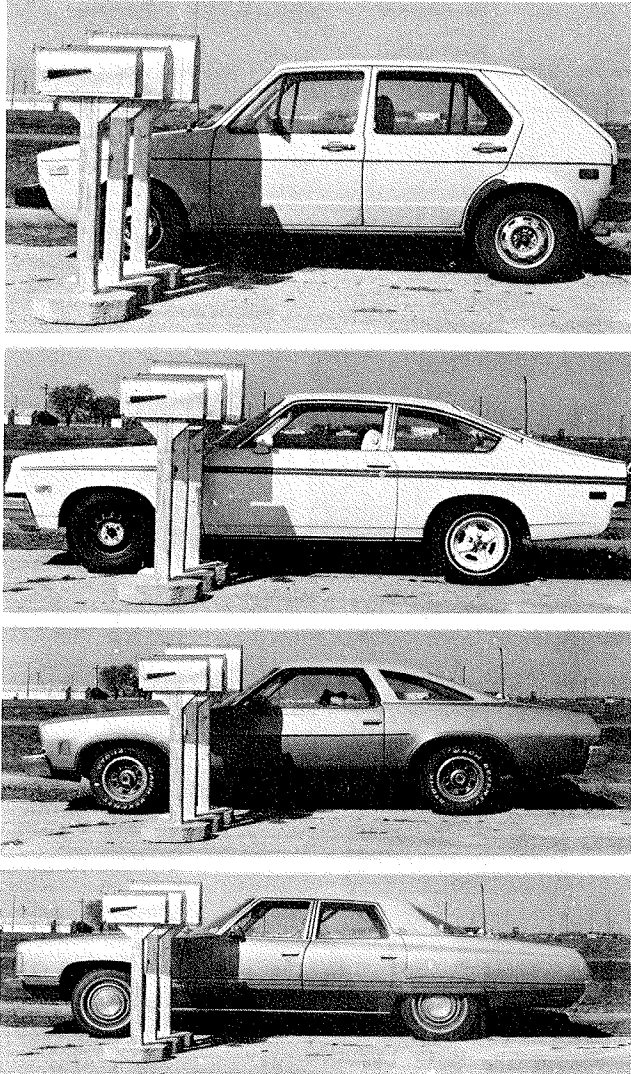
Figure 2. Mailbox height in relation to vehicle windshield.

Mailboxes are hazardous primarily because of the mounting height of the box. Most boxes are mounted approximately 42 in (106.7 cm) above ground to make it easier for the mail carrier to place mail in the box. As Figure 2 shows, this height places the box in direct line with the windshield of many vehicles. The support systems shown in Figure 2 were used for illustrative purposes only and are not considered crashworthy systems. The base of each of the three different-sized boxes is approximately 42 in above the ground.

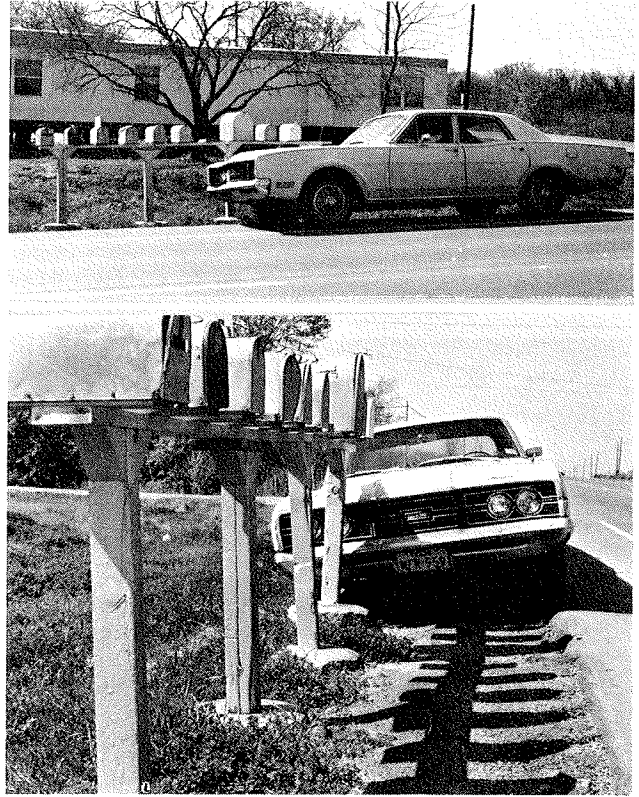
Figure 3. Multiple-box installation.

Mounting several boxes on a wood board compounds the problem, since the board can spear through the windshield. Field installations of multiple boxes are shown in Figure 3. Figure 4 shows what may be a record for the number of boxes mounted on one continuous support (more than 200).

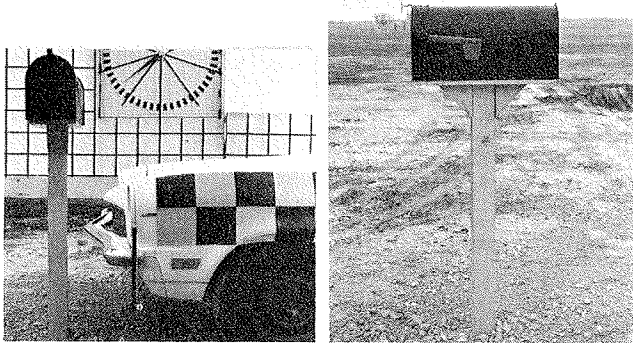
Figure 6. Completed installation, test 22.

In test 22, almost immediately after impact, the mailbox, mailbox base, and base braces separated from the post. Shortly thereafter, the post broke away at ground level. Because of inertia, the mailbox and timber cap remained almost stationary as the post broke away. Then the box struck the top of the hood and rolled into the windshield, breaking and dishing the windshield and bending the molding above it. It did not, however, penetrate into the passenger compartment. Other than a broken windshield, the vehicle sustained only minor damage.

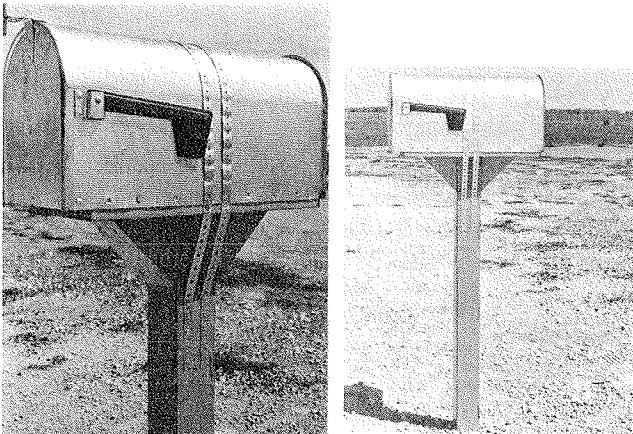
Figure 7. Completed installation, test 23.

In test 23, the post split on impact at the top where the connecting straps were attached to the post and then broke on the side away from impact. The mailbox and timber cap gained little velocity during the initial impact. After the support broke at ground level, the vehicle continued moving forward and the mailbox struck and broke the windshield. However, the box did not penetrate into the passenger compartment.

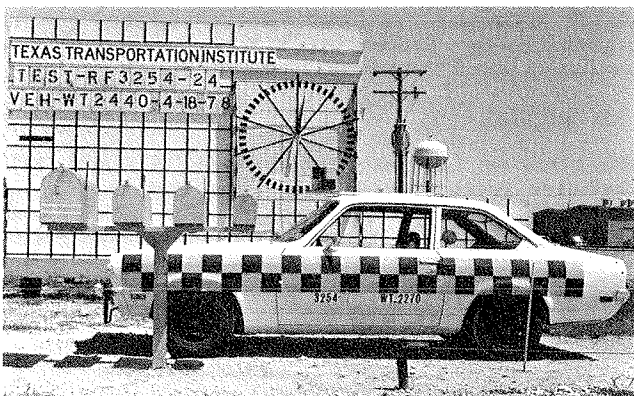
Figure 8. Completed installation, test 24.

In test 24, the support post broke on impact at ground level and at bumper height [20 in (50.8 cm)]. The support arm also separated from the post soon

after impact without gaining any significant velocity. As a result, the support arm and four mailboxes hung in midair as the vehicle drove into it. When the support arm hit the windshield, three mailboxes entered the passenger compartment along with 75 percent of the support arm (see Figure 15). The dummy was struck on the chin by the support arm and was almost decapitated. The impact also forced the seat back. There is little doubt that a driver would have been killed under these circumstances.
