Use of Horizontal Drains: Case Histories from the Colorado Division of Highways

ROBERT K. BARRETT

Horizontal drains have been used on western Colorado highways for several years, in both preconstruction and postconstruction applications. In specific cases, horizontal drains have proved to be cost-effective in preventing and correcting failures in cut-and-fill slopes. The use of horizontal drains has been limited to specific locations at which subsurface mapping and sampling indicates that groundwater is a major detrimental factor and that it can be effectively collected for a required period of time. This report describes four case histories, all located on Interstate 70 in the Vail area of west-central Colorado. At site 1, horizontal drains were used as a postconstruction alternative to a deep underdrain trench that would have cut across an Interstate roadway. At site 2, horizontal drains were used to improve drainage behind a cut slope. At site 3, the drains were used to improve slope stability prior to construction of a major reinforced-earth wall. At site 4, horizontal drains were used for correction of a major cut-slope failure that occurred during construction.

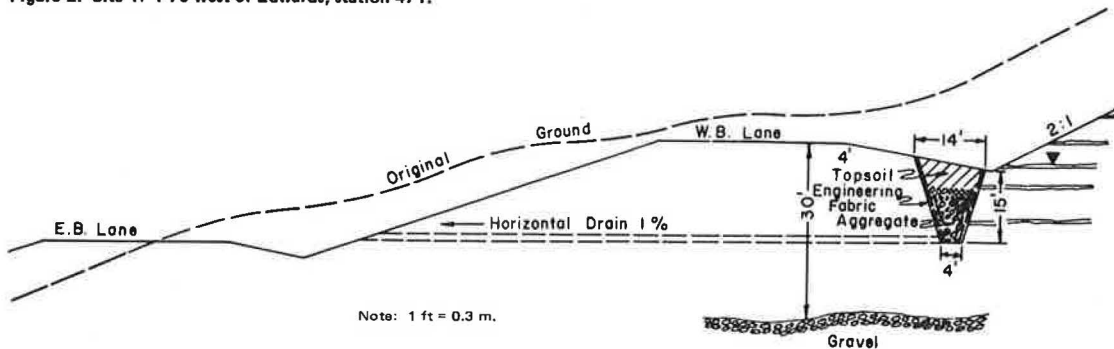
Figure 2. Site 1: I-70 west of Edwards, station 471.

An unusual groundwater problem developed in the cut slope north of the westbound lanes of I-70 around station 470, about 3.2 km (2 miles) west of Edwards in west-central Colorado. The westbound cut and the eastbound fill were constructed during the summer of 1969. Nothing was observed during preliminary soils and geologic studies to indicate a high water table, and the cut remained dry during construction (see Figure 2).

Each autumn following construction, the cut slope became progressively wetter yet remained dry during the spring and summer. During late summer and fall of 1976, the water problem expanded further to include the median section. It was feared that, should the trend continue, the eastbound embankment could become saturated and fail. An investigation was begun to determine causes for the seasonal groundwater occurrence.

It was concluded from the investigation that the seasonal groundwater flow was related to irrigation and snow melt. Water surfaced in the westbound cut from buried stream channels. The eastbound fill acted as a dam as well as compressing underlying soils. These two actions reduced permeability and caused more water to be available to the westbound ditch. Each annual cycle further developed water courses to the westbound ditch area, which caused a greater flow each year at the expense of other, slower paths.

It was concluded that the progressive development of these water courses could lead to sufficient saturation of the eastbound embankment and underlying soils to cause failure and that corrective action was warranted.

Collection of the water was facilitated by means of the 183-m trench, which was dug in the westbound ditch to a depth of about 4.7 m (15 ft). The trench was lined with a synthetic nonwoven engineering filter fabric and filled to within 1.5 m (5 ft) of the surface with free-draining screened aggregate. After the engineering fabric had been folded over

The horizontal drain outlets in the median were collected into an open-graded gravel French drain and piped via a short underdrain into the median culvert inlet.

This correction avoided the traffic-control problems. It was constructed at a total cost of \$44 344.66, a substantial saving over the conventional underdrain method (1).

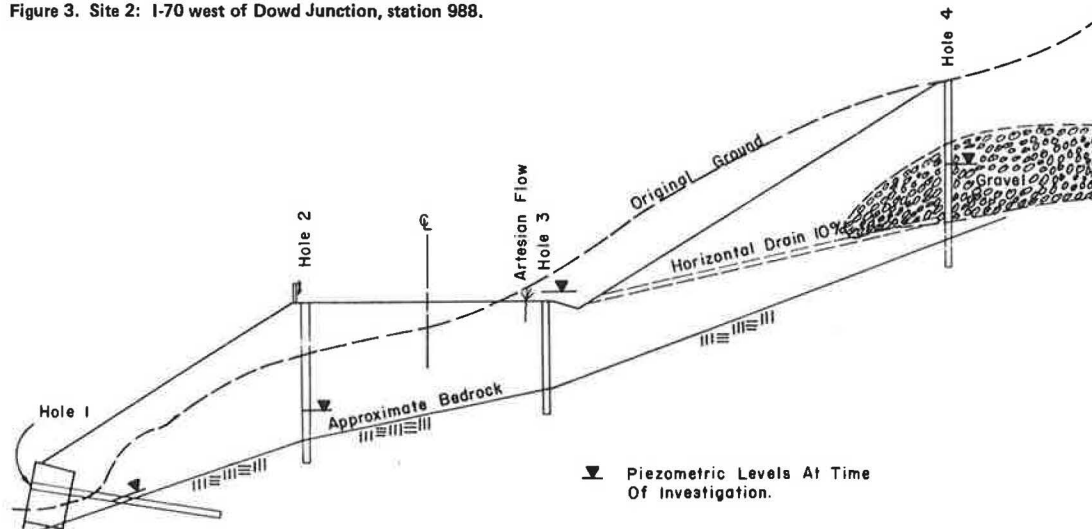
Figure 3. Site 2: I-70 west of Dowd Junction, station 988.

The roadway template in the subject area consists of a narrow-median, sidehill cut-fill section that has a 1.5:1 cut 17 m (50 ft) high for eastbound lanes and a 1.5:1 fill 17 m high retained by a metal bin wall 7 m (22 ft) high located on the shoulder of old US-6 (see Figure 3). When the water was observed, a field inspection was made of the entire area. The inspection revealed that the bin wall was exhibiting distress. Three vertical members were overriding and crushing at the mid-height connections. Total downward movement at mid-height had amounted to about 5 cm (2 in).

It was feared that the westbound fill had inhibited groundwater flow in the underlying soil and that a pore-pressure buildup had resulted that could overturn the wall. A drilling program was launched immediately to determine piezometric levels in the area.

Drilling was then extended upslope above the 17-m 1.5:1 cut. A totally unsuspected major gravel deposit was discovered--a buried channel of the Eagle River. This feature was not detectable on aerial photographs and had not been encountered during subsurface investigations during the preliminary engineering phase. Slope-design borings had not extended upslope far enough to encounter the channel.

The springtime artesian phenomenon in the pavement was determined to be related to snow-melt storage in the gravel. Construction of the fill and removal of a significant loading by cutting probably influenced preexisting, preferred drainage paths for the water.

The problem was resolved by installing a series of horizontal drains from the cut-slope ditch line upward into the base of the gravel formation. By the time the drains were actually installed, the artesian flow had ceased. Small amounts of water were initially encountered in the gravel, but this flow also ceased in the autumn. During the following spring, a considerable flow was observed from the drains, and no water appeared in the pavement.

It was determined that movement or readjustment in the bin wall had ceased. The wall was instrumented and monitored for two years; there was no indication of significant vertical or horizontal movement. A likely reason for the distress was some readjustment and settling of backfill material within the bins, which could pull the metal downward and produce overriding at joints in vertical members.

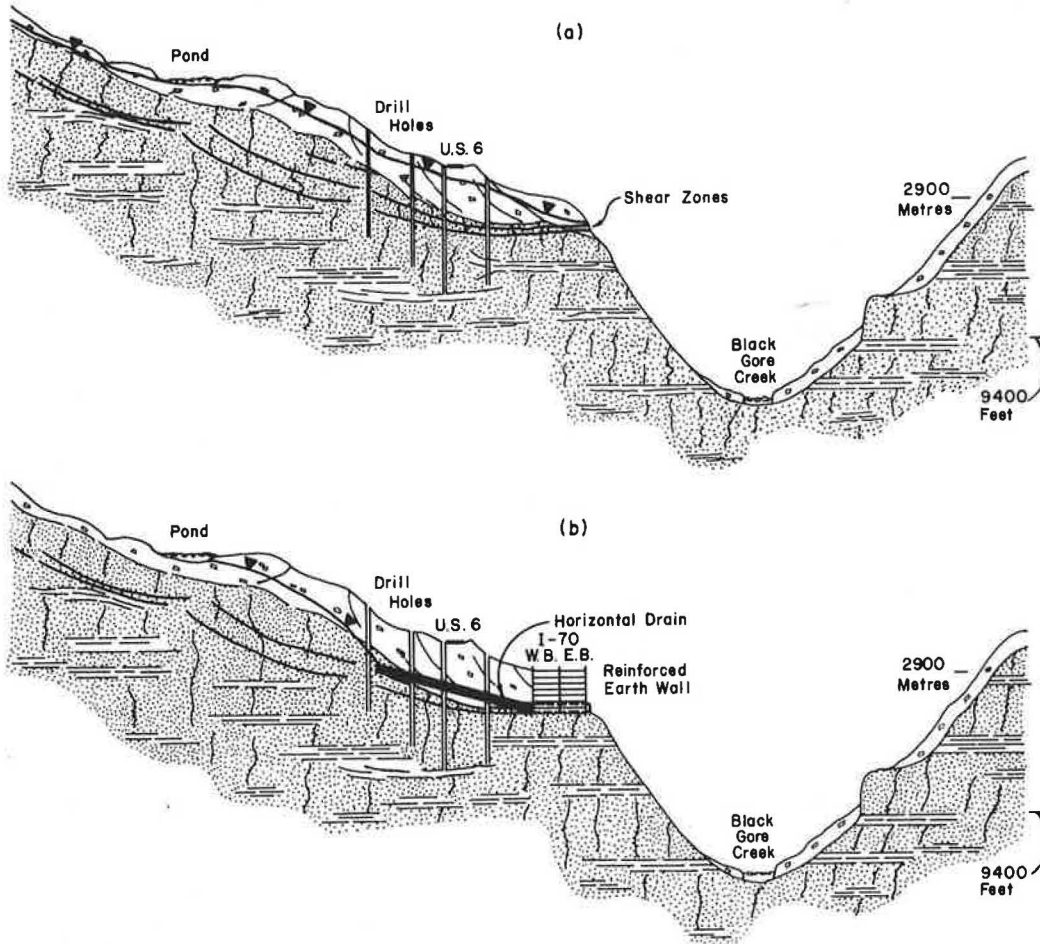
Figure 4. Site 3: I-70, Miller Creek area, Vail Pass, station 550.

The most difficult and challenging problem for geotechnicians on Vail Pass was in the area known as the Miller Creek slide. Maximum dimensions of the slide area are more than 1 km (0.75 mile) long, almost 1 km (0.50 mile) wide, and about 46 m (150 ft) deep. The slide consists of up to 21 m (70 ft)

of surficial silty soils that overlie about 24 m (80 ft) of failed bedrock. Water levels varied; in some areas there was water standing in escarpment ponds while other areas were dry (see Figure 4a and 4b).

During the earliest drilling, the lowermost failure plane was thought to be at the interface between soil and rock. Two core drill holes that extended 6 m (20 ft) below this contact indicated intact sandstone and siltstone that dipped about 4°. This matched the geology in the surrounding area. It was found, however, that this did not match a deep core hole drilled previously by the Denver Water Board in conjunction with a proposed water-diversion tunnel (3). A third hole was drilled to 46 m (150 ft) and several obvious shear zones were found. Additional drilling revealed areas of completely disrupted bedrock. Competent, intact bedrock was below this zone. The bedrock failure planes were dipping only 4° in the lower reaches of the slide.

In March 1974, a series of horizontal drainage holes was drilled in an effort to lower the groundwater table. A drill access road was attempted along the lower margin of the slide toe along the rim of the canyon. The area was saturated and not frozen. A 2.1-m (7-ft) snow cover had not allowed frost penetration and the bulldozer became helplessly mired. A second road was successfully built about 6 m (20 ft) higher vertically that allowed access of drill equipment. Minimum expectation from drainage holes at this level was to help dry the lower area for a future drainage project.

The horizontal drilling proved successful and interesting. Some intact blocks of rock were encountered that were as large as 24 m (80 ft) across, and almost invariably great bursts of water would flood from the drill holes when the bit broke through and into a shear zone. One such flow was measured at about 575 L/min (200 gal/min). Most flows dropped off substantially in 30 min to 2 h after the aquifer had been tapped.

Water levels were reduced almost 11 m. Due to the low cost and great success of the drainage program, it was decided that it would be worthwhile to drill another series of holes at a lower elevation in conjunction with the construction project. When the second series of drain holes was completed more than two years later, the toe area had, in the interim, dried substantially. The second series lowered water levels to about 17 m below the ground surface within the roadway template.

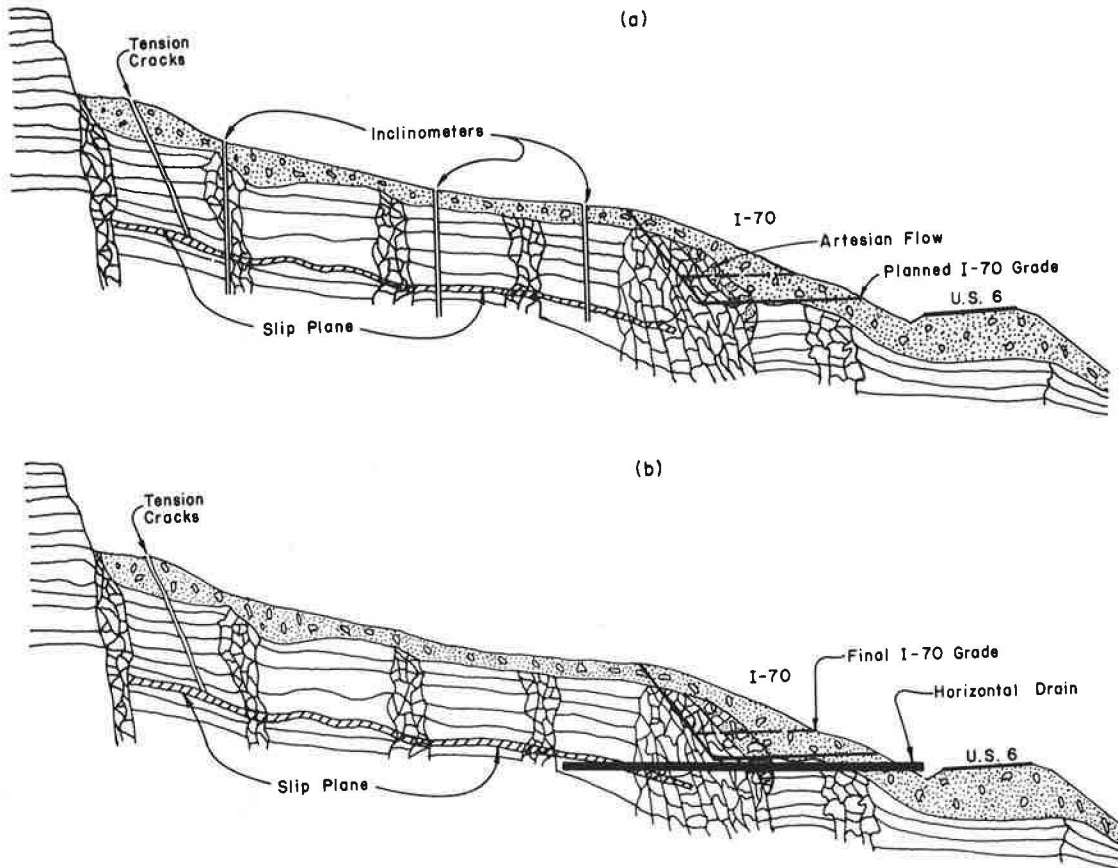
Figure 5. Site 4: I-70 west of Vail Pass Summit, station 712.

tion had proceeded to the 33-m (100-ft) level of a through-cut at station 712 planned to be 46 m (150 ft) deep when water began to flow from the floor of the cut. By the following day, tension cracks had appeared 91 m (300 ft) upslope. The contractor was ordered to cease work in the immediate area. An investigation was initiated immediately, which included drilling and instrumentation (see Figure 5a and 5b).

The investigation revealed that the failure was a reactivation of an original failure along a very thin, weak clay shale seam that underlay a sandstone-siltstone sequence. This dipping slip zone was impermeable to the extent that groundwater trapped underneath was under artesian pressure. Exit paths that appeared in the cut floor were quite selective, even though the cut proper was in a highly rubblized zone. It was apparent that a vertical drill hole could have missed the groundwater. The single upslope slope-design drill hole was also drilled in a shear zone. Hence, it was felt at that time that a 1.5:1 slope would have a reasonable probability of stability. Drilling and instrumentation subsequent to the failure located failure planes and piezometric levels in the slide. It was apparent that high piezometric levels were the cause of the failure.

Installation of horizontal drains began some three weeks after the problem was first observed. By that time, total movement exceeded 2 m (6 ft) in some areas, and the failure had spread both upslope and laterally until about 152 000 m³ (200 000 yd³) were involved. Drain holes were drilled below the slip plane from US-6, which was about 12 m (40 ft) vertically below final grade and about 18 m (60 ft) below the slip plane.

The initial holes produced spectacular results. Flows that exceeded 378 L/min (100 gal/min) were encountered in the vicinity of the contact between the slip plane and the shear zone. Water in the grade quickly dried and piezometric levels dropped substantially over the lower portion of the slide. Movement slowed and ceased shortly thereafter.

The final correction included a grade raise of 6 m (20 ft) along with provisions for positive, long-term flow capability from the various drains. Total cost of the slide correction was \$785 000, due
