# Rockwood Embankment Slide Between Stations 2001+00 and 2018+00: A Horizontal Drain Case History

WILLIAM D. TROLINGER

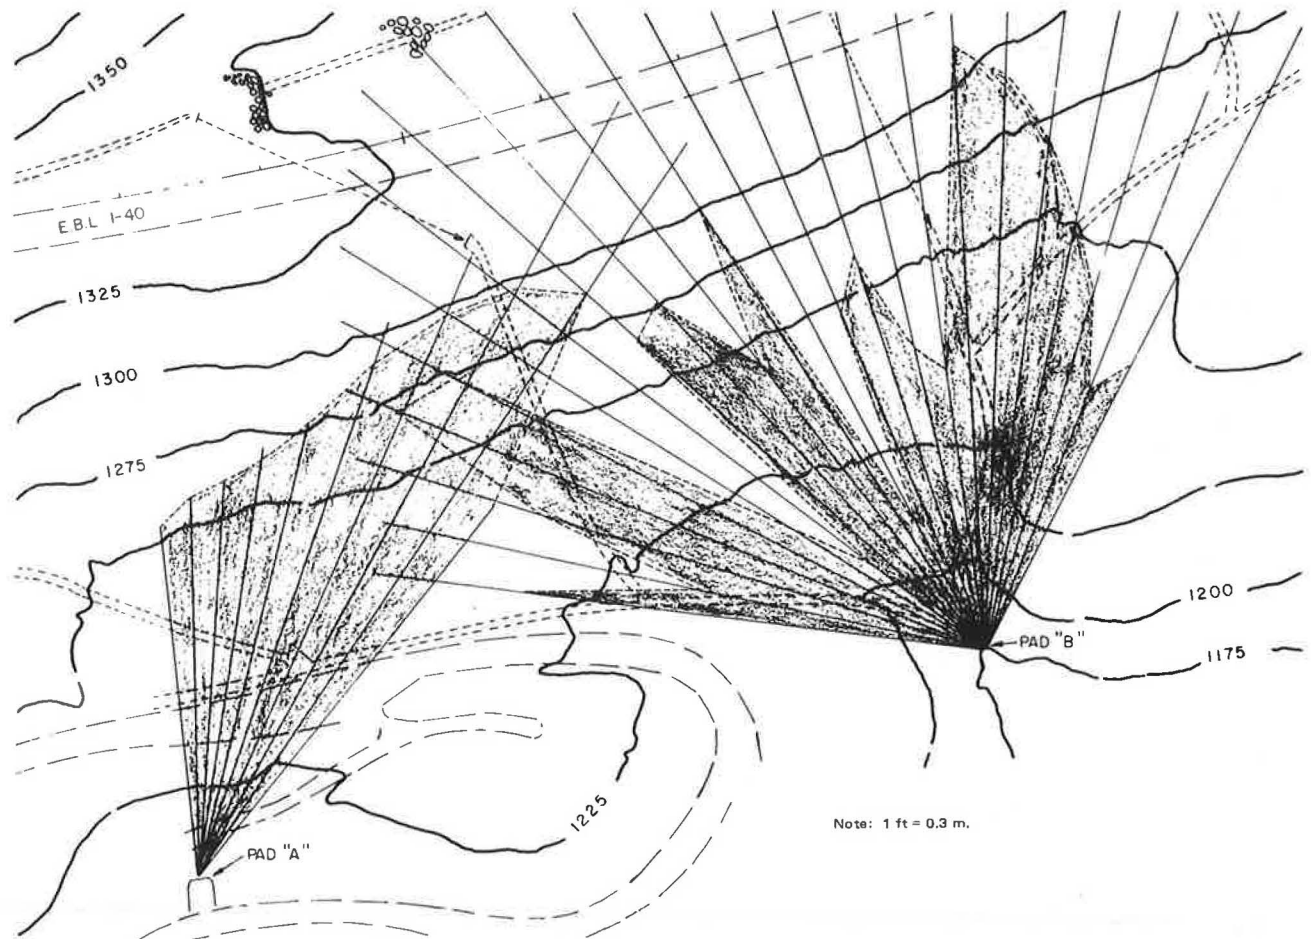
Figure 5. Horizontal drain layout at pad A and pad B, 2001+00-2018+00 slide.

Because of the success of horizontal drains on the I-75 projects it was felt that a modified deep drainage system as proposed in June 1969 could be installed at a much lower cost by using horizontal drains. As a result, a project was begun in August 1975 to install horizontal drains in the two ravines below the fill. Along the slide between stations 2001+00 and 2018+00, 33 drains were to fan out from two centers, one in each ravine (shaded area, Figure 5). At these two centers (pad A and pad B), drilling platforms were excavated at an elevation of 367 m (1175 ft). The excavations into natural slopes of approximately 4H:1V provided a vertical face into which drilling progressed. Grades of 5 percent and lengths that ranged from 27 to 146 m (90-480 ft) were installed in the 10 holes at pad A and 23 holes at pad B. Lengths of up to 183 m (600 ft) were planned for several holes in order to provide drainage from beneath the embankment; however, because of the geologic conditions and the equipment and procedures available at the time, these lengths could not be achieved. Most of the holes were

Schedule 80, type II polyvinyl chloride plastic pipe that had an inside diameter of 38.1 mm (1.5 in) was inserted in each hole as a liner. The pipe, supplied in 6.1-m (20-ft) sections, was inserted through the drill stem as it was extracted from the hole. Because of the variation in the grain size of the materials in the embankment, slot openings of 0.51 mm (0.020 in) were used. After all drains at a pad had been completed, the outer 3-6 m (10-20 ft) of the plastic pipe was encased in corrugated pipe 152.4 mm (6 in) in diameter and the slope reshaped by using shot rock (Figure 6).

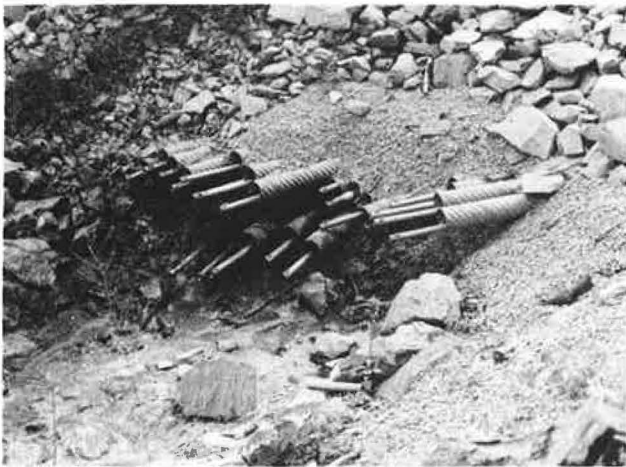
Figure 6. Completed horizontal drain installation at pad B.

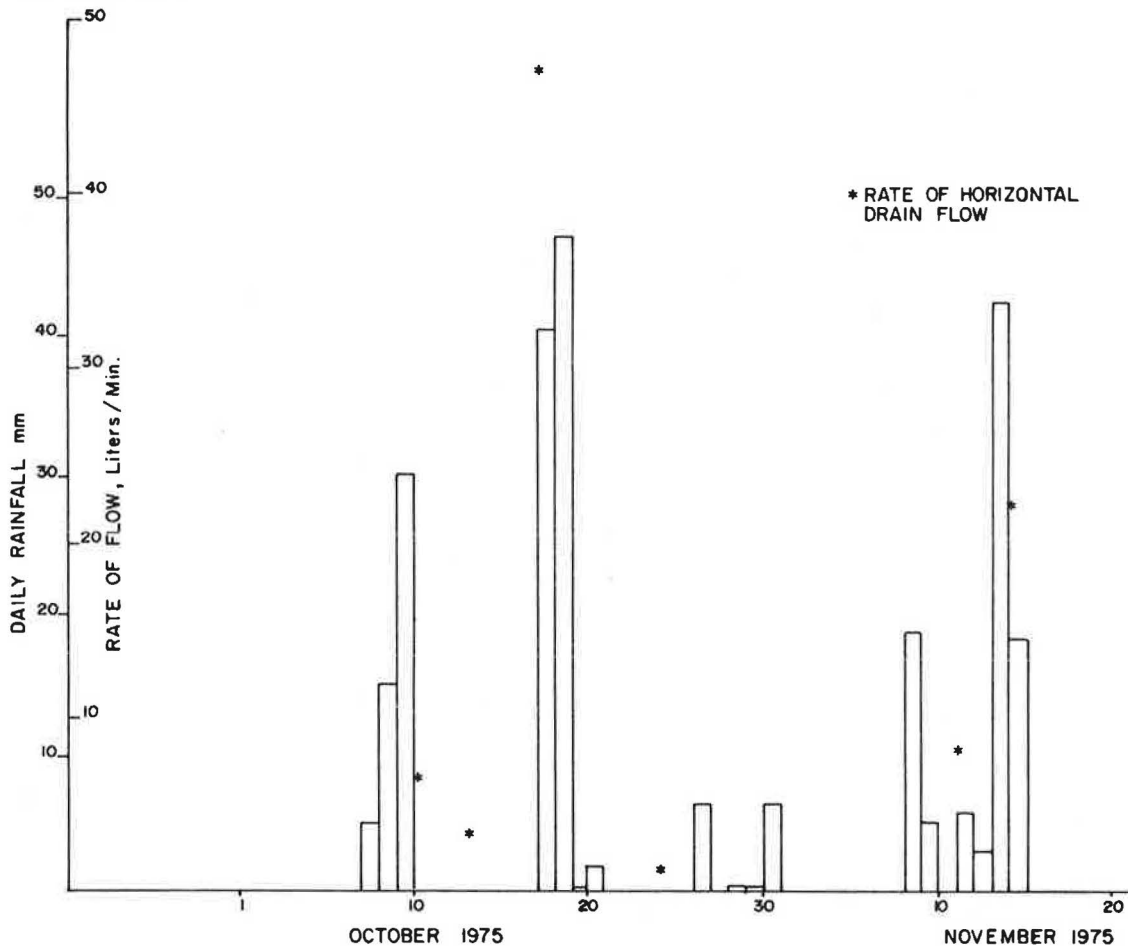
The second factor that influenced the total flow consisted of the almost-immediate response to short-duration heavy rainfall. Figure 7 shows the daily rainfall and the corresponding rate of flow for drain number 23 during October and November 1975. On both October 17 and November 13, the rate

Figure 7. Daily rainfall versus rate of flow at drain number 23.

of flow increased either during or immediately after heavy rainfall.
