Long-Term Performance of Horizontal Drains

DUANE D. SMITH

A history is given of the 40 years of development of horizontal drain installation techniques and equipment in California. The long-term performance of three drain installations—Cloverdale, 1941; Nojoqui Grade, 1940; and Pacific House, 1969—is evaluated. Major factors that influence the long-term performance of horizontal drains are discussed, such as location and installation methods, the frequency and quality of inspections, cleaning and maintenance programs, the types of casing used, the lithologic characteristics of the site, the pH and mineral contents of the groundwater, and the protective measures necessary to preserve external features such as outlets and collector systems.

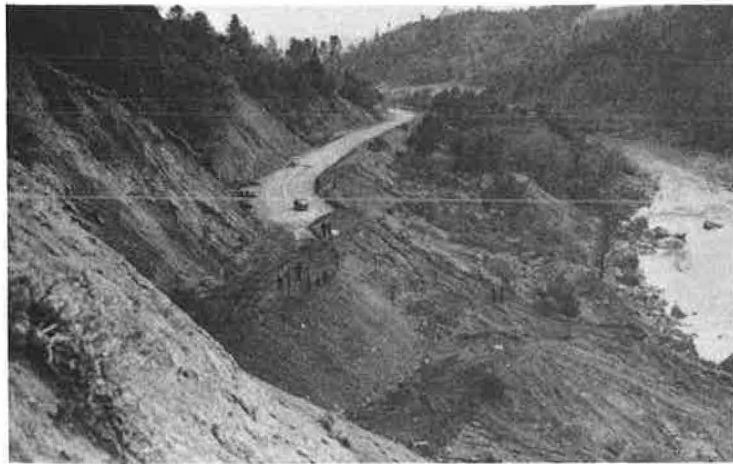
During extremely heavy rainstorms in February 1941, a large landslide occurred on CA-101 near Cloverdale, about 145 km (90 miles) north of San Francisco. Portions of a high cut slope and side-hill embankment in poorly bedded, sheared shale with minor lenses and beds of sandstone slid into the Russian River and severed approximately 335 m (1100 ft) of the roadway (Figure 7). Large quantities of water in the form of springs and saturated slide debris were associated with the failure.

Figure 7. Cloverdale landslide and slipout, December 1941.

Corrective measures included a benched 1.5:1 cut slope and a reconstructed 2:1 embankment slope. Between March and June 1941, 97 horizontal drains were installed by using the Hydrauger equipment and 5.1-cm (2-in) perforated steel casing placed in 10.2-cm (4-in) drilled holes. The loose broken shale caused a great deal of difficulty during the installation. The average drain length was only 16.7 m (55 ft). Several holes were abandoned because of

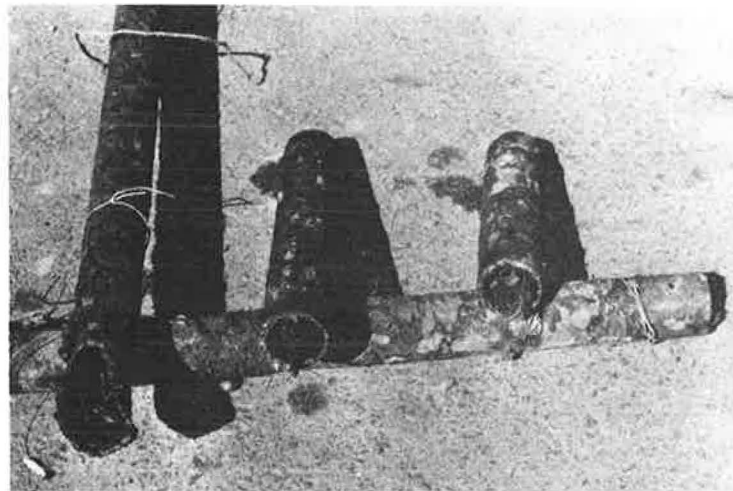
Drain outlets and downpipes were connected to corrugated metal pipe that was buried below the shoulder, which thus prevented periodic inspection of the drains. Heavy rains during the winter of 1955-1956 produced appreciable quantities of water, which appeared in various places along the toe of the cut slope. Investigation of the 15-year-old installation showed that this water was coming from around the horizontal drains, which had ceased to function properly because of heavy deposits of rust, gypsum, and root growth (Figure 8).

Figure 8. Rusty and rootbound 5.1-cm (2-in) casing from Cloverdale.

As a result of the inspection, a drain-cleaning and restoration program was recommended and completed in the summer of 1956. A total of 49 drains was located. Prior to cleaning, the drains produced a combined total flow of 697 m³/day (184 250 gal/day); one drain produced 541 m³/day (143 000 gal/day) of this total. Immediately after being cleaned, they produced a cumulative total flow of 1077 m³/day (284 440 gal/day). This flow increase clearly illustrates the value of the work performed (Table 1).

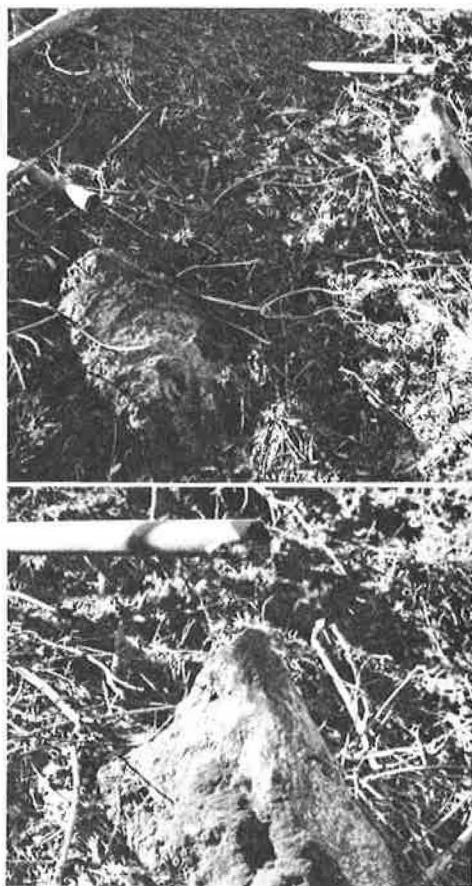
Figure 9. Iron oxide and algae build-up, Nojoqui Grade, 1978: distant view of two drains (top) and close-up of drain at right (bottom).

Several of the buried drains were uncovered by the contractor's equipment and were still functioning. The casings were mostly rusted through. Those drains that had exposed outlets had large accumulations of rust and algae on the ground below the casing (Figure 9).
