Fatigue Cracks and Their Detection

J.W. BALDWIN, JR., H.J. SALANE, AND R.C. DUFFIELD

A three-span continuous composite bridge of modern design was field tested under fatigue loading that produced stresses equal to or greater than design stresses. During the fatigue loading, a regular inspection schedule was carried out by using radiographic, ultrasonic, and visual methods. Ultrasonic inspection was the most reliable and, in the regions inspected regularly, no cracks are known to have grown to a length greater than 38 mm (1.5 in) before detection. Radiography was nearly as reliable as ultrasonic inspection where it could be used, but more than half the material to be inspected was inaccessible to radiography. A total of 18 fatigue cracks developed at the ends of welded cover plates and 2 fatigue cracks developed in base metal not adjacent to welds. At 471 000 cycles of loading, these cracks had propagated far enough to completely sever the girder flanges at five different sections. The fatigue life in regions where the stress range was 155 MPa (22.5 ksi) was considerably longer than would be predicted on the basis of current code requirements. However, the fatigue life in regions

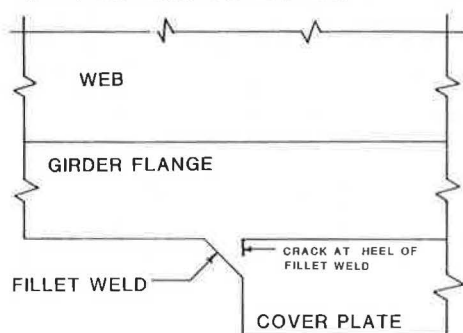
During the inspection at the end of 19 500 cycles of load, cracks of the order of 6.4 mm (0.25 in) length were detected ultrasonically in five of the eight critical flange regions. After 287 000 fatigue cycles, cracks had been detected in all eight of these critical regions. These cracks did not initiate at the toe of the weld as might have been expected but started at the root or heel of the weld at some point across the end of the cover plate as shown in Figure 3. These cracks did not enter the girder flange at this point but propagated along the

Figure 3. Crack initiation at heel of weld.

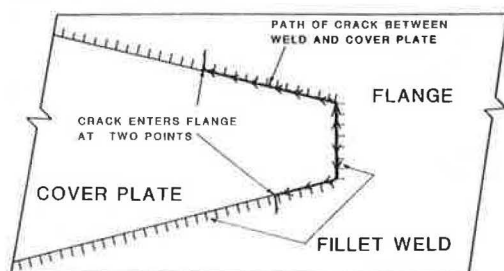
Figure 4. Crack propagation.

fusion line to the surface of the weld and across the end of the cover plates. In most cases, they turned the corner of the cover plate and proceeded along the beveled edge until at some point the crack turned into the weld metal propagating perpendicular to the axis of the beam (Figure 4). Once the cracks had entered the weld material, they continued through it into the base metal of the bottom flange and continued to grow in the typical semielliptical pattern. In five of the eight critical flange regions, the cracks propagated into the base metal on both sides of the cover plate, which resulted in two separate cracks in the base metal (Figure 5).

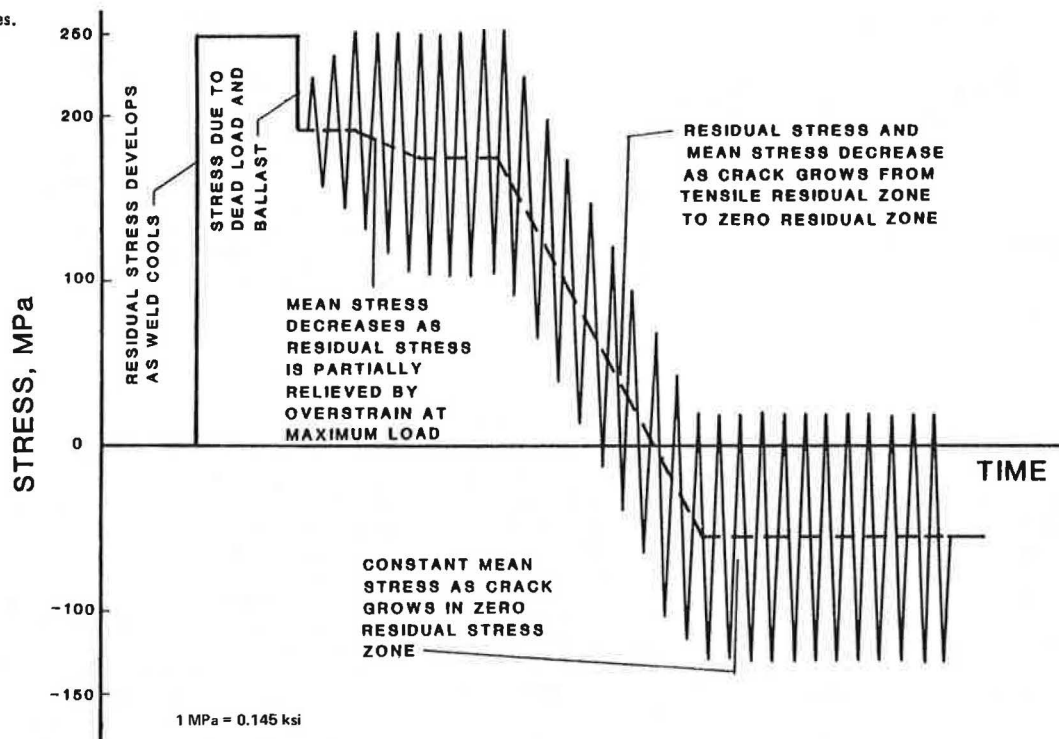
Mean stress at the crack tip then remained constant and maximum stress reached the yield point on each cycle as the crack propagated through the tensile-residual-stress zone. As the crack propagated from the tensile-residual-stress region into the region of zero residual stress, the mean stress decreased to -60 MPa (-8.75 ksi), the sum of dead load and ballast stresses.

Figure 6. Fatigue stress cycles.

The total stress would remain at the tensile yield point and stress cycles would be unaltered during crack initiation and growth through the tensile-residual-stress zone. Once the crack tip reached the zero-residual-stress region, presence of tensile erection or settlement stress would raise the mean stress above the level shown in Figure 6 by an amount equal to the erection or settlement stress.

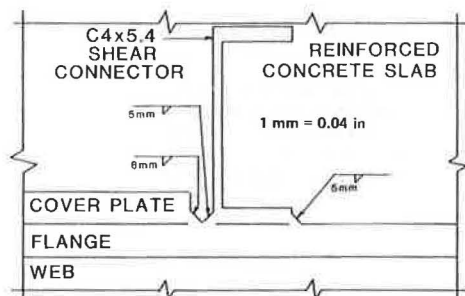
However, at 415 000 fatigue cycles, a routine visual inspection of the bridge revealed that cracks approximately 150 mm (6 in) long had developed in the top flanges of girder 1 at section 2 and girder 2 at section 6. Ultrasonic monitoring of the top flanges at sections 2 and 6 was immediately reinstated, but no additional cracks in top flanges were detected during the tests. The cracks in girder 1 at section 2 and girder 2 at section 6 propagated to failure, completely severing the flanges at 453 000 and 462 000 cycles, respectively. After completion of the fatigue test, the slab was removed and cracks in the welds at the ends of the cover plates were detected by using dye penetrant at sections 2.1A, 2.3A, and 6.1A.

Figure 7. Detail of top-flange critical section.

to essentially the same loading failed at less than 25 percent of the cycles permitted by the current code is reason for concern. In addition to the magnitude of stress range, there were two primary differences between these top-flange critical sections and the bottom flanges immediately below them. In the top flanges, the nominal stress range was entirely in the tension region; the maximum tensile stress was 101 MPa (14.7 ksi), whereas the nominal stress range in the bottom flanges was primarily in the compression region and the maximum tensile stress was only 17 MPa (2.5 ksi). The other difference was the particularly severe weld detail in the top flange. A channel shear connector had been fillet-welded to the base metal of the top flange adjacent to the end of the cover plate so that the two fillet welds were toe to toe and slightly overlapped (Figure 7).

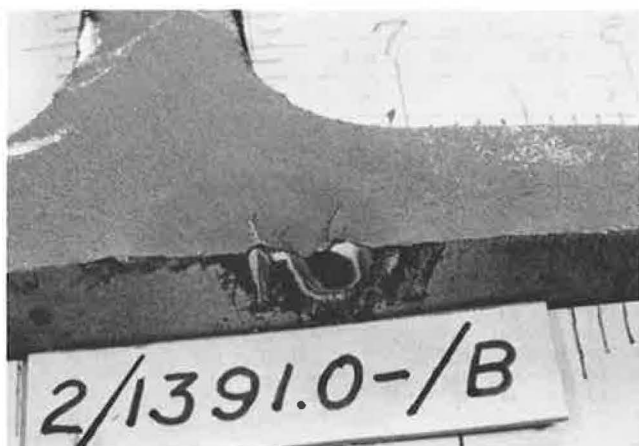
At 373 500 fatigue cycles, the bottom flange at girder 2 failed with a loud bang at the center of the center span. Although the stress cycles at this section were from essentially nothing to 223 MPa (32.3 ksi), there were no welds on the flange, and base metal at a stress range of 223 MPa would not be expected to fail until more than 1.25 million fatigue cycles had been applied. Examination of the fracture revealed that a fatigue crack had started at a heat number stamped on the face of the bottom flange (Figure 8).

A piece of the beam around the fracture was cut out for laboratory examination and a bolted splice applied so that the test could continue. At 470 700 fatigue cycles, this girder fractured again at another heat number about 102 mm (4 in) from the end of the splice. Although girder 2 suffered two fractures, no cracks were detected in the girders on either side of this girder even though they were both subjected to the same stress conditions and were also heat-stamped on the face of the bottom flange. Girder 2 was from a different heat of steel than the girders on either side, which led to speculation that there was a difference in the fatigue resistance of these two levels of heat. However, subsequent tests of material cut from these three girders have shown no significant differences in material properties. Thus, the difference appears to have been in the sharpness of the heat-stamp dies.

Figure 8. Fatigue crack initiated by heat stamp.

The premature failure of girder 2 at midspan points out the potential for fatigue-crack initiation resulting from the stamping of heat numbers in the flanges. Although this practice has been largely discontinued for rolled sections, it is still common practice to stamp identification numbers in plates during fabrication. If the final location of a stamped identification number is one of high repeated tensile stress, there is certainly a potential for fatigue-crack initiation. Consideration should be given to controlling the use of such identification stamps. The depth and sharpness of the stamp as well as its location are important factors.
