## Restoration of Meem's Bottom Covered Bridge

KENNETH M. SMITH AND JOHN E. ANDREWS

On October 28, 1976, the Meem's Bottom Covered Bridge in Shenandoah County, Virginia, was set on fire. Listed as a historical landmark on the Virginia Landmarks Register, the structure is the longest covered bridge in the state and is one of two that still carry traffic. At the direction of the Virginia General Assembly, the Virginia Department of Highways and Transportation undertook the task of rebuilding the structure and restoring it to service in such a manner as to maintain its historical significance. The conclusions derived from a structural analysis of the Burr arch-truss design and the novel procedures undertaken by the department to restore the bridge are presented. In completing the task, the department successfully maintained the 80-year-old structure's historical significance and satisfied the mandate of the General Assembly. Although completely destroyed, the load-carrying joints were rebuilt through extensive use of epoxy. Specially treated lumber, fire retardant varnishes, and stainless-steel roofing were used in the restoration to meet the need for fire protection and to minimize

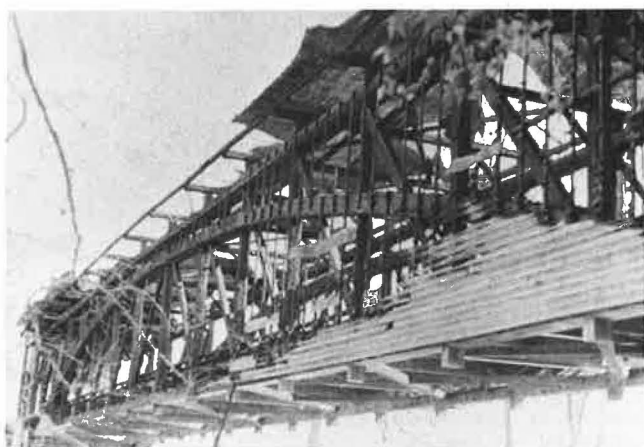
bridge in 1932 and maintained it in good repair. It carried a 9-t (10-ton) traffic rating until it was set on fire in 1976. In spite of the efforts of a volunteer fire department, the bridge was severely damaged, as can be seen in Figure 2. The roof system, top lateral system, siding, and framing were totally destroyed. The nail laminated oak strip flooring, which had been installed on steel stringers to replace the original timber floor system in 1937, was burned beyond repair but would later serve as a work platform during repairs. Only the main structural members remained and these had lost as much as 3.8 cm (1.5 in) of material from all sides. The heat was so intense that three floor stringers buckled and their weldments to the floor beams were broken.

Figure 2. Meem's Bottom Covered Bridge after the fire.

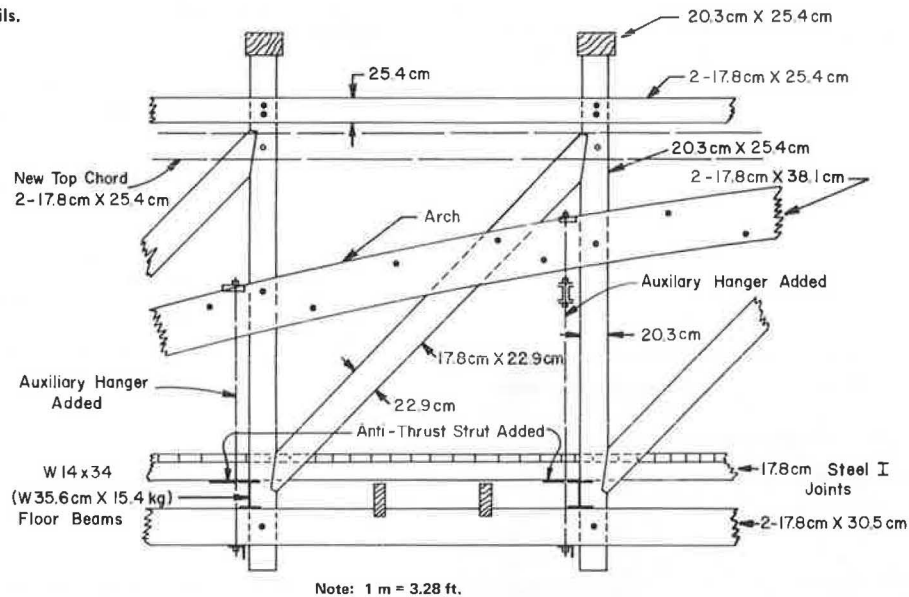
Figure 4. Typical panel details.

The most crucial of these errors was the manner in which the diagonal members were framed into the truss verticals, as illustrated in Figure 4. The eccentricity of the diagonal with respect to inter-sections of the top and bottom chords and the vertical members created the significant bending moments. The fixed joints at the intersection of the

The top chord of the truss was severely damaged and was later found to have large sections of rotting material and insect infestation. A new top chord was warranted and could be put immediately below the old one before it was removed so that the eccentric load of the diagonal would be eliminated (Figures 4 and 5).

The point of eccentricity at the bottom chord was at a position where the horizontal thrust of the diagonal could be transferred through the vertical into the floor system by welding a strut plate to the floor beam and the exterior stringer, as shown in Figures 4 and 6. Although all of the bending in the vertical at this point could not be eliminated, this procedure did reduce the undesirable bending to acceptable levels.

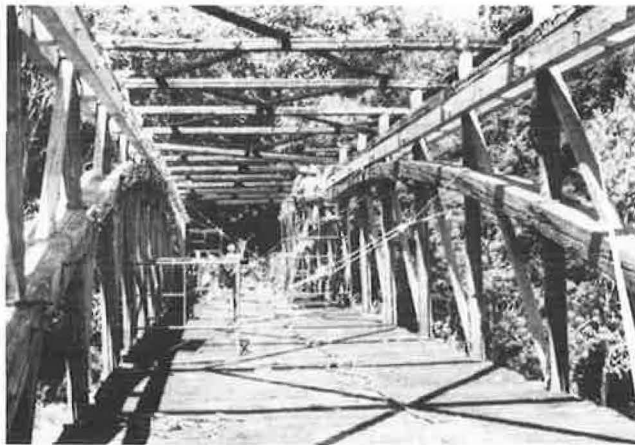
Figure 5. Installation of new top chord.

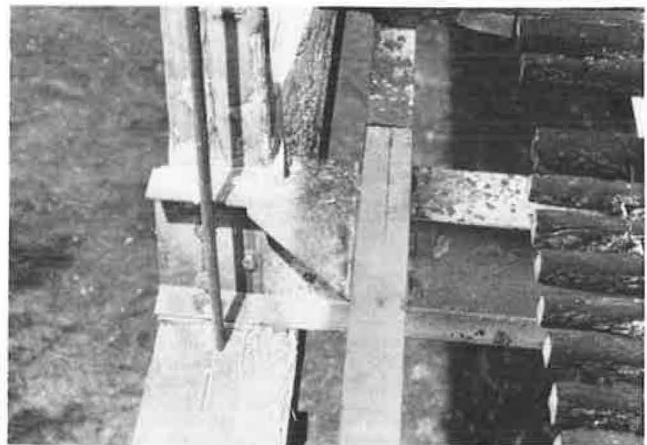
Figure 6. Installation of antithrust strut plate.

The new top lateral system was erected along with the framing for the new roof (see Figure 12). Stringers warped from the intense heat were replaced and the antithrust strut plates (Figure 6), which were to reduce the bending moments in the verticals at the lower diagonal connections, were welded in place.

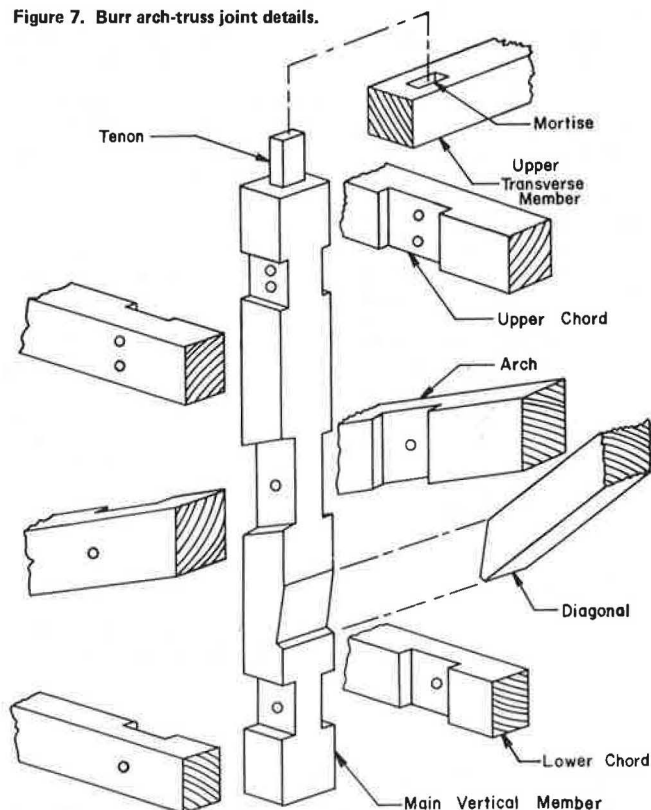
Figure 7. Burr arch-truss joint details.

Originally, the vertical truss member had been shaped to lock into the top chord, arch, and bottom chord and was notched to provide a bearing seat for the diagonal members that passed cleanly through the arch (Figure 7). When a live load was placed on the verticals, the interlocking action of the joints transferred the load to the truss members and into the arch. These joints, which had been cut, shaped, and matched to bear the loads, had been destroyed by the fire, as shown in Figure 8. Large gaps were left where tight bearing surfaces had been. Only the splice joints in the arch escaped fire damage, perhaps because of the tight bearing caused by the dead load. In many places the gap around the vertical through the arch was large enough to pass an arm through the arch all around the vertical. Neat rectangular cross sections no longer existed.

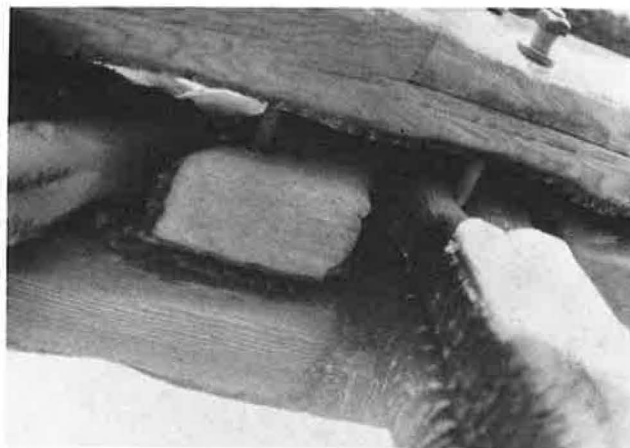
Figure 8. Typical joint destruction.

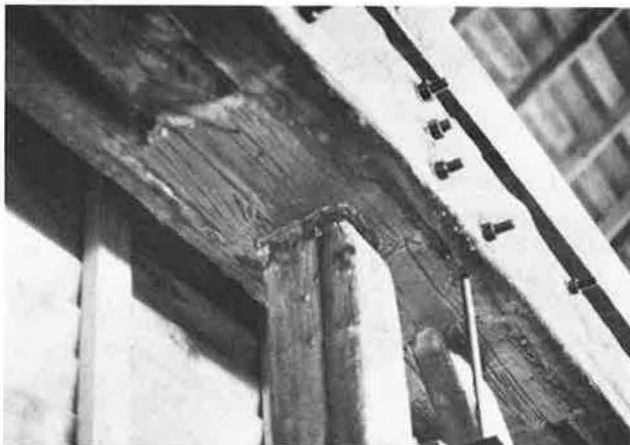
Figure 9. Typical joint restoration.

Several ideas were considered in engineering the reconstruction of the joints, all of which incorporated the use of epoxy to some degree. Ultimately, a high modulus, low-viscosity epoxy resin system was used that, when mixed with a wood flour, gave the appearance of wood to the rebuilt areas, as can be seen in Figure 9. Several different flours were considered. Walnut shell, maple wood, and pine flours (the last called white tag) were mixed in the laboratory. The specification finally written left the type of flour open and only required that the epoxy and wood-flour mixture should closely resemble the color of the timber being repaired.

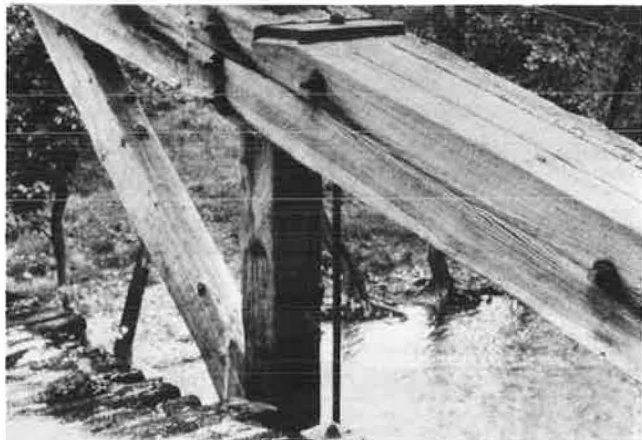
Figure 10. Auxiliary hanger system.

The epoxy-restored joints were considered satisfactory where they were in pure compressive bearing, but there was still doubt about the adequacy of the vertical-to-arch connection. The fire had destroyed these bearing surfaces and the epoxy restoration could not be trusted at this location because its purpose was to fill the void, not to transfer load by shear and tension forces. Consequently, an auxiliary hanger system, shown previously in Figure 4, was devised (see Figure 10). To serve as a stirrup, a structural angle was placed close to the floor beam and under the bottom chord. The stirrup angle was then suspended from the arch by a threaded, high-strength rod that passed through the bottom chord and the arch. Above the arch the rod was attached to a structural steel bearing plate, which was seated in the epoxy and wood-flour compound on a chamfer cut across the arch in such a manner as to ensure that the hanger load was applied uniformly across the arch members.

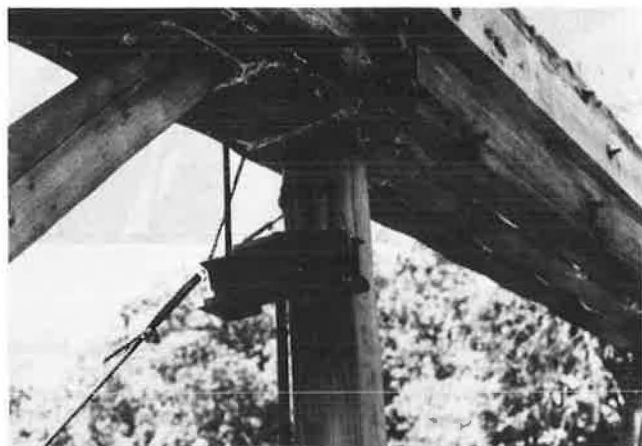
Figure 11. Auxiliary hanger system at middle verticals.

A slight variation of this device, shown in Figure 11, was necessary at the three middle verticals due to the framing of the diagonal at the top of the arch. At these locations the hanger rod was supported by a bracket composed of two small channels. This bracket was suspended from the arch by two rods that passed through the arch on either side of the diagonal truss member. Individual bearing plates seated on a chamfer and bedded with the epoxy and wood-flour compound on both sides of the diagonal to support the two rods completed this variation of the hanger system.

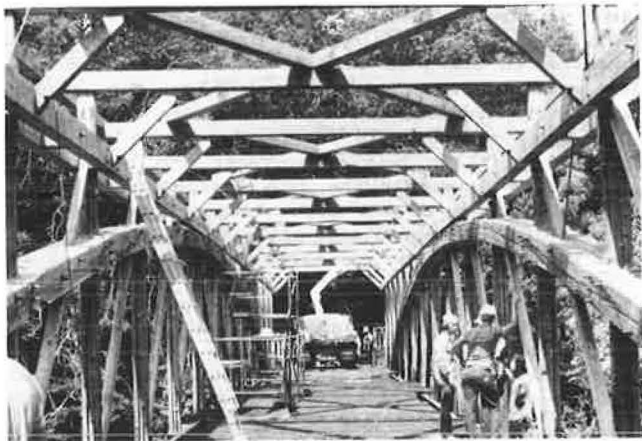
Figure 12. Installation of top lateral system.

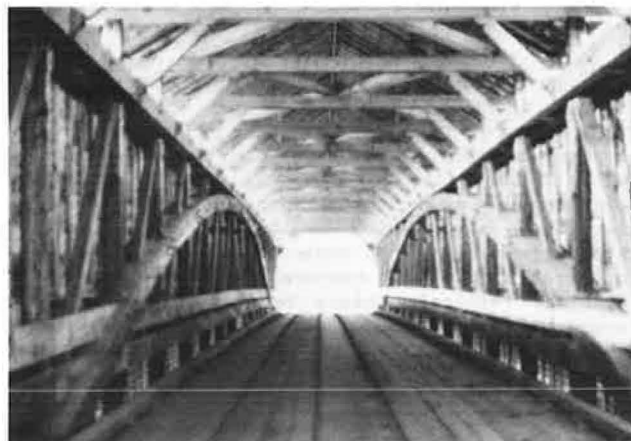
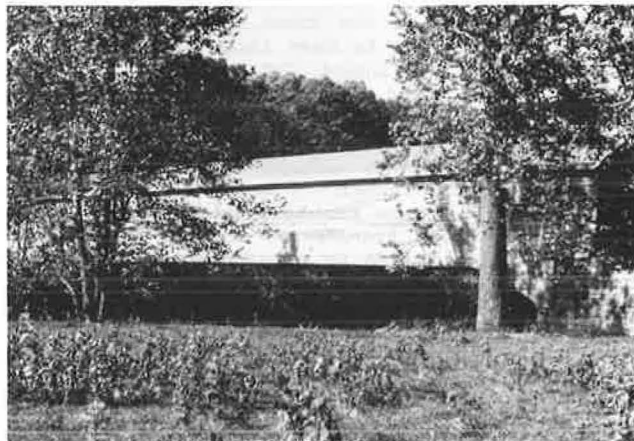
Figure 13. Interior of bridge after restoration.

Figure 14. Restored Meem's Bottom Covered Bridge.

All new timber used in the restoration was given a dual pressurized treatment of a preservative and a fire retardant that would not alter the appearance of the wood. The existing material left in place was given several coats of a clear fire-retardant varnish that slightly darkened the old timbers. Oak plank wearing strips were placed over the deck panels and the bridge was once again ready for service (see Figures 13 and 14).
