Effect of Moving Traffic on Fresh Concrete During Bridge-Deck Widening

HOWARD L. FURR AND FOUAD H. FOUAD

Traffic in lanes adjacent to a deck that is being widened or reconstructed causes deflections and vibrations in the fresh concrete deck. A study of the effects of

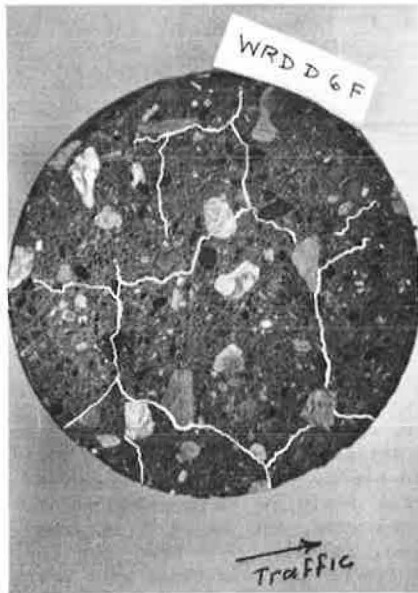
Figure 9. Trace of cracks on polished surface of 4-in-diameter concrete core.

through perpendicular to their axes, polished, and inspected through a magnifying glass. These polished surfaces were then treated with a crack-detecting substance that was fluorescent under black light; they were then studied further for crack patterns. The cracks on one of these surfaces have been inked in for emphasis in Figure 9.

Examination of the bridge cores revealed numerous microscopic to hairline cracks, but the patterns were random and the depths were, for the most part, shallow. The few that extended through the slabs were attributed to shrinkage or a combination of shrinkage and flexure from traffic. Twenty-one of 55 randomly cracked cores were taken from undisturbed areas, and 34 came from disturbed areas. The 21 cores make up 58 percent of all undisturbed cores, and the 34 make up 47 percent of the disturbed cores. It is concluded from this that random cracking was not caused by traffic disturbance during placement and curing of the deck concrete. There is no indication that transverse bending caused longitudinal cracking in the decks.

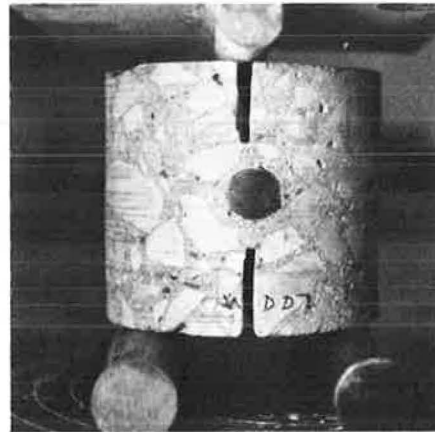
Figure 10. Grooved core prepared for inspection of dye penetration.

crete. Figure 10 shows a specimen being broken to reveal the steel; the grooves in the core were sawed after removal of the core from the vacuum pot.

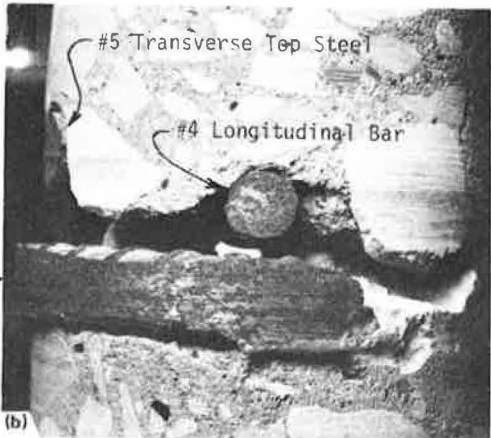
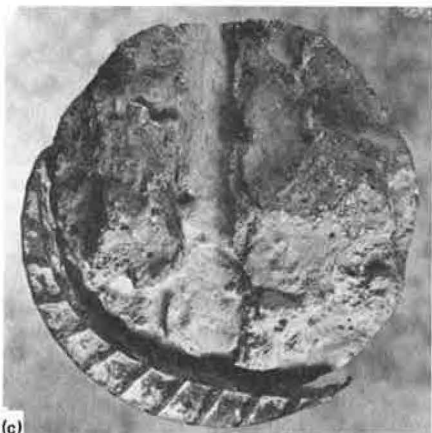
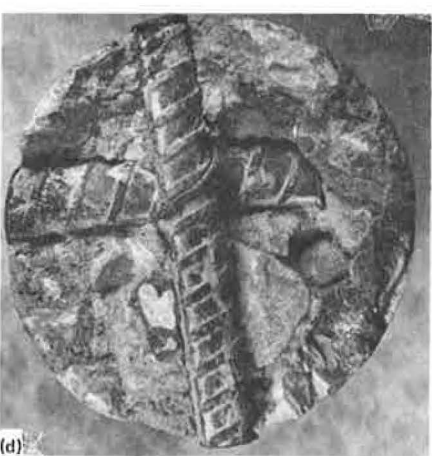
Figure 13. Core WRDD10F from south-bound traffic bridge, US-75 and White Rock Creek: (a) layout, (b) side view, (c) lower section, and (d) upper section.

study of disturbance in the fresh concrete. The top surface was cracked in the general direction of traffic, and the interface of steel to concrete had the appearance of puddled plastic concrete. All traces of bar deformation marks were lost. It is believed that intermittent deflections from traffic caused puddling of the fresh concrete. This puddling formed a layer of uncemented particles that was flushed out by the water from the core drill. Figures 13a-13d show details of the core.

The bridge from which this core was taken had a dowel-bar detail that was different from any other in the study, and no record has been found of its use in any other bridge. This dowel was bent 90 degrees in the horizontal plane on emerging from the older concrete, and it was embedded when the new concrete was placed. In some spots either longitudinal steel or transverse steel or both were tied to or rested on the bent dowel prior to placement of the new concrete. The bent dowel can be seen in Figure 13. The dowels in all of the other bridges ran straight across the joint and were not bent. No problems were found with the straight dowels.

Horizontal bend, #5 bar from old concrete crossing joint to new concrete.

Extend all dowel reinforcing bars approximately 24 bar diameters straight into the new deck area. Lap splice these dowels 20 bar diameters with the reinforcing bars that serve as transverse reinforcing for the new concrete. Tie the top-mat steel system to the dowels to prevent relative vertical movement between the dowels and the top-mat steel. This detail will provide a space between the end of the

top rebars and the break joint for a temporary filler, sometimes used in construction by stages, and sufficient lap length for transfer of flexural stress. The ties are needed to ensure that the dowels and the rebars move in harmony, thus preventing the occurrence of voids found at the bent dowels.

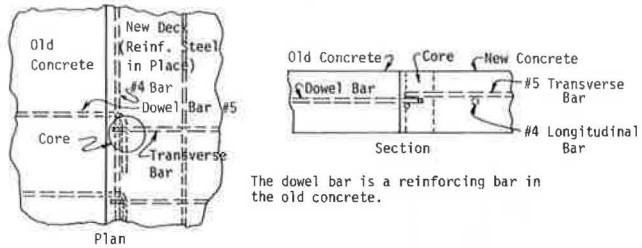
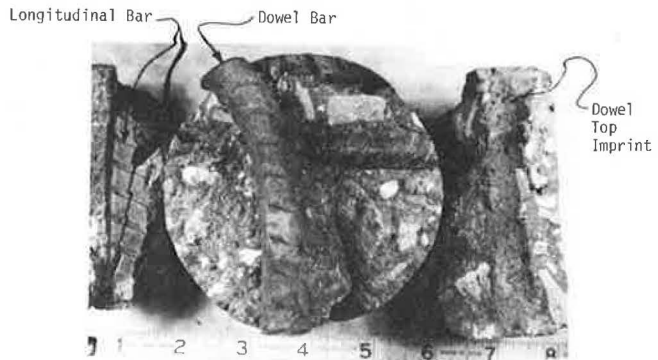
Figure 14. Core WRDD4: (top) schematic indicating location, (bottom) actual dowel bar and imprint.

Four other cores from the bent-bar dowel bridges (they were twin structures) showed evidence of differential movement between the steel and the concrete. All of them were located within 12 in of the break line. Puddled areas or poor bar imprints were found at the dowel or at steel that was tied directly or indirectly to the dowel. No cores located more than 12 in from the joint showed any distress.

Under vacuum, dye penetrated around the bars of three of the four cores mentioned in the paragraph above. One of these is seen in Figure 14. In all of these, penetration along with poor bar imprints indicated poor or total absence of bond at the particular location. Some dye penetrated a fraction of an inch along the ends of all bars cut by the drill in coring, but bar imprints were good in all except those noted above.
